## **ASBESTOS INSPECTION REPORT**

**1131 W. Second St.  
Dayton, OH 45402**

**Lynda M. Hart  
Asbestos Hazards Evaluation Specialist  
Ohio #ES-32558  
Feb 17, 2014**

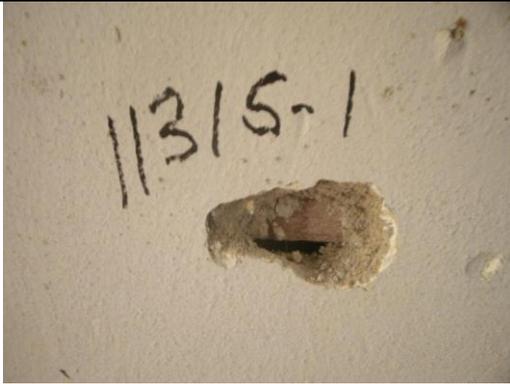
Photo 1: Plaster (1131S-1) Dining Room, Wall B. No Asbestos Detected.

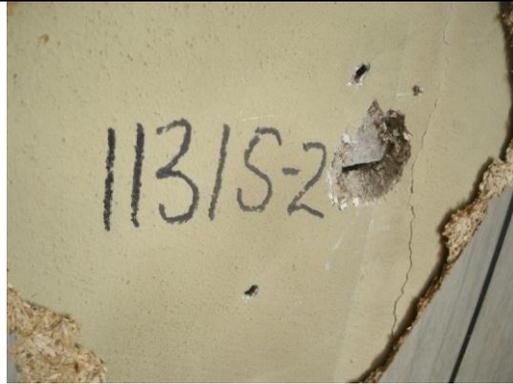
Photo 2: Plaster (1131S-2) Living Room Wall D. No Asbestos Detected.

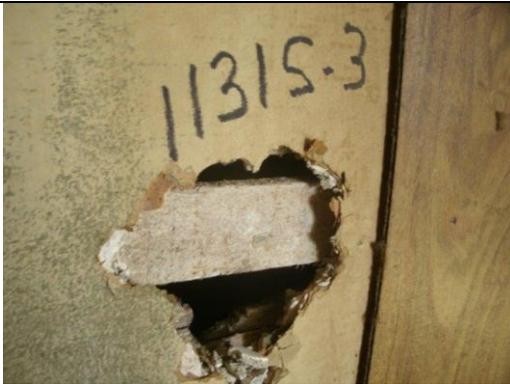
Photo 3: Plaster (1131S-3) Bedroom 1, Wall C. No Asbestos Detected.

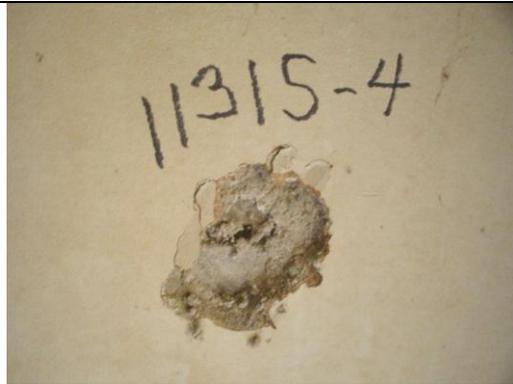
Photo 4: Plaster (1131S-4) Bedroom 3, Wall D. No Asbestos Detected.

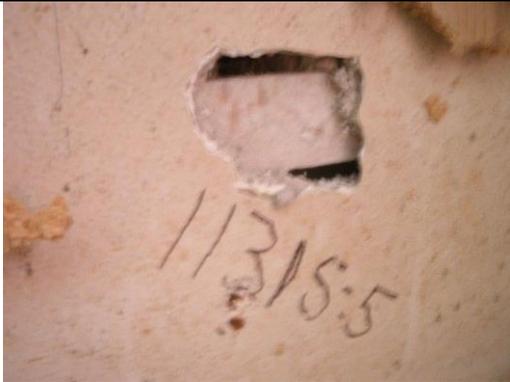
Photo 5: Plaster (1131S-5) Bath, Wall A. No Asbestos Detected.

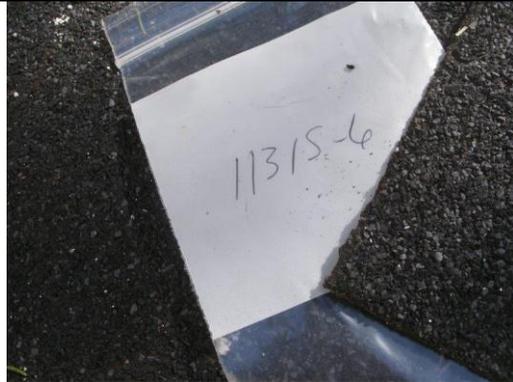
Photo 6: Shingles (1131S-6) Roof. No Asbestos Detected.

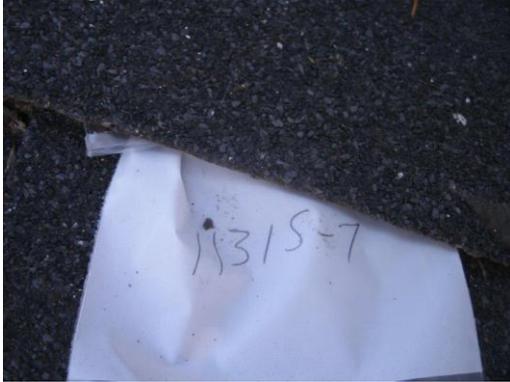
**Photo 7: Shingles (1131S-7) Roof. No Asbestos Detected.**

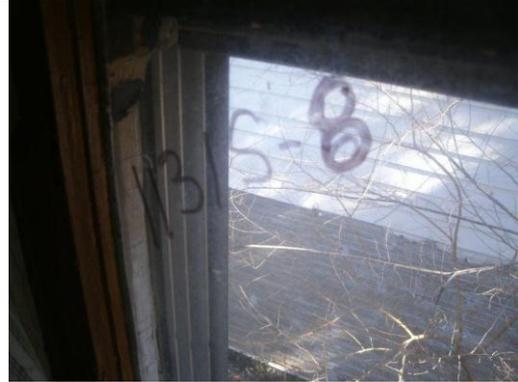
**Photo 8: Window glazing (1131S-8) Bedroom 3, Wall D. 3% Chrysotile (PC=1.75%) Asbestos Detected.**

Confirmed or assumed asbestos-containing materials, which will be disturbed during demolition activities, are regulated under current Federal and State regulations. Hart Environmental Resources recommends the removal of these materials by a licensed asbestos abatement contractor. It is also strongly recommended that the specifications for the removal program be developed by a licensed Asbestos Project Designer to ensure that all regulatory requirements are satisfied. The work should be properly documented in the event of future litigation.

<u>Material</u>	<u>Est. Qty.</u>	<u>Est. Unit Cost</u>	<u>Est. Cost</u>
Window Glazing	12	\$ 25/ea	\$ 300

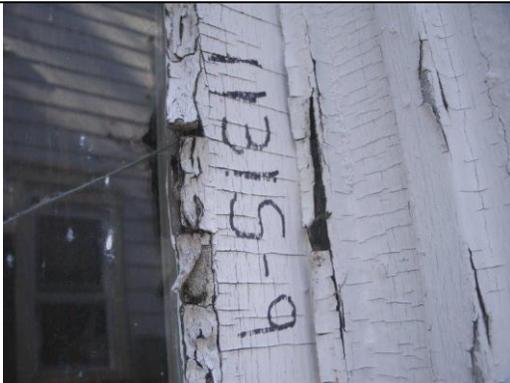
**Photo 9: Window glazing (1131S-9) Kitchen, Wall D. 3% Chrysotile (PC=2.25%) Asbestos Detected.**
