ASBESTOS INSPECTION REPORT

**1609 Salem Avenue
Dayton, OH 45406**

Re: Asbestos Inspection
1609 Salem Avenue
Dayton, Ohio 45406

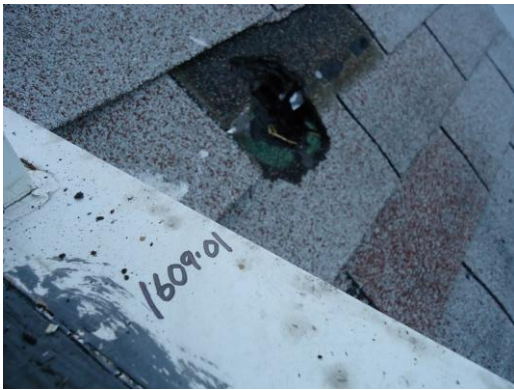
Photo 1: Roofing, (1609-1) Roof. No Asbestos Detected.

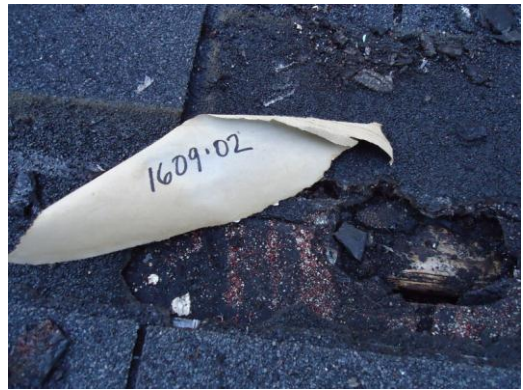
Photo 2: Roofing, (1609-2) Roof. No Asbestos Detected.

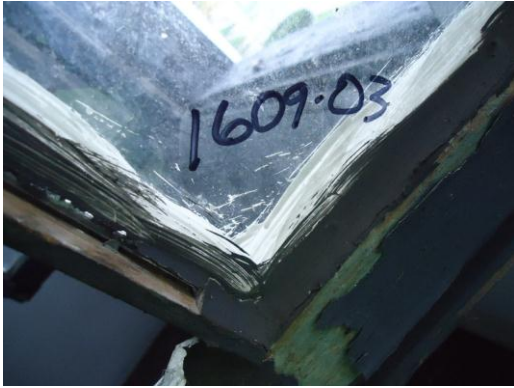
Photo 3: Window caulk (1609-3) Hallway South Wall. No Asbestos Detected.

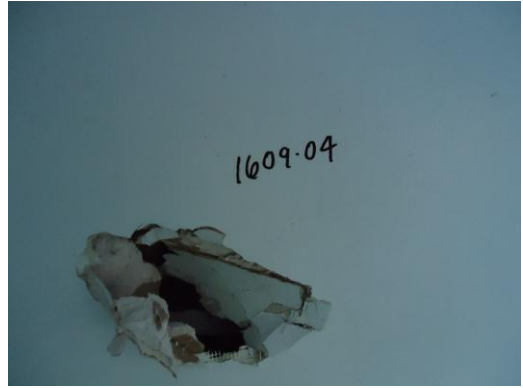
Photo 4 Drywall (1609-4) Room 1 West Wall. No Asbestos Detected.

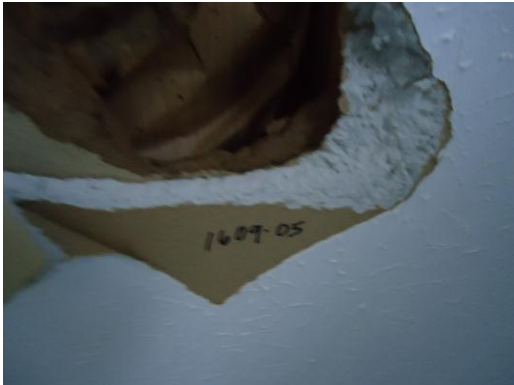
Photo 5: Drywall (1609-5) Room 1 West Wall. No Asbestos Detected.

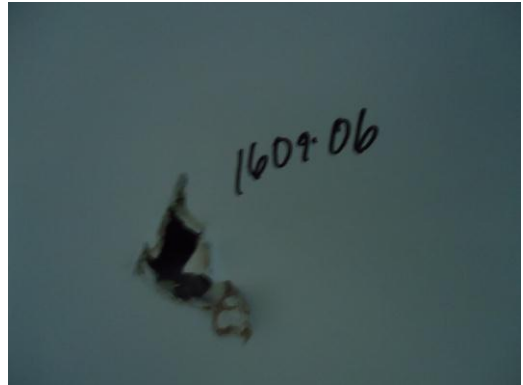
Photo 6: Drywall (1609-6) Room 3 East Wall. No Asbestos Detected.

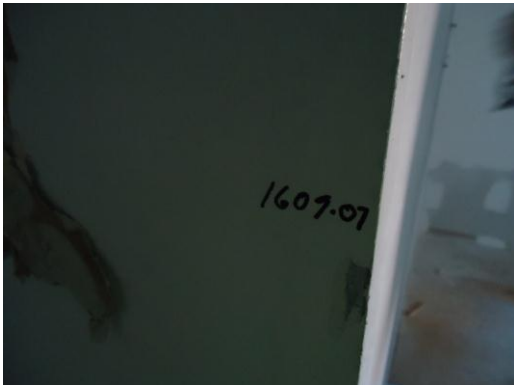
Photo 7: J.C. (1609-7) Bath East Wall. No Asbestos Detected.

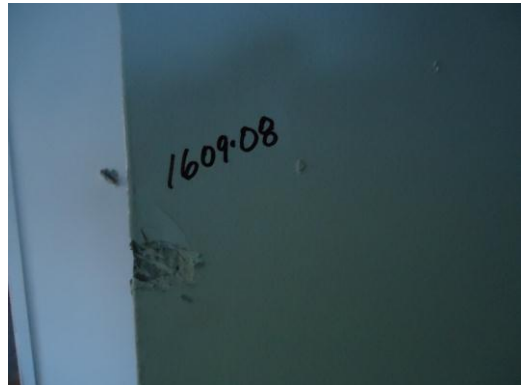
Photo 8: J.C. (1609-8) Hallway West Wall. No Asbestos Detected.

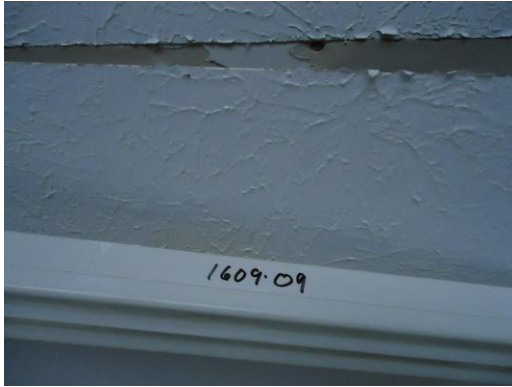
Photo 9: J.C. (1609-9) Room 1 West Wall. No Asbestos Detected.

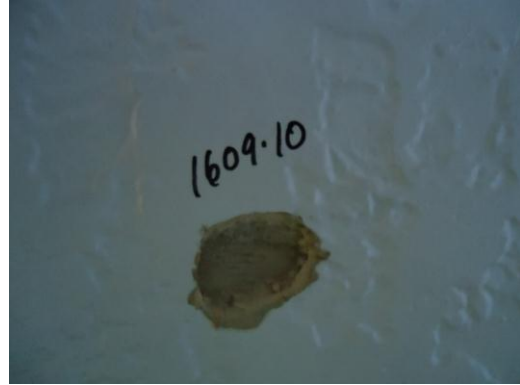
Photo 10: Wall Plaster (1609-10) Living Room North Wall. No Asbestos Detected.

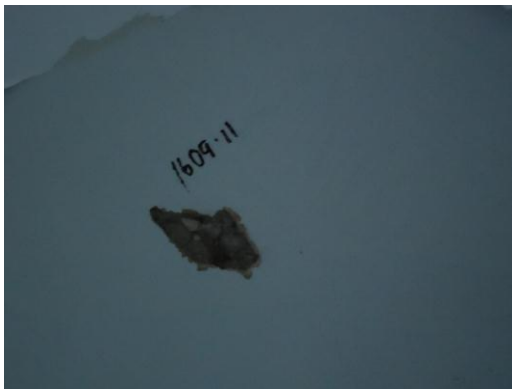
Photo 11: Ceiling Plaster (1609-11) Dining Room. No Asbestos Detected.

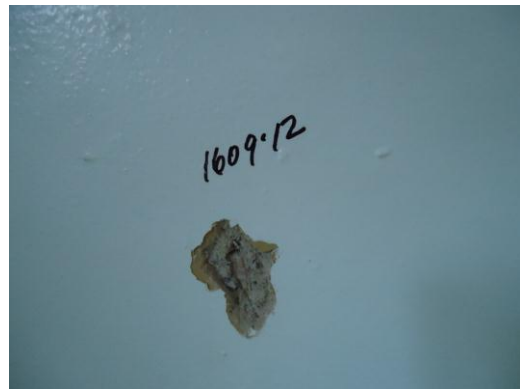
Photo 12: Wall Plaster (1609-12) Kitchen East Wall. No Asbestos Detected.

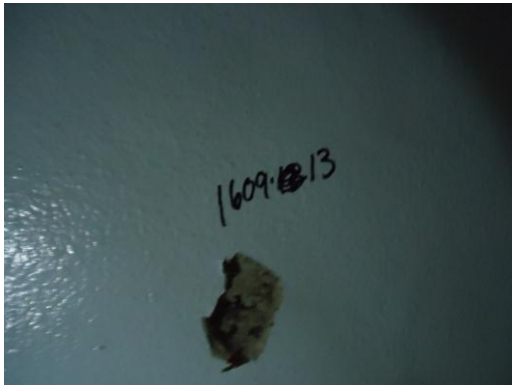
Photo 13: Wall Plaster (1609-13) Room 5 South Wall. No Asbestos Detected.

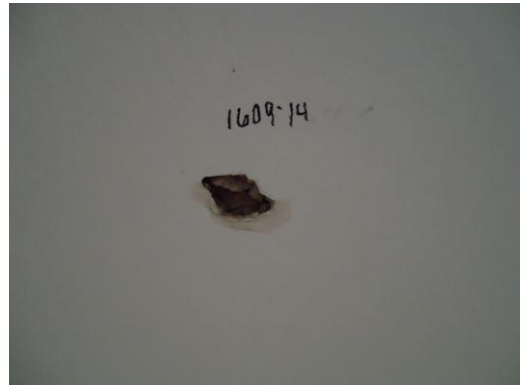
Photo 14: Ceiling Plaster. (1609-14) Bath. No Asbestos Detected.

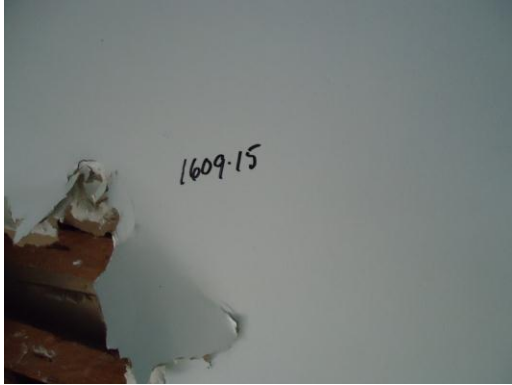
Photo 15: Drywall (1609-15) Kitchen West Wall. No Asbestos Detected.

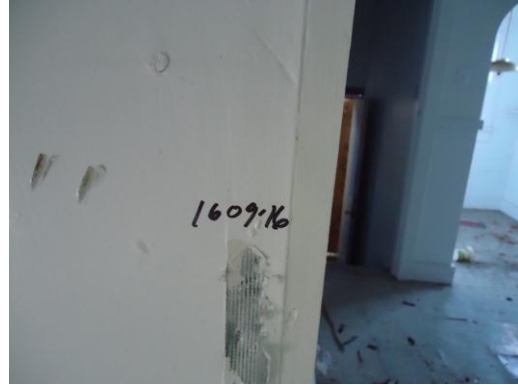
Photo 16: J.C. (1609-16) Kitchen West Wall. No Asbestos Detected.

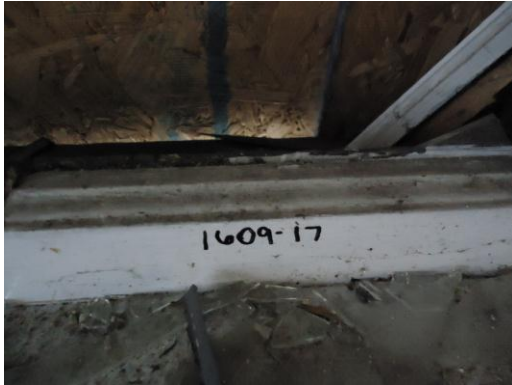
Photo 17: Window Caulk (1609-17) Living Room East Wall. No Asbestos Detected

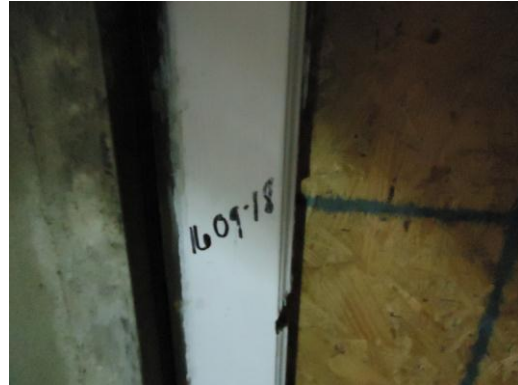
Photo 18: Window Caulk (1609-18) Room 5 South Wall. No Asbestos Detected

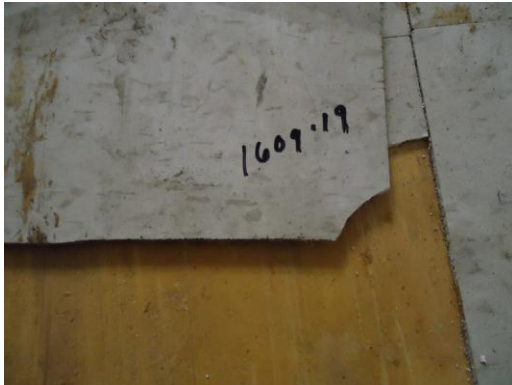
Photo 19: Floor Tile (1609-19) Bath. No Asbestos Detected

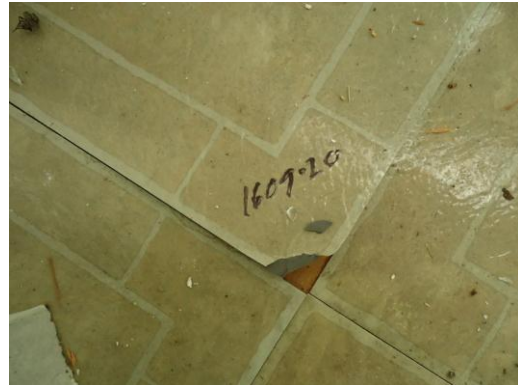
Photo 20: Floor Tile (1609-20) Kitchen. No Asbestos Detected

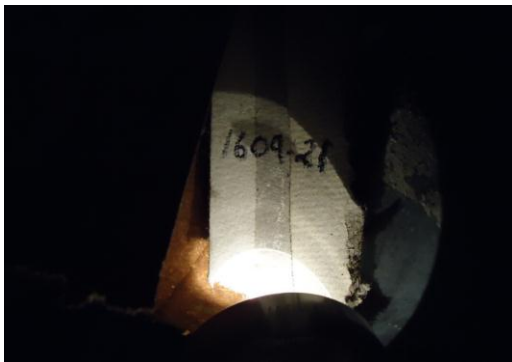
- White, Duct Paper, Basement.

Photo 21: Duct Paper (1609-21) Basement. 50% Chrysotile Asbestos Detected.

SanAir ID / Description	Stereoscopic Appearance	Components		Asbestos Fibers
		% Fibrous	% Non-Fibrous	
1609-21 / 13024813-021 Basement Duct Paper	White Fibrous Homogeneous		50% Other	50% Chrysotile

Confirmed or assumed asbestos-containing materials, which will be disturbed during demolition activities, are regulated under current Federal and State regulations. Hart Environmental Resources recommends the removal of these materials by a licensed asbestos abatement contractor. It is also strongly recommended that the specifications for the removal program be developed by a licensed Asbestos Project Designer to ensure that all regulatory requirements are satisfied. The work should be properly documented in the event of future litigation.
