## **ASBESTOS INSPECTION REPORT**

**152 Kirkham St.  
Dayton, OH 45417**

**Lynda M. Hart  
Asbestos Hazards Evaluation Specialist  
Ohio #ES-32558  
February 20, 2015**

**Re:** Asbestos Inspection  
152 Kirkham St.  
Dayton, OH 45417

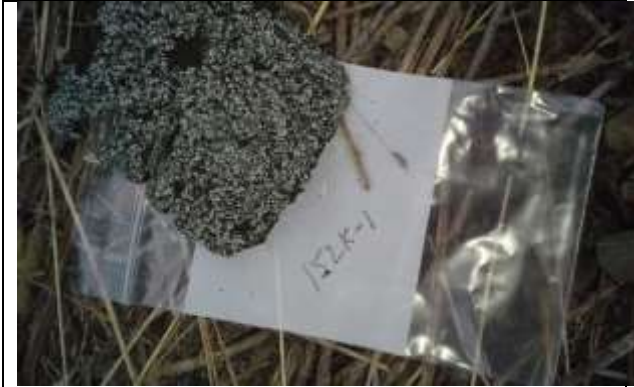
**Photo 1: Roof Shingle (152K-1) Exterior.  
No Asbestos Detected.**

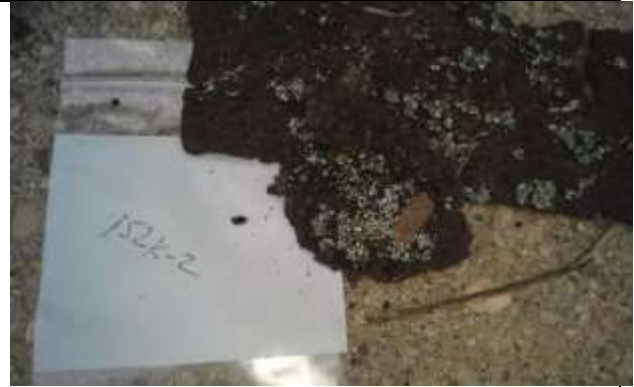
**Photo 2: Roof Shingle (152K-2) Exterior.  
No Asbestos Detected.**

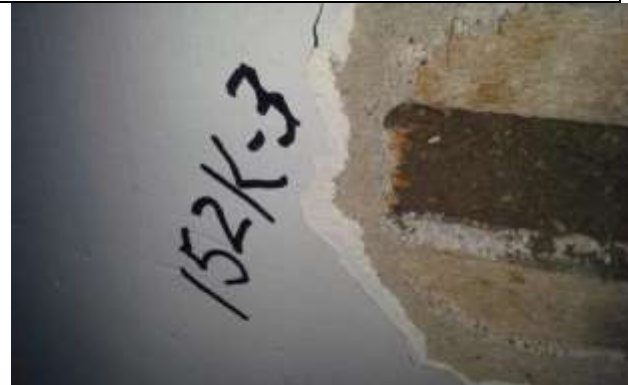
**Photo 3: Plaster (152K-3) Living Room,  
Wall A.  
No Asbestos Detected.**

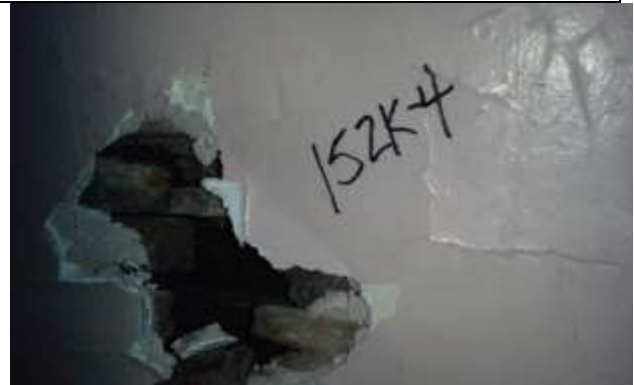
**Photo 4: Plaster (152K-4) Kitchen, Wall D.  
No Asbestos Detected.**

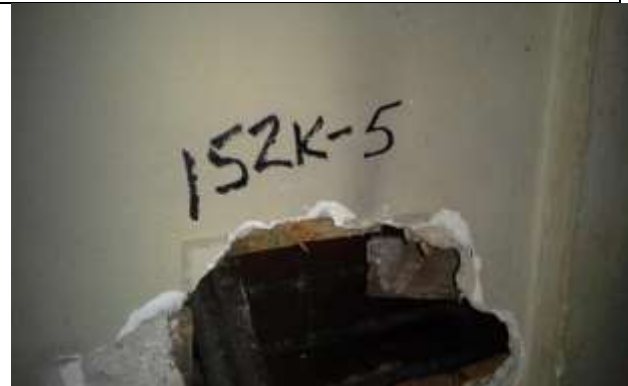
**Photo 5: Plaster (152K-5) Dining Room, Wall B.  
No Asbestos Detected**

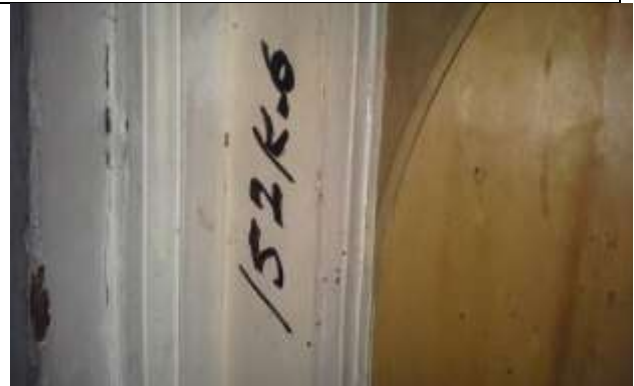
**Photo 6: Window Glazing (152K-6) Dining Room, Wall D.  
No Asbestos Detected**

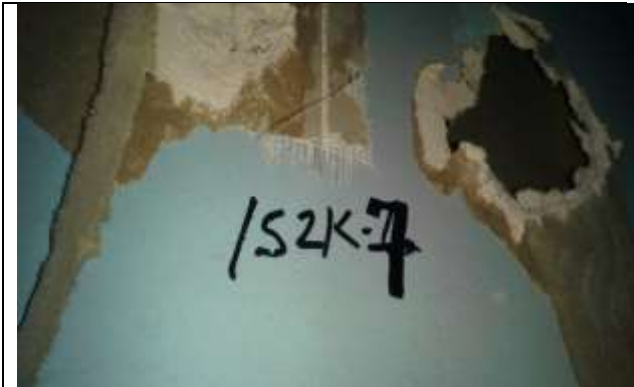
Photo 7: Drywall/J.C. (152K-7) Bath 1, Wall A.  
No Asbestos Detected.

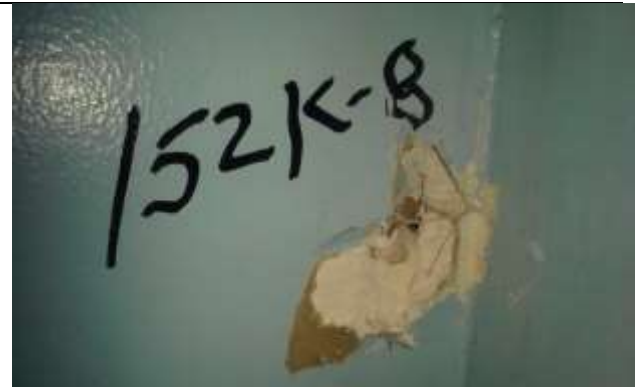
Photo 8: Drywall/J.C. (152K-8) Bath 1, Wall D.  
No Asbestos Detected.

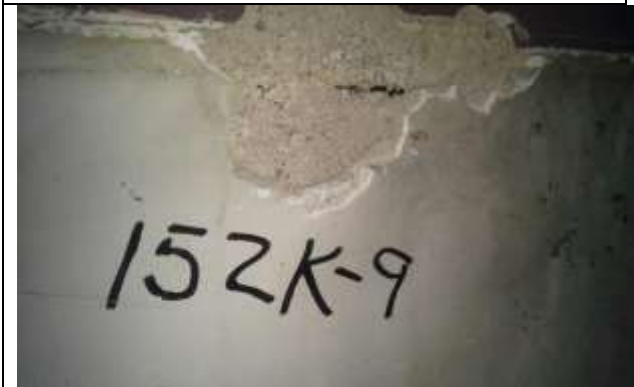
Photo 9: Plaster (152K-9) Bedroom 2, Wall B.  
No Asbestos Detected.

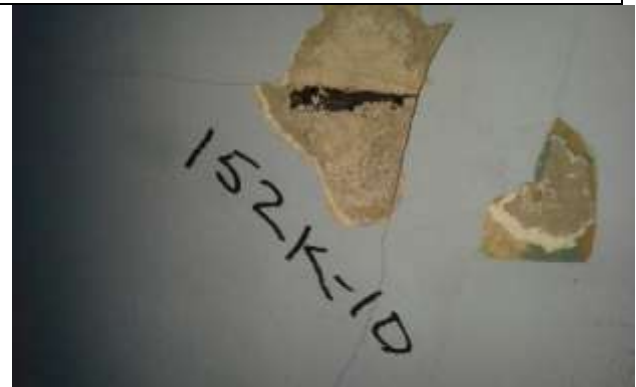
Photo 10: Plaster (152K-10) Bedroom 1, Wall C.  
No Asbestos Detected.

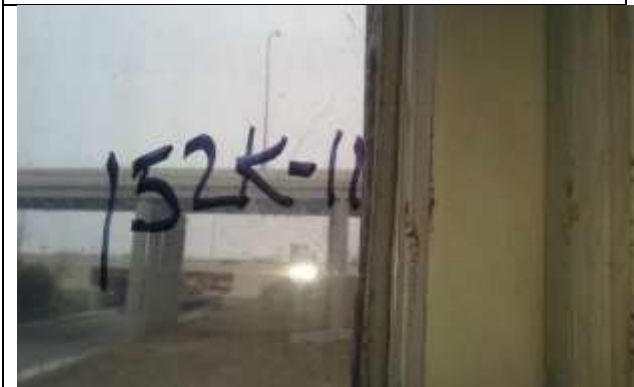
Photo 11: Window Glazing (152K-11) Bedroom 1, Wall A.  
No Asbestos Detected.
