ASBESTOS INSPECTION REPORT

**154 Kirkham St.
Dayton, OH 45417**

Re: Asbestos Inspection
154 Kirkham St..
Dayton, OH 45417

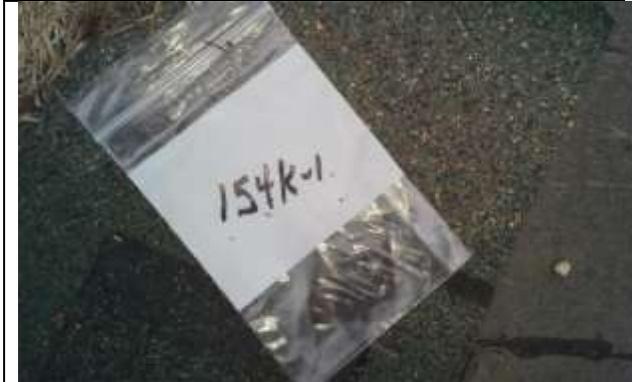
Photo 1: Roof Shingle (154K-1) Exterior.
No Asbestos Detected.

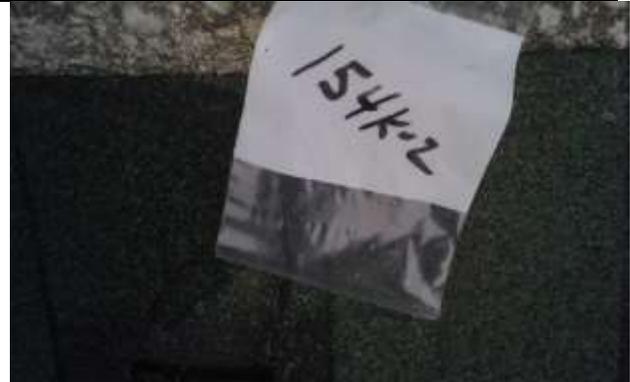
Photo 2: Roof Shingle (154K-2) Exterior.
No Asbestos Detected.

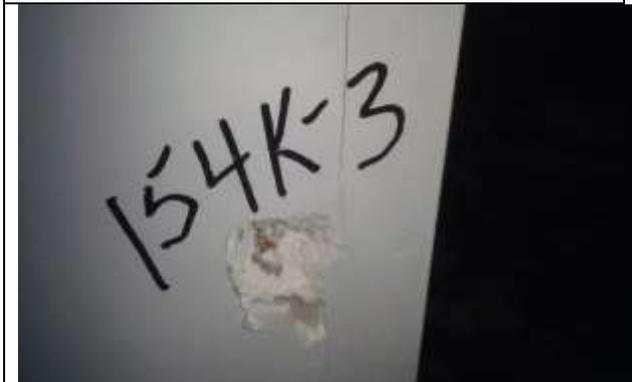
Photo 3: Drywall (154K-3) Kitchen.
No Asbestos Detected.

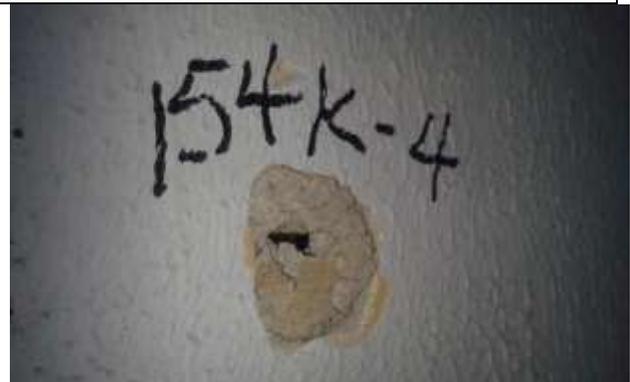
Photo 4: Plaster (154K-4) Dining Room, Wall A.
No Asbestos Detected.

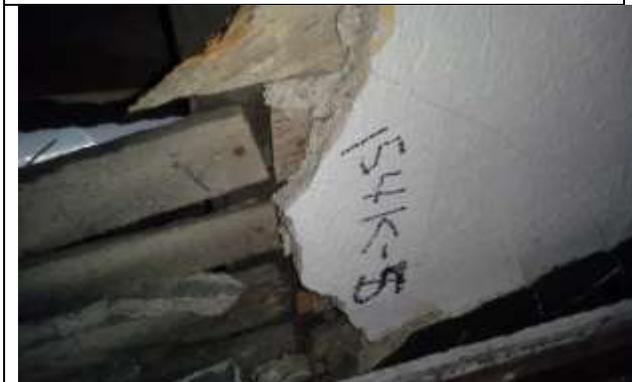
Photo 5: Plaster (154K-5) Living Room, Wall D.
No Asbestos Detected

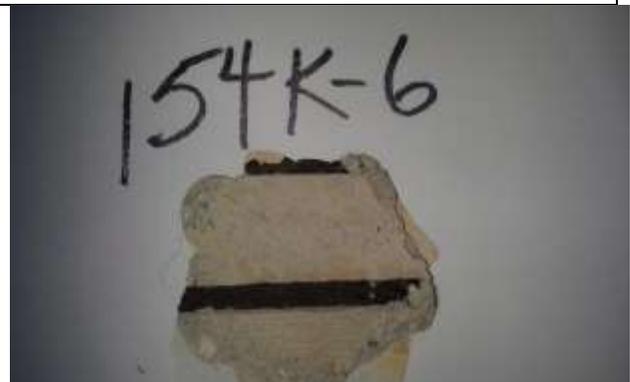
Photo 6: Plaster (154K-6) Bedroom 1, Wall A.
No Asbestos Detected

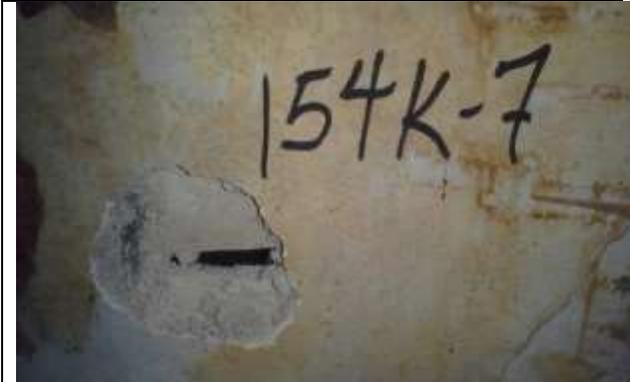
Photo 7: Plaster (154K-7) Bedroom 3, Wall A.
No Asbestos Detected.

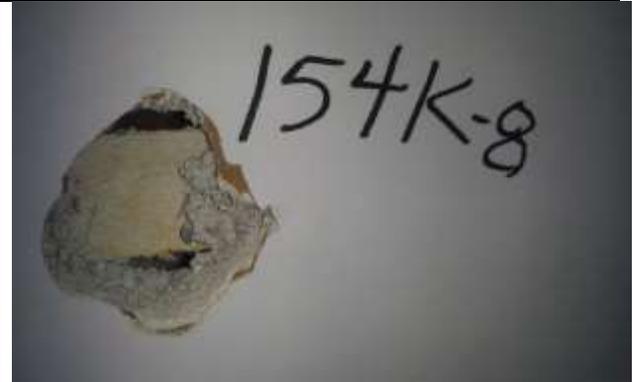
Photo 8: Plaster (154K-8) Bedroom 2, Wall C.
No Asbestos Detected.

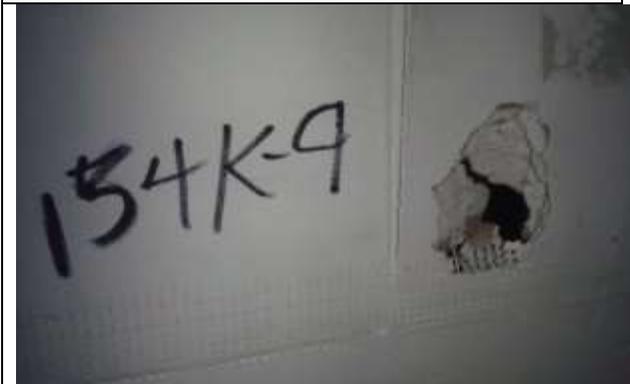
Photo 9: Drywall/J.C. (154K-9) Bedroom 4, Stairs, Wall B.
No Asbestos Detected.

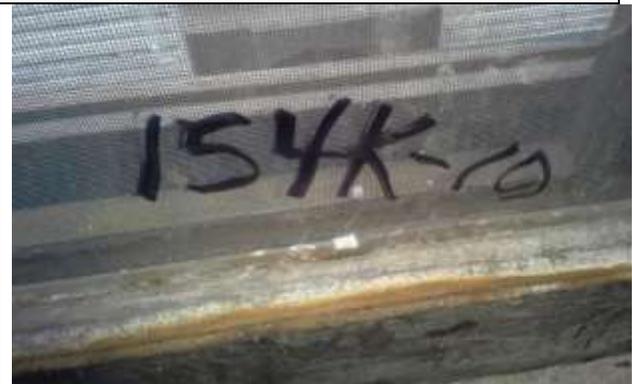
Photo 10: Window Glazing (154K-10) Stairwell Second Floor, Wall B.
No Asbestos Detected.

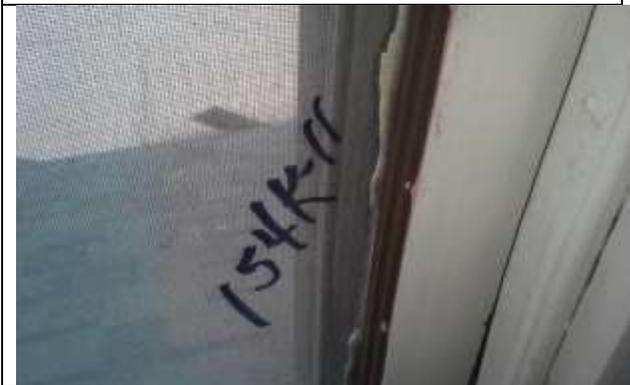
Photo 11: Window Glazing (154K-11) Bedroom 3, Wall A.
No Asbestos Detected.
