## **ASBESTOS INSPECTION REPORT**

**4645 Dayview Ave.  
Dayton, Ohio 45417**

**Lynda M. Hart  
Asbestos Hazards Evaluation Specialist  
Ohio #ES-32558  
February 20, 2015**

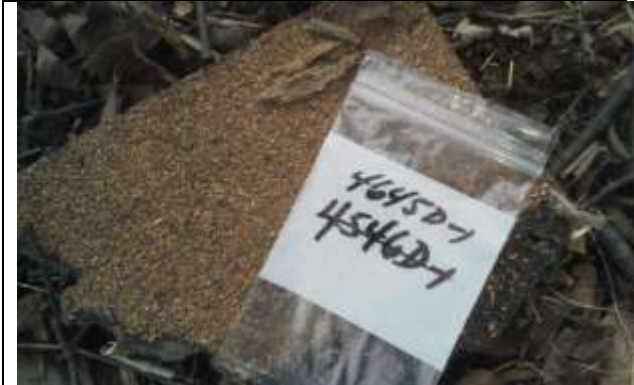
Photo 1: Roof Shingle (4645D-1) Roof.  
No Asbestos Detected.

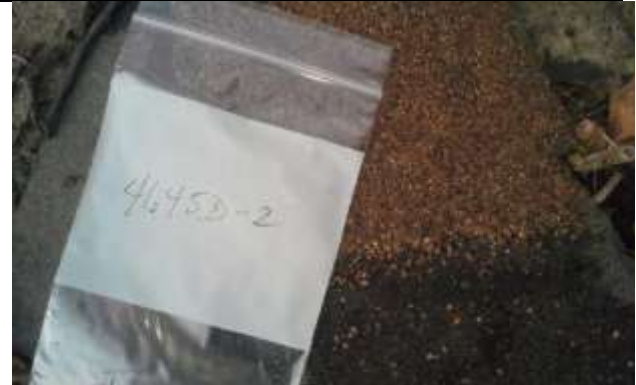
Photo 2: Roof Shingle (4645D-2) Roof.  
No Asbestos Detected.

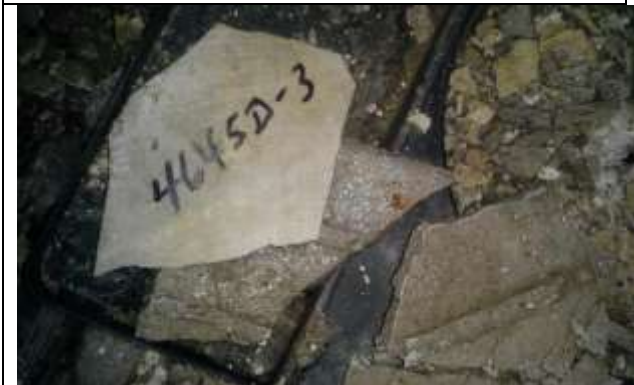
Photo 3: Plaster (4645D-3) Living Room, Ceiling.  
Trace <1% Chrysotile Asbestos Detected (PC=0.25%).

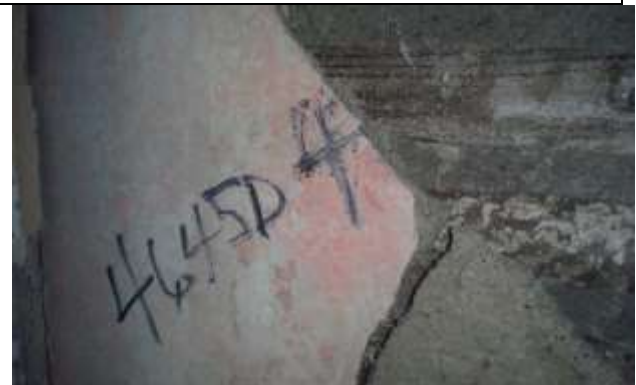
Photo 4: Plaster (4645D-4) Dining Room, Wall D.  
Trace <1% Chrysotile Asbestos Detected (PC=<0.25%).

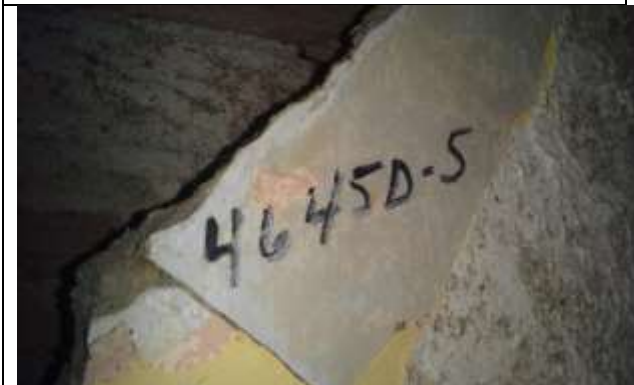
Photo 5: Plaster (4645D-5) Kitchen, Wall A.  
Trace <1% Chrysotile Asbestos Detected (PC=<0.25%).

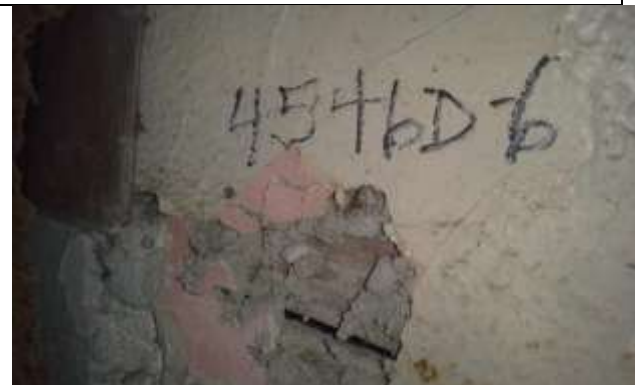
Photo 6: Plaster (4645D-6) Bedroom 2, Wall D.  
Trace <1% Chrysotile Asbestos Detected (PC=0.25%).

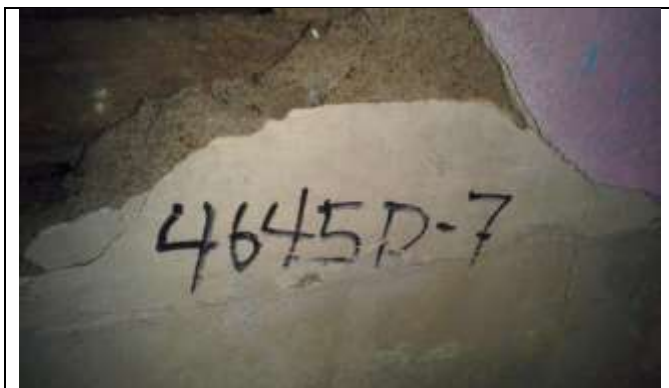
4645D-07 15-02-01447-007 15-02-01447-005	-	2	Plaster, Bedroom 1, Wall D, Inhomogeneous	Non-friable	<b>Trace &lt;1% Chrysotile Asbestos Detected (PC=&lt;0.25%)</b>

**Photo 7: Plaster (4645D-7) Bedroom 1, Wall D.  
Trace <1% Chrysotile Asbestos Detected (PC=<0.25%).**
