## **ASBESTOS INSPECTION REPORT**

**312 Geneva Rd.  
Dayton, OH 45417**

**Lynda M. Hart  
Asbestos Hazards Evaluation Specialist  
Ohio #ES-32558  
February 20, 2015**

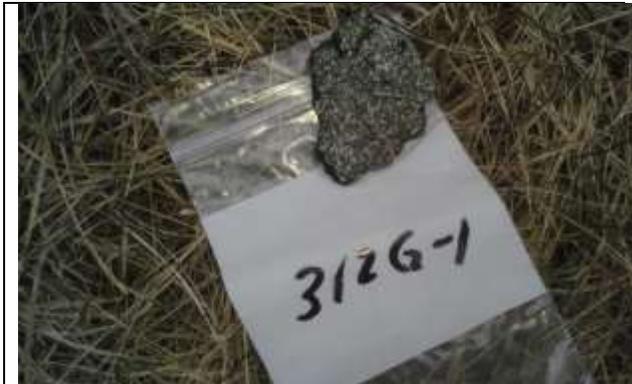
Photo 1: Roof Shingle (312G-1) Roof.  
No Asbestos Detected.

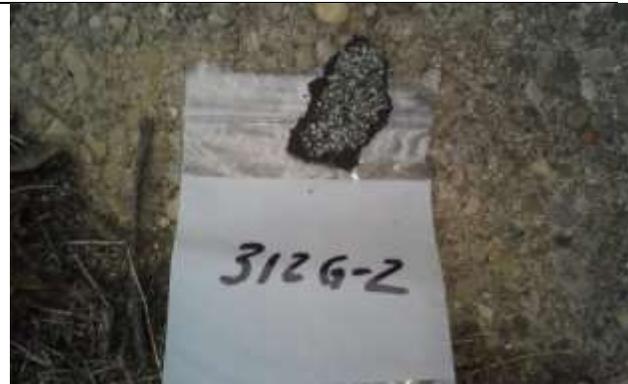
Photo 2: Roof Shingle (312G-2) Roof.  
No Asbestos Detected.

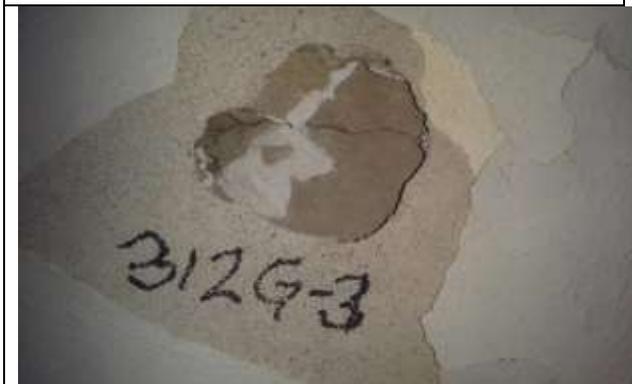
Photo 3: Plaster Board/Drywall (312G-3) Living Room,  
Wall A. No Asbestos Detected.

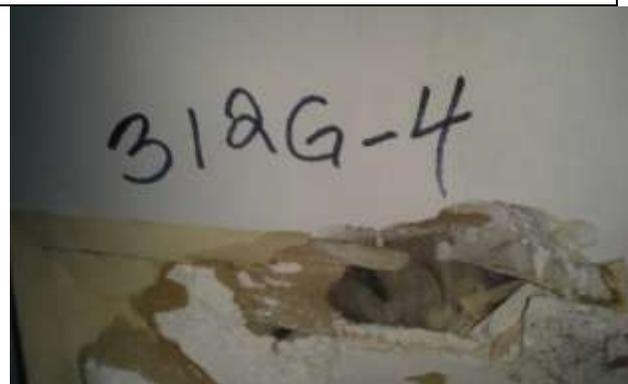
Photo 4: Drywall/J.C. (312G-4) Bedroom 3, Wall B.  
Trace <1% Chrysotile Asbestos Detected (PC=1.0%).

Lab Sample Number	Client Sample Number	Lab Gross Description	% Asbestos	Narrative ID
15-02-01740-001	312G-4(A-Joint Comp.)	Yellow Granular	1.00 % Chrysotile	
15-02-01740-002	312G-5	Yellow Granular	1.00 % Chrysotile

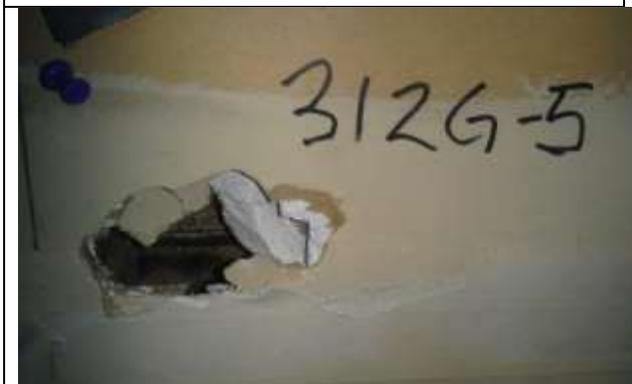
Photo 5: Drywall/J.C. (312G-5) Family Room, Wall A.  
Trace <1% Chrysotile Asbestos Detected (PC=1.0%).

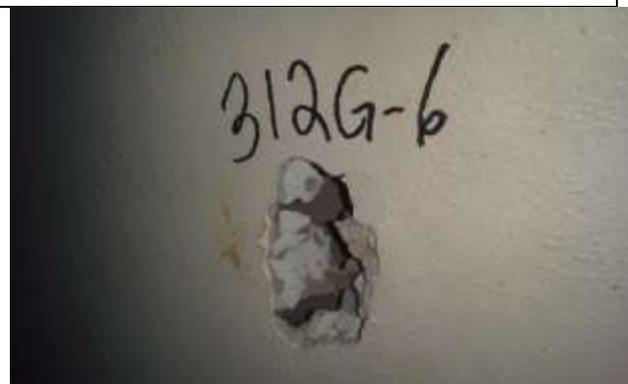
Photo 6: Plaster Board/Drywall (312G-6) Hall Front, Wall C.  
No Asbestos Detected.

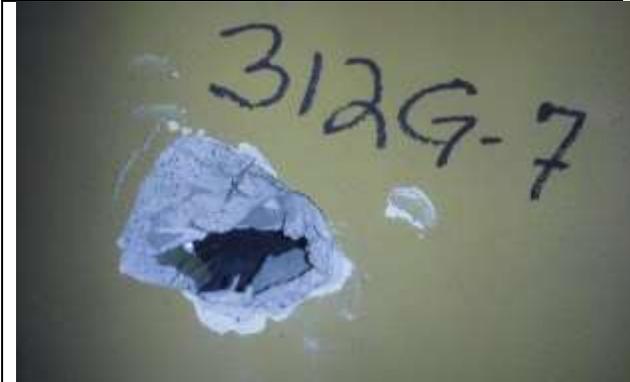
**Photo 7: Plaster Board/Drywall (312G-7) Bedroom 2, Wall B. No Asbestos Detected.**

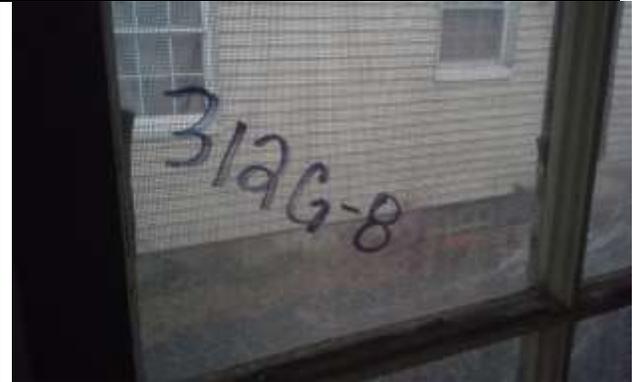
**Photo 8: Window Glazing (312G-8) Bedroom 2, Wall B. No Asbestos Detected.**

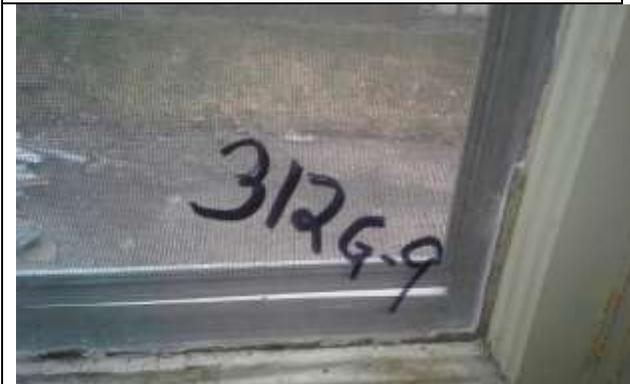
**Photo 9: Window Glazing (312G-9) Living Room, Wall D. No Asbestos Detected.**
