ASBESTOS INSPECTION REPORT

**449 Quitman St.
Dayton, Ohio 45410**

**Lynda M. Hart
Asbestos Hazards Evaluation Specialist
Ohio #ES-32558
August 20, 2015**

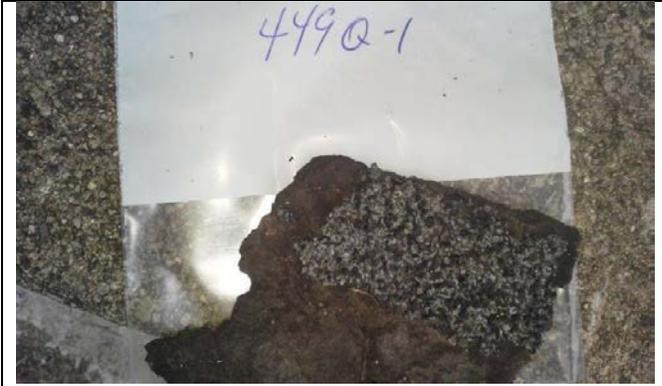
Photo 1: Roof Shingle (449Q-1) Exterior.
No Asbestos Detected.

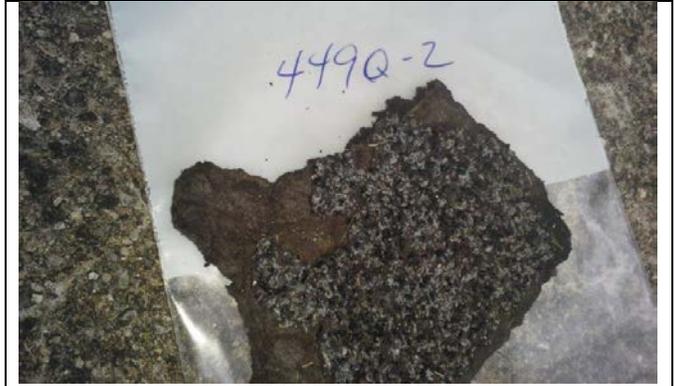
Photo 2: Roof Shingle (449Q-2) Exterior.
No Asbestos Detected.

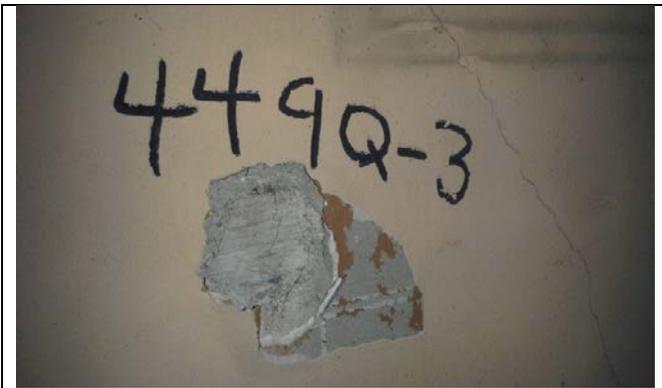
Photo 3: Plaster (449Q-3) Family Room, Wall A.
No Asbestos Detected.

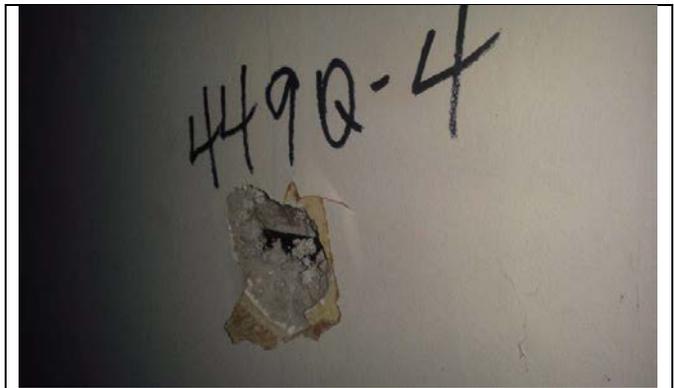
Photo 4: Plaster (449Q-4) Living Room, Wall C.
No Asbestos Detected.

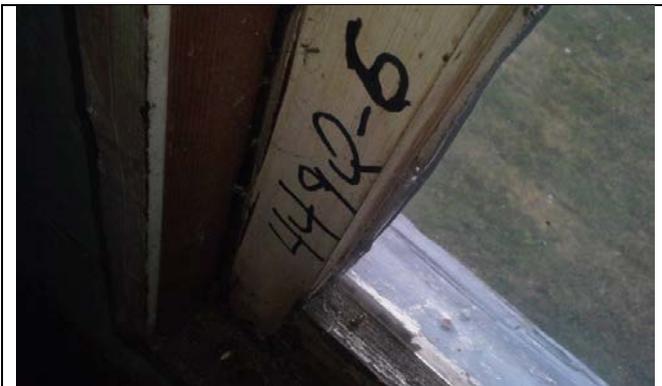
Photo 5: Window Glazing (449Q-6) Bedroom 2, Wall B.
No Asbestos Detected.

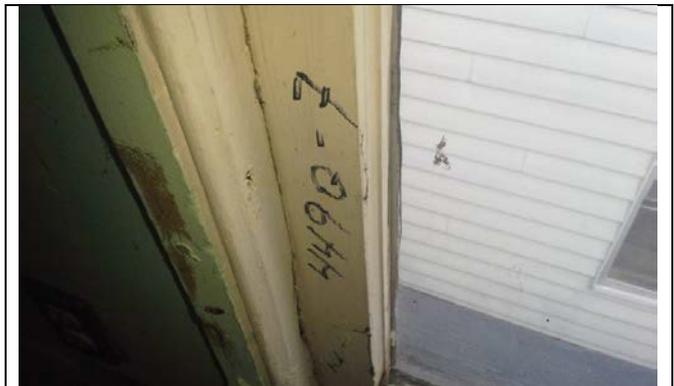
Photo 6: Window Glazing (449Q-7) Bedroom 2, Wall D.
No Asbestos Detected.

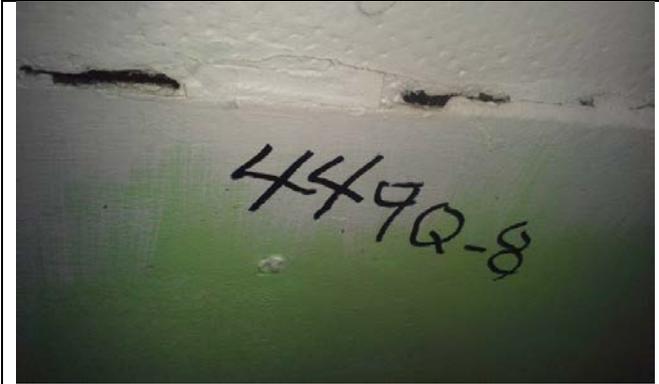
Photo 7: Joint Compound (449Q-8) Bedroom 2, Ceiling.
No Asbestos Detected.

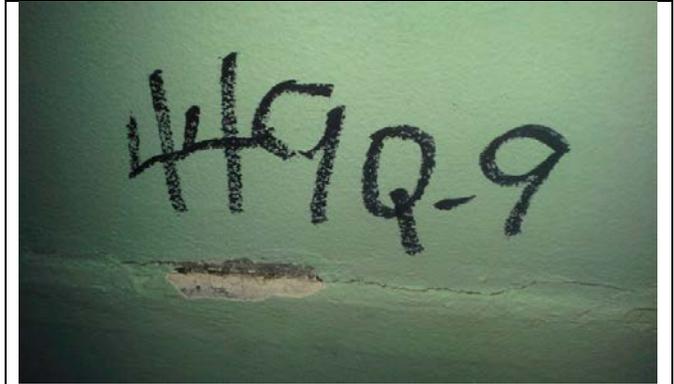
Photo 8: Joint Compound (449Q-9) Bedroom 2, Ceiling.
No Asbestos Detected.

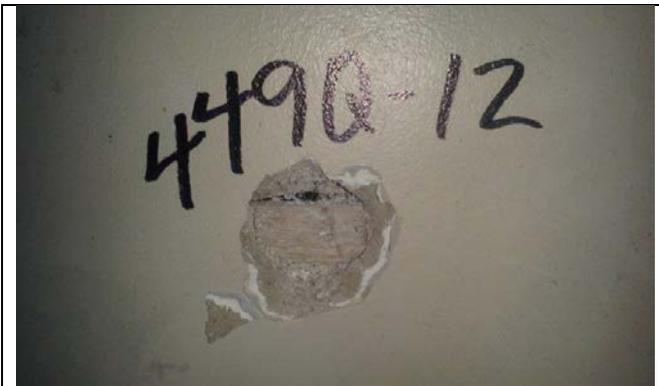
Photo 9: Plaster (449Q-12) Bedroom 1, Wall B.
No Asbestos Detected.

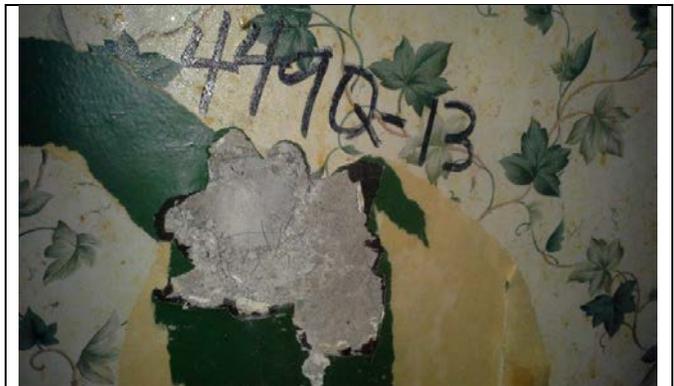
Photo 10: Plaster (449Q-13) Kitchen, Wall A.
No Asbestos Detected.
