## **ASBESTOS INSPECTION REPORT**

**711 St. Nicholas Ave.  
Dayton, Ohio 45410**

**Lynda M. Hart  
Asbestos Hazards Evaluation Specialist  
Ohio #ES-32558  
August 20, 2015**

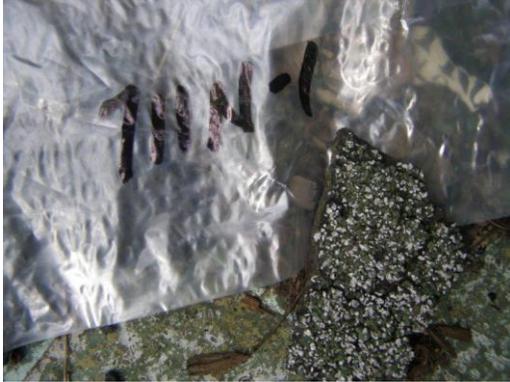
Photo 1: Roof Shingle (711N-1) Exterior.  
No Asbestos Detected.

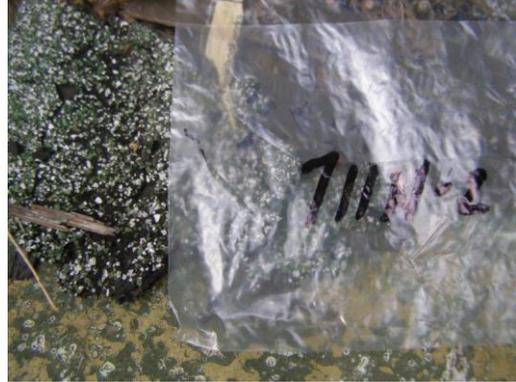
Photo 2: Roof Shingle (711N-2) Exterior.  
No Asbestos Detected.

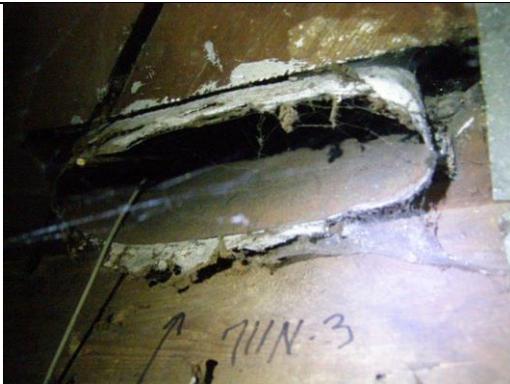
Photo 3: Boot Wrap (711N-3) Basement, Ceiling.  
65% Chrysotile Asbestos Detected.

Confirmed or assumed asbestos-containing materials, which will be disturbed during demolition activities, are regulated under current Federal and State regulations. Hart Environmental Resources recommends the removal of these materials by a licensed asbestos abatement contractor. It is also strongly recommended that the specifications for the removal program be

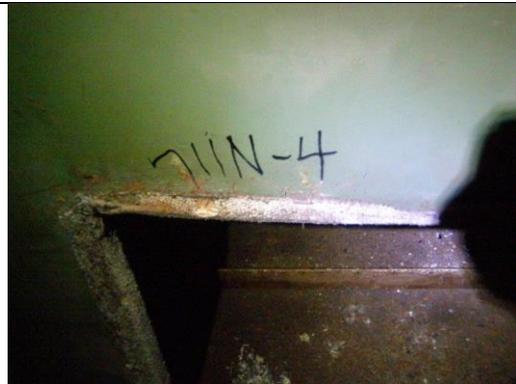
Photo 4: Furnace Gasket (711N-4) Basement, in Boiler.  
55% Chrysotile Asbestos Detected.

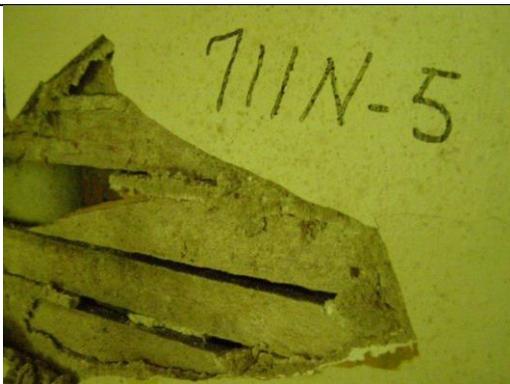
Photo 5: Plaster (711N-5) Living Room, Wall C.  
No Asbestos Detected.

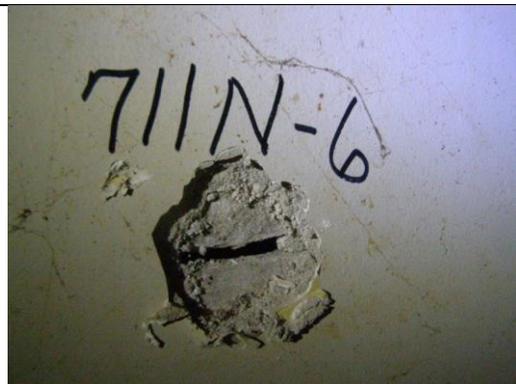
Photo 6: Plaster (711N-6) Dining Room, Wall B.  
No Asbestos Detected.

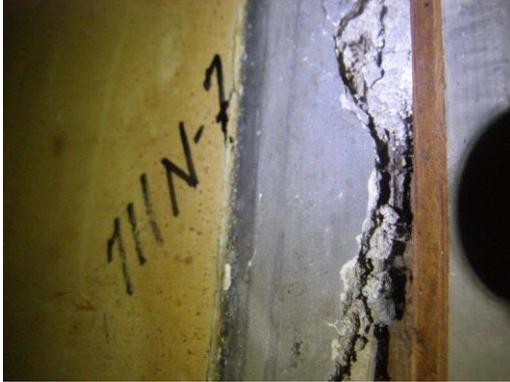
Photo 7: Plaster (711N-7) Kitchen, Wall C.  
No Asbestos Detected.

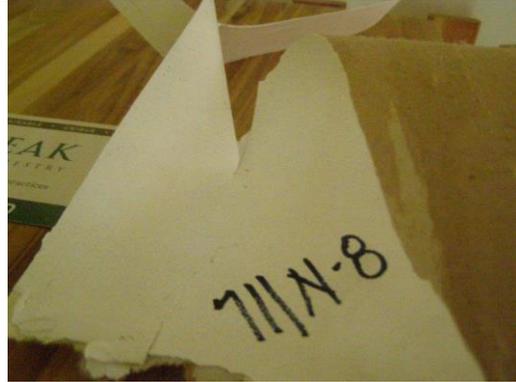
Photo 8: Drywall/JC (711N-8) Living Room, Ceiling.  
No Asbestos Detected.

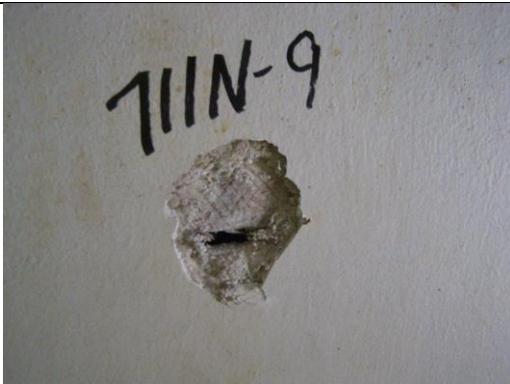
Photo 9: Plaster (711N-9) 2<sup>nd</sup> Floor Hall, Wall C.  
No Asbestos Detected.

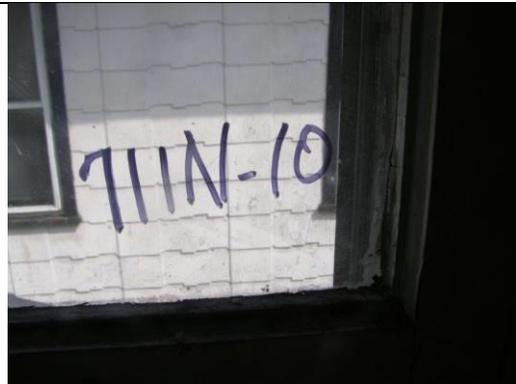
Photo 10: Window Glazing (711N-10) 2<sup>nd</sup> Floor Hall,  
Wall D. 2% Chrysotile Asbestos Detected (PC=1.0%).

Lab Sample Number	Client Sample Number	Lab Gross Description	% Asbestos	Narrative ID
15-08-02668-001	711N-10	Tan Brittle	1.00 % Chrysotile	
15-08-02668-002	711N-12	Tan Brittle	1.25 % Chrysotile

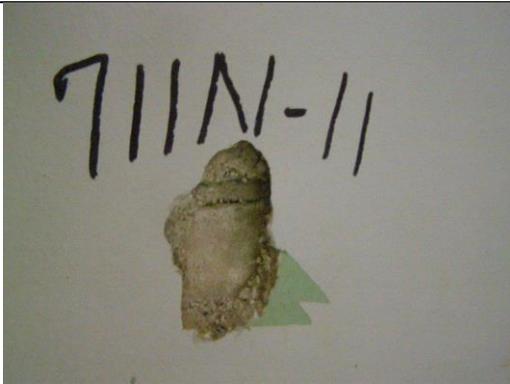
Photo 11: Plaster (711N-11) Bedroom 3, Wall A.  
No Asbestos Detected.

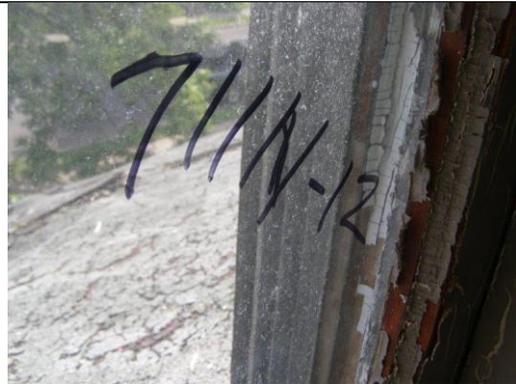
Photo 12: Window Glazing (711N-12) Bedroom 1, Wall A.  
2% Chrysotile Asbestos Detected (PC=1.25%).

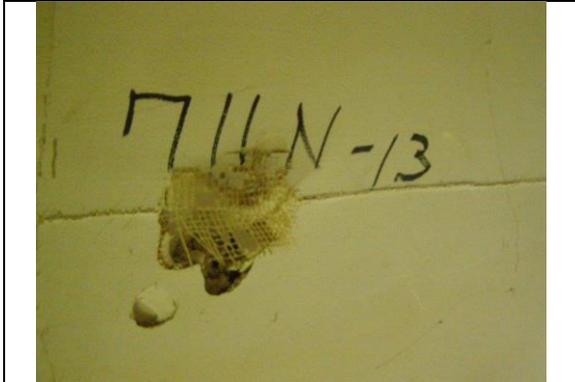
**Photo 13: Drywall/JC (711N-13) Living Room, Ceiling.  
No Asbestos Detected.**
