ASBESTOS INSPECTION REPORT

**731 St. Nicholas Ave.
Dayton, Ohio 45410**

**Lynda M. Hart
Asbestos Hazards Evaluation Specialist
Ohio #ES-32558
August 20, 2015**

Re: Asbestos Inspection
731 St. Nicholas Ave.
Dayton, Ohio 45410

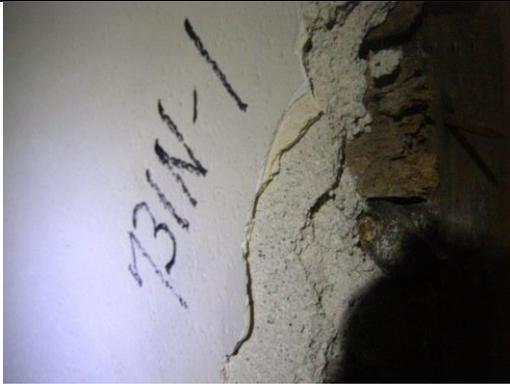
Photo 1: Plaster (731N-1) Living Room, Wall D.
Trace <1% Chrysotile Asbestos Detected (PC=0.25%).

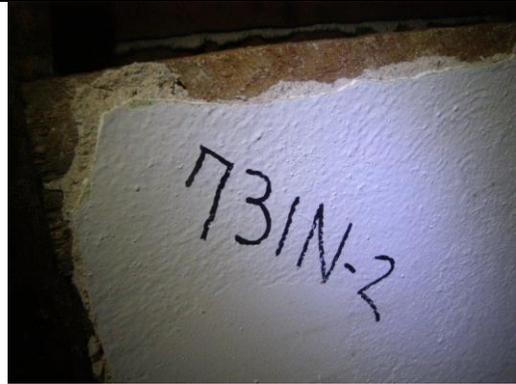
Photo 2: Plaster (731N-2) Kitchen, Wall B.
Trace <1% Chrysotile Asbestos Detected (PC=0.25%).

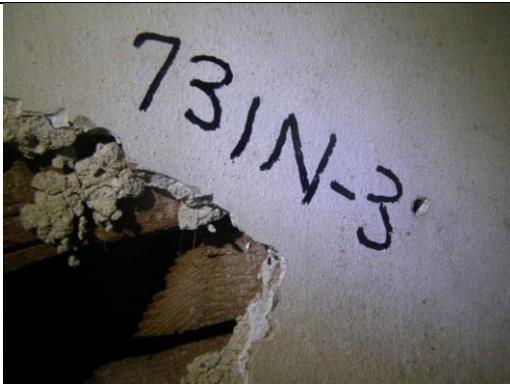
Photo 3: Plaster (731N-3) Basement Stairs, Wall C.
Trace <1% Chrysotile Asbestos Detected (PC=0.25%).

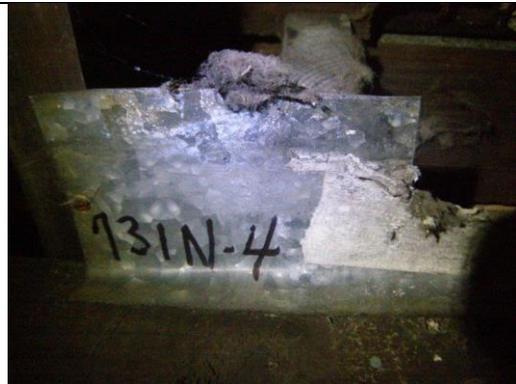
- Seam Tape, Basement
- Duct Work Wrap, Living Room, Dining Room, Kitchen

Photo 4: Seam Tape (731N-4) Basement, Ceiling.
65% Chrysotile Asbestos Detected.

Confirmed or assumed asbestos-containing materials, which will be disturbed during demolition activities, are regulated under current Federal and State regulations. Hart Environmental Resources recommends the removal of these materials by a licensed asbestos abatement contractor. It is also strongly recommended that the specifications for the removal program be

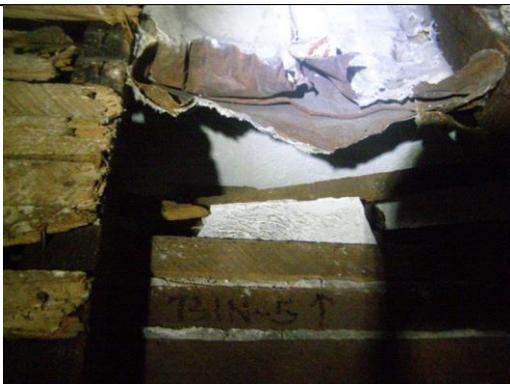
Photo 5: Duct Work Wrap (731N-5) Living Room,
Wall D. 65% Chrysotile Asbestos Detected.

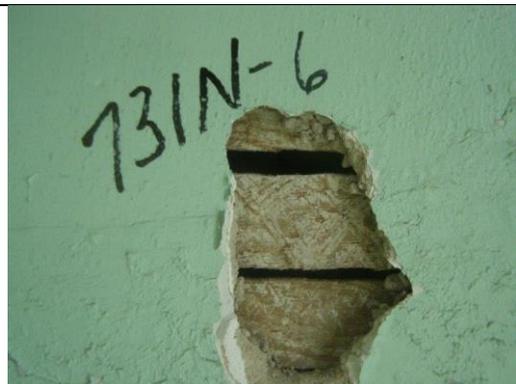
Photo 6: Plaster (731N-6) Bedroom 2, Wall A.
Trace <1% Chrysotile Asbestos Detected (PC=0.25%).

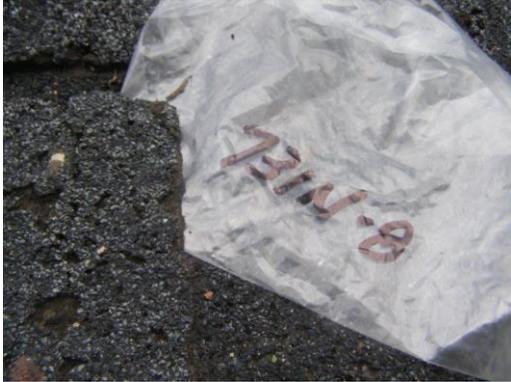
Photo 7: Roof Shingle (731N-8) Exterior.
No Asbestos Detected.

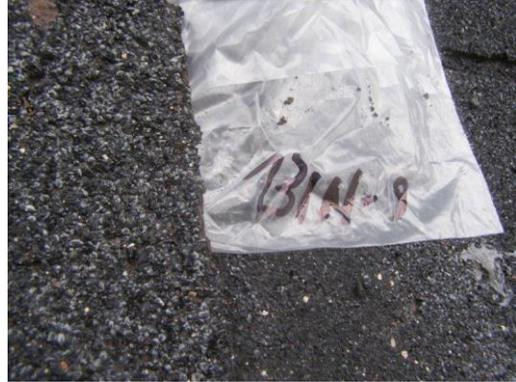
Photo 8: Roof Shingle (731N-9) Exterior.
No Asbestos Detected.

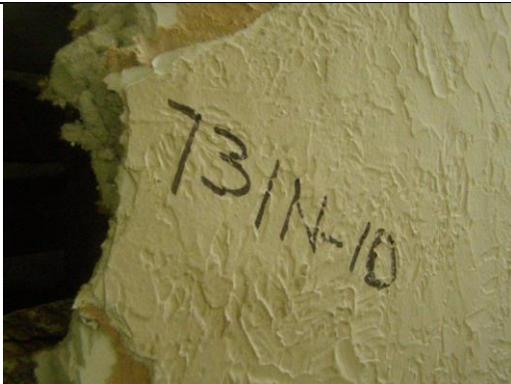
Photo 9: Drywall/Txt Pt (731N-10) Basement Steps,
Wall C. No Asbestos Detected.

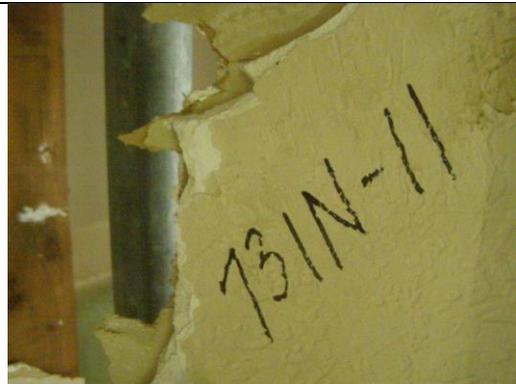
Photo 10: Drywall/Txt Pt (731N-11) Closet Foyer, Wall A.
No Asbestos Detected.

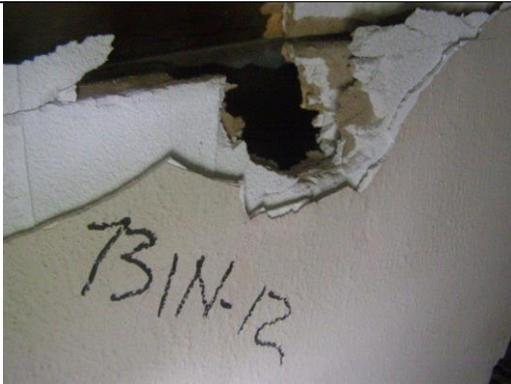
Photo 11: Drywall/Txt Pt (731N-12) Bath, Wall C.
No Asbestos Detected.
