ASBESTOS INSPECTION REPORT

**525 Steele Ave.
Dayton, Ohio 45410**

**Lynda M. Hart
Asbestos Hazards Evaluation Specialist
Ohio #ES-32558
August 20, 2015**

Re: Asbestos Inspection
525 Steele Ave.
Dayton, Ohio 45410

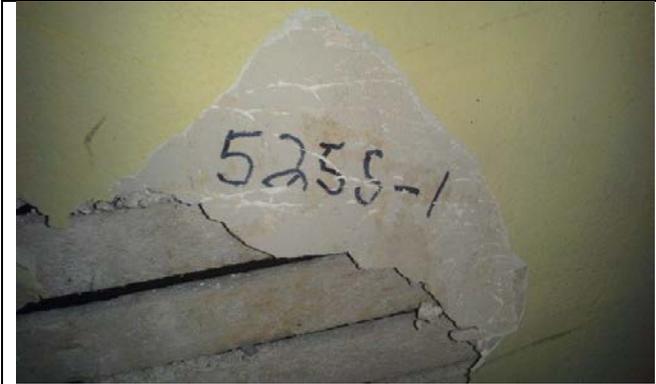
Photo 1: Plaster (525S-1) Hall 1st Floor, Wall B.
No Asbestos Detected.

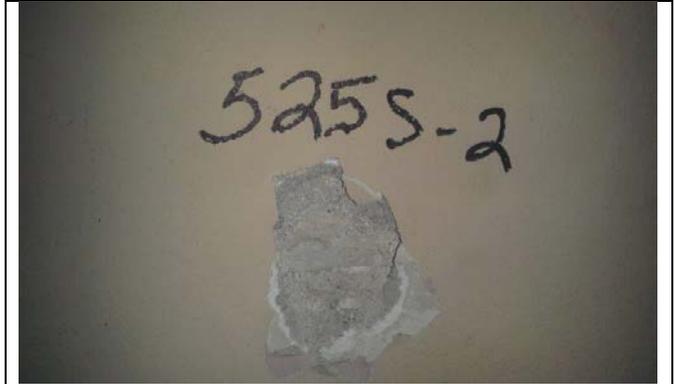
Photo 2: Plaster (525S-2) Living Room, Wall D.
No Asbestos Detected.

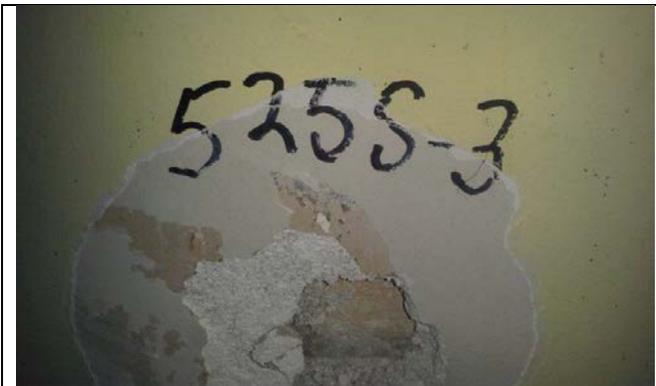
Photo 3: Plaster (525S-3) Utility Room, Wall B.
No Asbestos Detected.

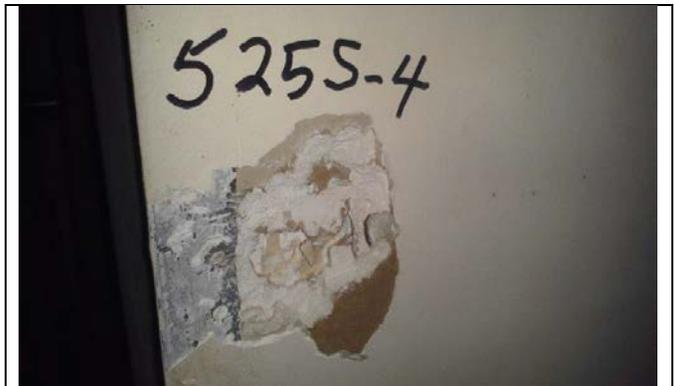
Photo 4: Drywall/JC (525S-4) Bedroom 2, Wall B.
No Asbestos Detected.

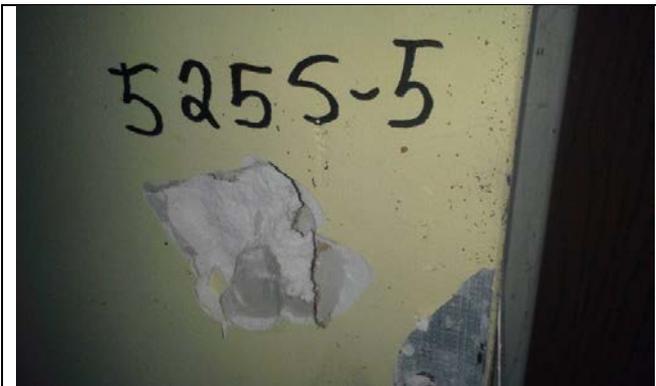
Photo 5: Drywall/JC (525S-5) Utility Room, Wall C.
No Asbestos Detected.

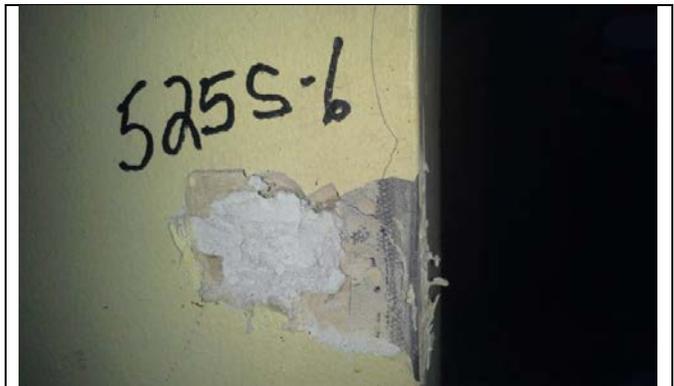
Photo 6: Drywall/JC (525S-6) Kitchen, Wall A.
No Asbestos Detected.

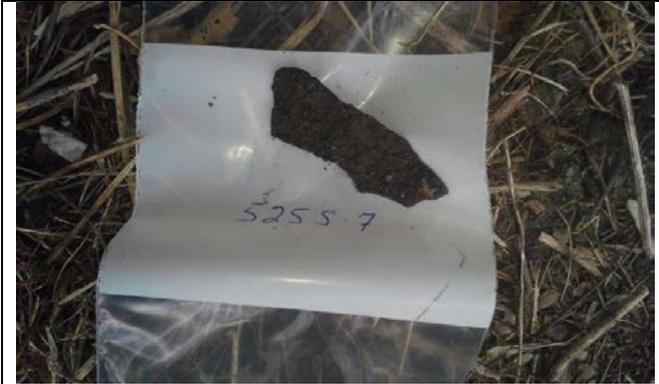
**Photo 7: Roof Shingle (525S-7) Exterior.
No Asbestos Detected.**

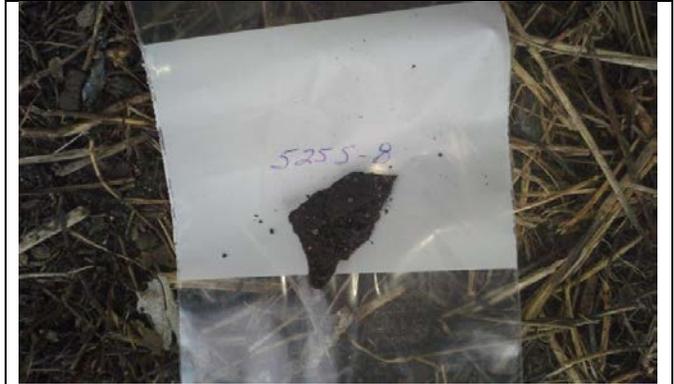
**Photo 8: Roof Shingle (525S-8) Exterior.
No Asbestos Detected.**
