## **ASBESTOS INSPECTION REPORT**

**1615 Warner Ave.  
Dayton, Ohio 45404**

**Lynda M. Hart  
Asbestos Hazards Evaluation Specialist  
Ohio #ES-32558  
August 20, 2015**

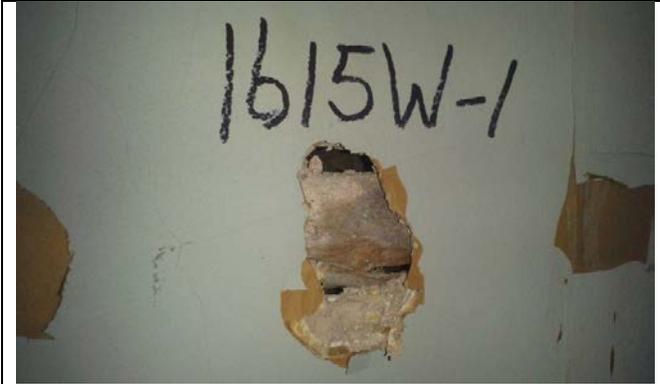
Photo 1: Plaster (1615W-1) Living Room, Wall D.  
No Asbestos Detected.

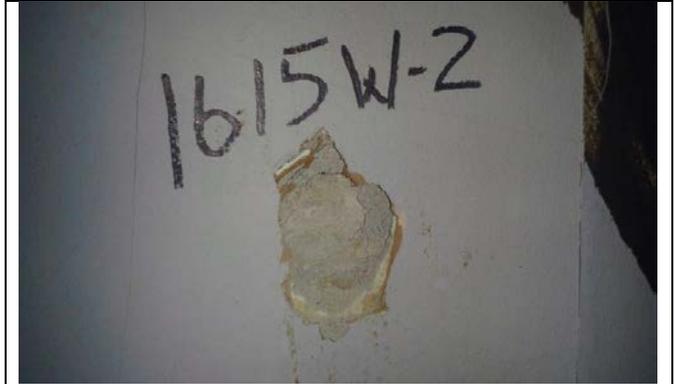
Photo 2: Plaster (1615W-2) Family Room, Wall D.  
No Asbestos Detected.

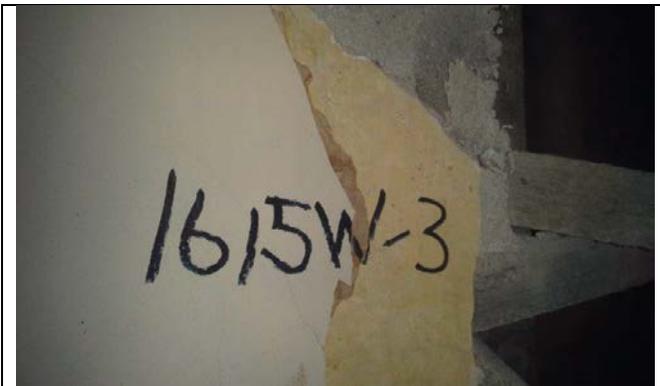
Photo 3: Plaster (1615W-3) Dining Room, Wall C.  
No Asbestos Detected.

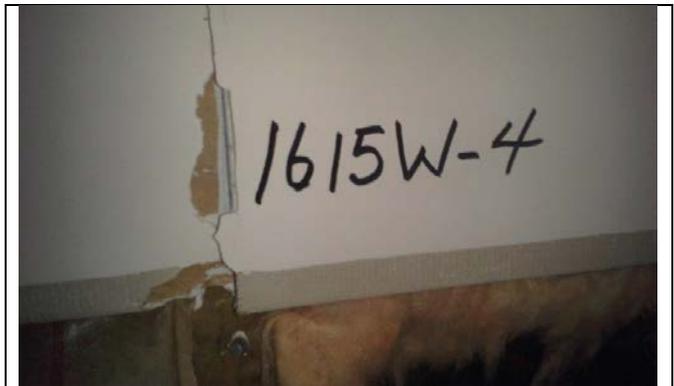
Photo 4: Drywall/JC (1615W-4) Bedroom 1, Wall C.  
No Asbestos Detected.

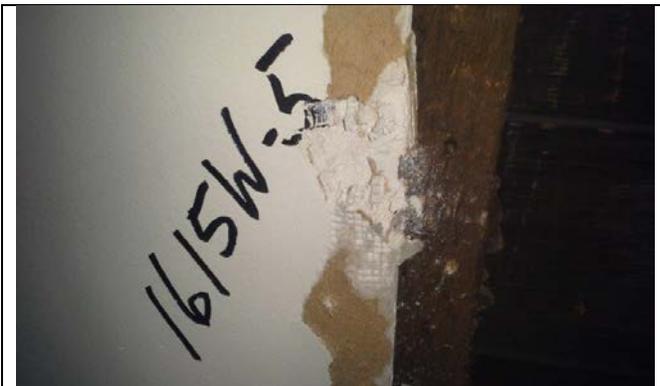
Photo 5: Drywall/JC (1615W-5) Bedroom 2, Wall A.  
No Asbestos Detected.

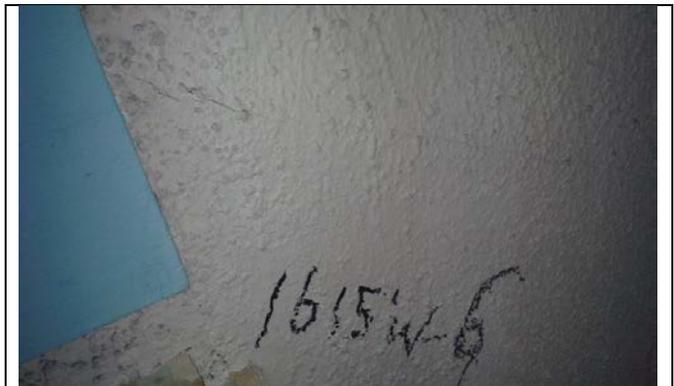
Photo 6: Textured Pt (1615W-6) Bedroom 2, Hall Stairs, Wall C.  
No Asbestos Detected.

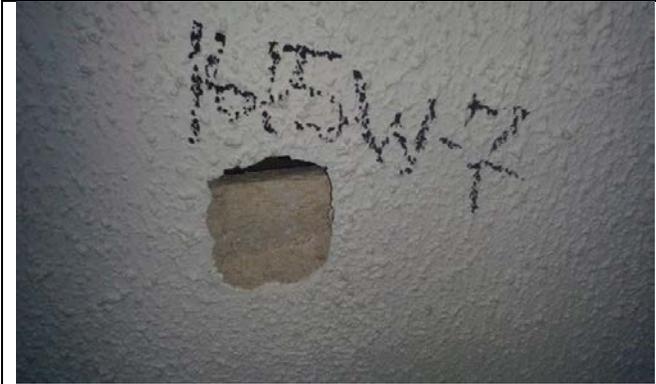
Photo 7: Textured Pt (1615W-7) Hall Stairs, Wall B.  
No Asbestos Detected.

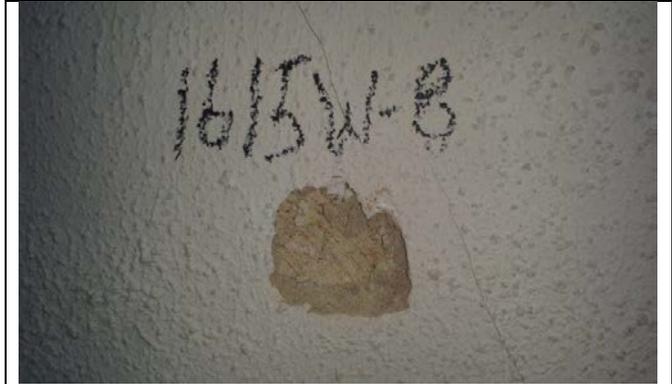
Photo 8: Textured Pt (1615W-8) Hall Stairs, Wall A.  
No Asbestos Detected.

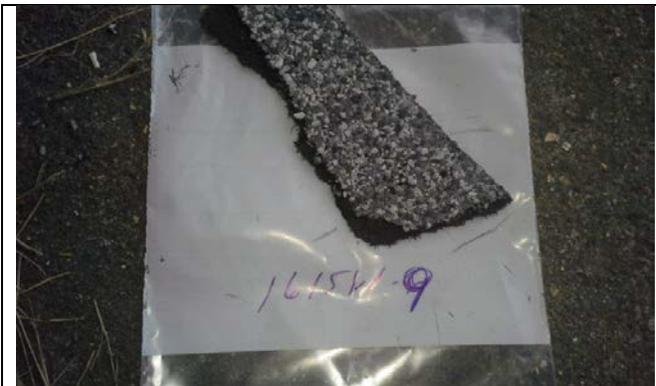
Photo 9: Roof Shingle (1615W-9) Exterior.  
No Asbestos Detected.

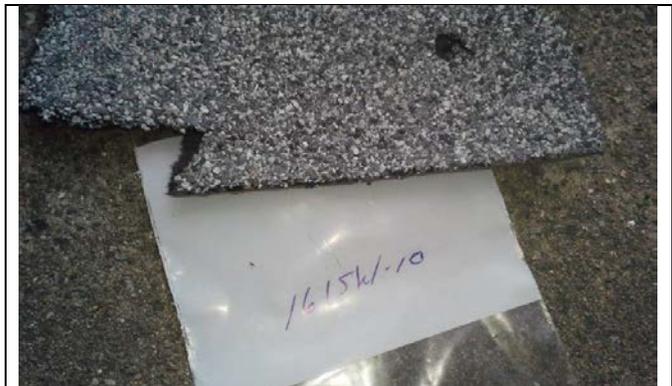
Photo 10: Roof Shingle (1615W-10) Exterior.  
No Asbestos Detected.
