ASBESTOS INSPECTION REPORT

**933 Xenia Ave.
Dayton, Ohio 45410**

**Lynda M. Hart
Asbestos Hazards Evaluation Specialist
Ohio #ES-32558
August 20, 2015**

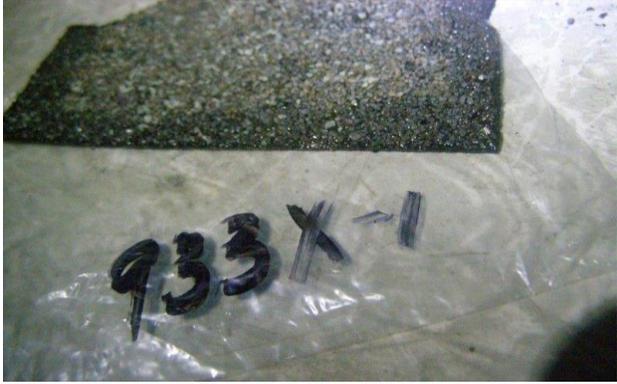
Photo 1: Roof Shingle (933X-1) Roof.
No Asbestos Detected.

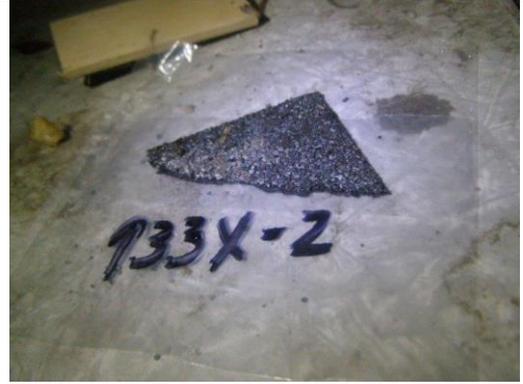
Photo 2: Roof Shingle (933X-2) Roof.
No Asbestos Detected.

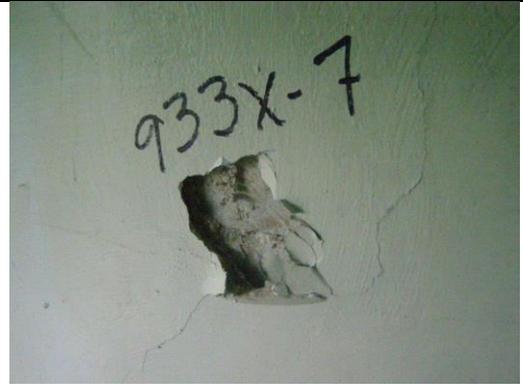
- Air Cell, Basement
- Plaster, Bedroom 2, 3, bath and upstairs hall (Confirmed areas noted on 8/26/15)
- Ground Debris, Basement

Photo 4: Plaster (933X-7) Bedroom 2, Wall B.
Trace <1% Chrysotile Asbestos Detected (PC=0.50%).

Confirmed or assumed asbestos-containing materials, which will be disturbed during demolition activities, are regulated under current Federal and State regulations. Hart Environmental Resources recommends the removal of these materials by a licensed asbestos abatement contractor. It is also strongly recommended that the specifications for the removal program be developed by a licensed Asbestos Project Designer to ensure that all regulatory requirements are satisfied. The work should be properly documented in the event of future litigation.

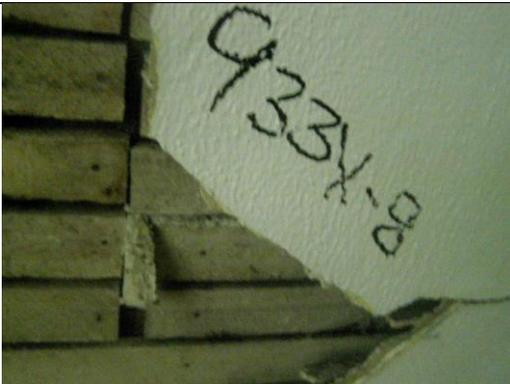
Photo 5: Plaster (933X-8) Bedroom 3, Ceiling.
Trace <1% Chrysotile Asbestos Detected (PC=2.25%).

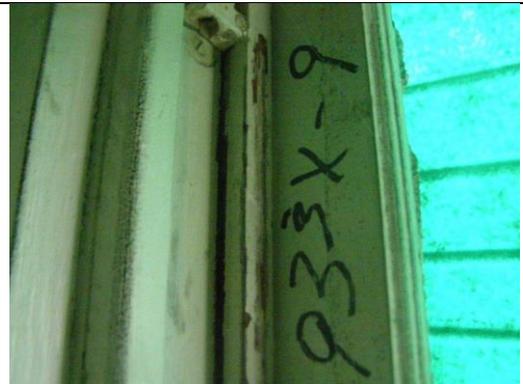
933X-09 15-08-02449-009 15-08-02677-004	-	2	Window Glazing, Bedroom 2, Wall A, Inhomogeneous	Friable	2% Chrysotile Asbestos Detected (PC=0.75%)
933X-10 15-08-02449-010	-	3	Window Glazing, Bedroom 2, Wall A, Inhomogeneous	Friable	None Detected

Photo 6: Window Glazing (933X-9) Bedroom 2, Wall A.
2% Chrysotile Asbestos Detected (PC=0.75%).

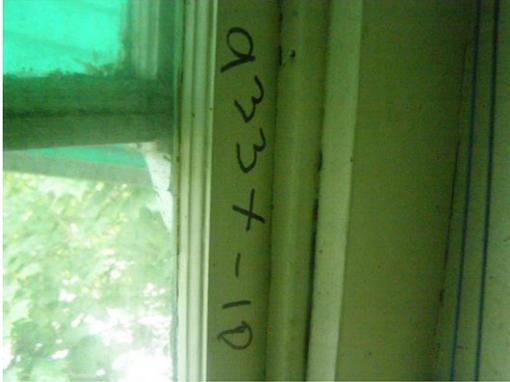
**Photo 7: Window Glazing (933X-10) Bedroom 2, Wall A.
No Asbestos Detected.**

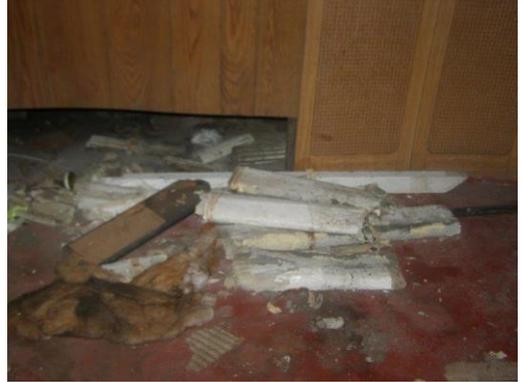
Photo 8: Ground Debris in Basement.

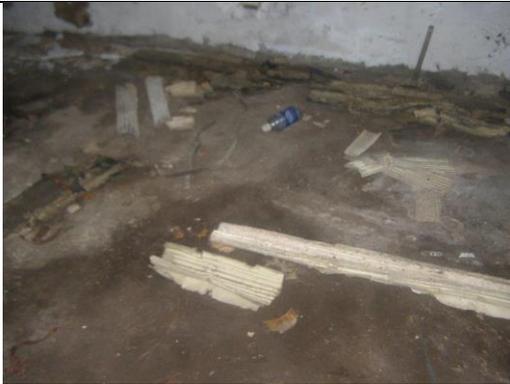
Photo 9: Ground Debris in Basement.
