ASBESTOS INSPECTION REPORT

**318 Clover St.
Dayton, Ohio 45410**

Re: Asbestos Inspection
318 Clover St.
Dayton, Ohio 45410

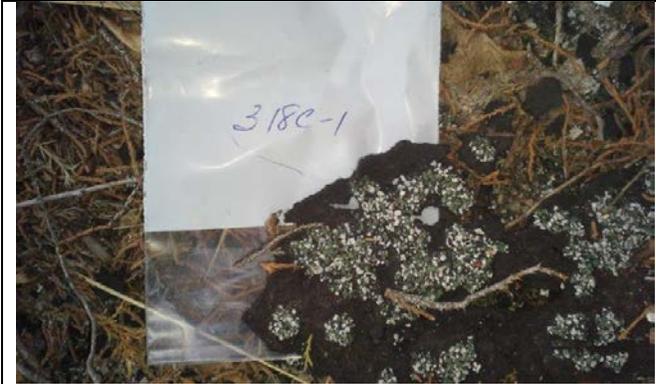
Photo 1: Roof Shingle (318C-1) Roof.
No Asbestos Detected.

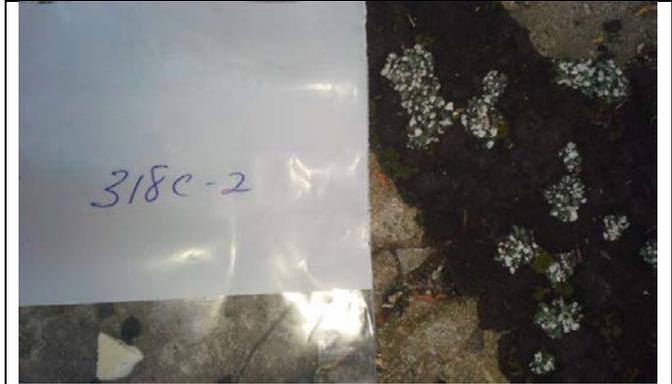
Photo 2: Roof Shingle (318C-2) Roof.
No Asbestos Detected.

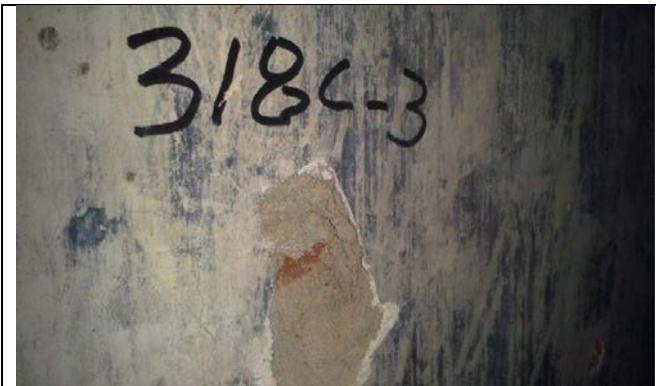
Photo 3: Plaster (318C-3) Family Room, Wall A.
No Asbestos Detected.

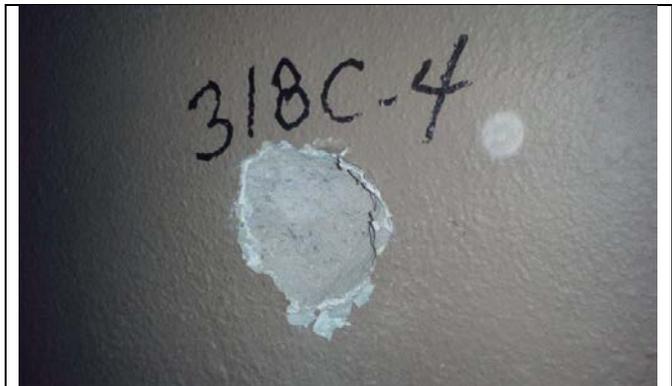
Photo 4: Plaster (318C-4) Living Room, Wall D.
No Asbestos Detected.

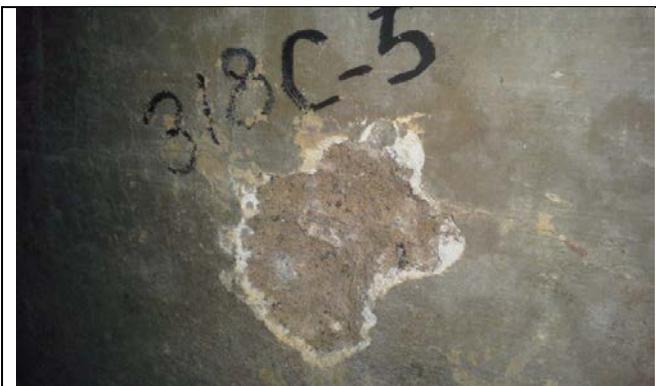
Photo 5: Plaster (318C-5) Kitchen, Wall C.
No Asbestos Detected.

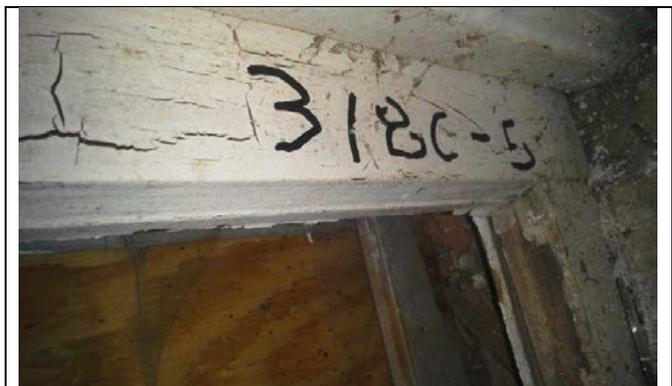
Photo 6: Window Glazing (318C-6) Family Room, Wall D.
No Asbestos Detected.

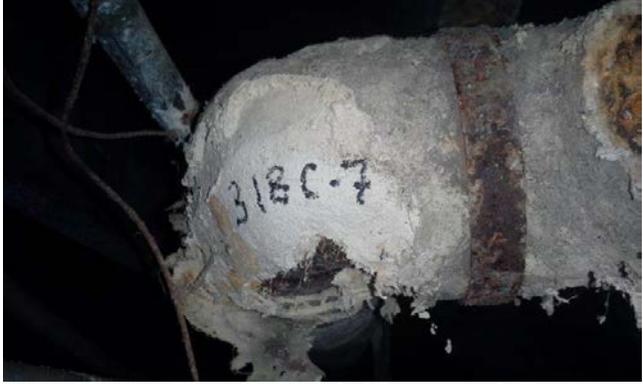
- Elbow Mud, Basement
- Air Cell, Basement
- Ground Debris
- Window Glazing, All

Photo 7: Elbow Mud (318C-7) Basement, Ceiling.
65% Chrysotile Asbestos Detected.

Confirmed or assumed asbestos-containing materials, which will be disturbed during demolition activities, are regulated under current Federal and State regulations. Hart Environmental Resources recommends the removal of these materials by a licensed asbestos abatement contractor. It is also strongly recommended that the specifications for the removal program be

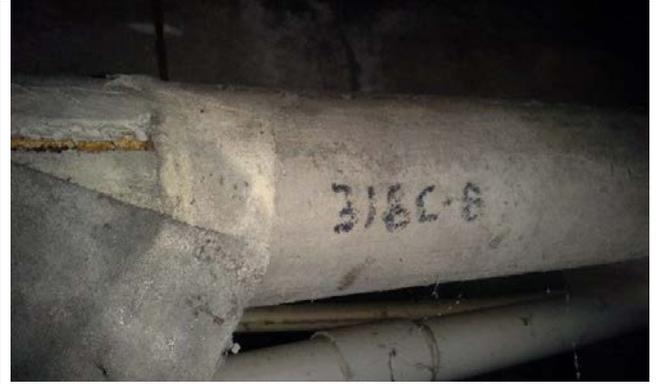
Photo 8: Air Cell (318C-8) Basement, Ceiling.
75% Chrysotile Asbestos Detected.

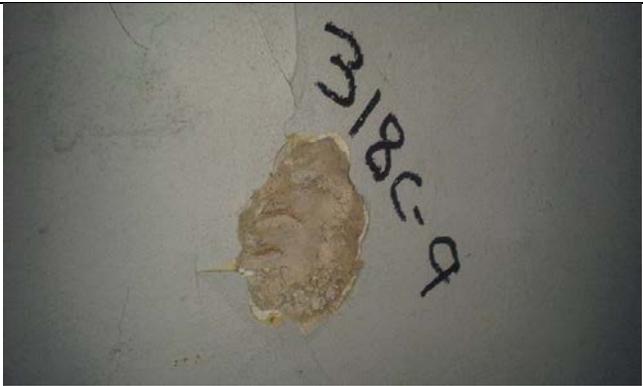
Photo 9: Plaster (318C-9) Bedroom 2, Wall B.
No Asbestos Detected.

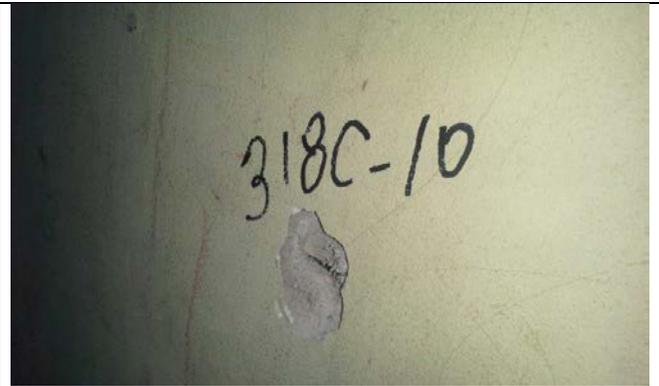
Photo 10: Plaster (318C-10) Bedroom 3, Wall A.
No Asbestos Detected.

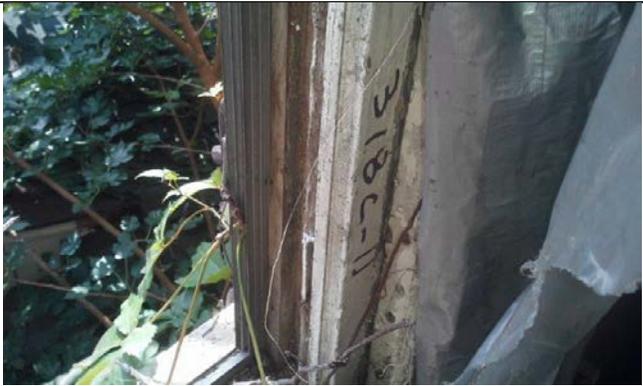
Photo 11: Window Glazing (318C-11) Stairs to 2nd Floor, Wall B.
3% Chrysotile Asbestos Detected (PC=1.50%).

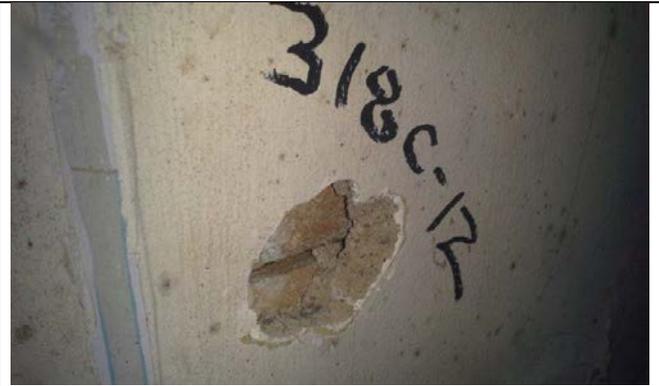
Photo 12: Plaster (318C-12) Bedroom 1, Wall A.
Trace <1% Chrysotile Asbestos Detected (PC=0.25%).
