## **ASBESTOS INSPECTION REPORT**

**1032 Clover St.  
Dayton, Ohio 45410**

**Lynda M. Hart  
Asbestos Hazards Evaluation Specialist  
Ohio #ES-32558  
August 20, 2015**

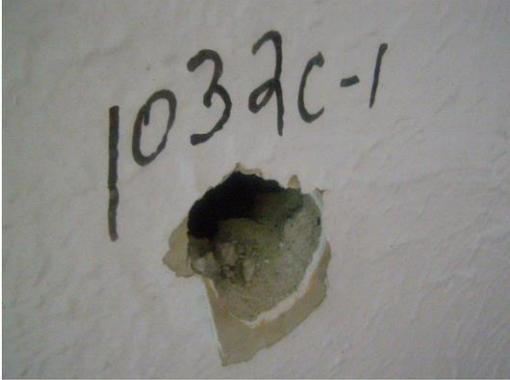
Photo 1: Plaster/Txt Pt. (1032C-1) Family Room, Wall B.  
No Asbestos Detected.

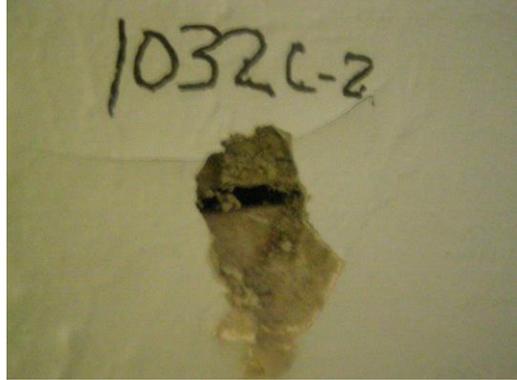
Photo 2: Plaster (1032C-2) Living Room, Wall C.  
No Asbestos Detected.

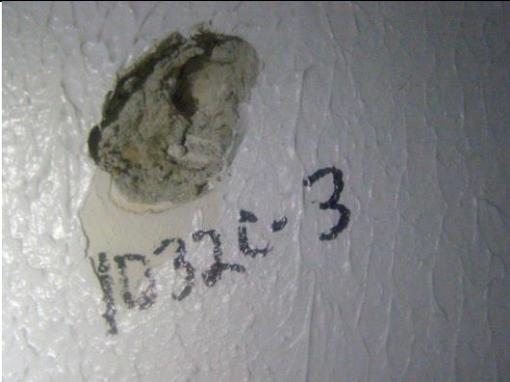
Photo 3: Plaster (1032C-3) Kitchen, Wall A.  
No Asbestos Detected.

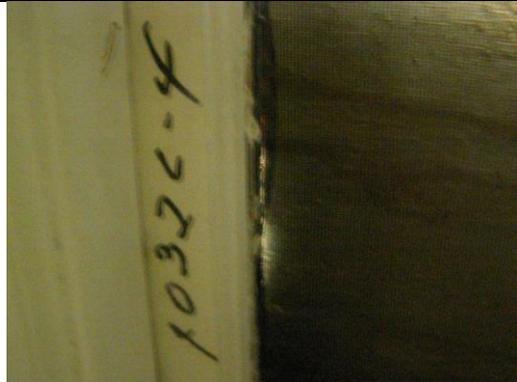
Photo 4: Window Glazing (1032C-4) Living Room, Wall A.  
2% Chrysotile Asbestos Detected (PC=0.75%).

Lab Sample Number	Client Sample Number	Lab Gross Description	% Asbestos	Narrative ID
15-08-02678-001	1032 C-4	Cream Brittle	0.75 % Chrysotile

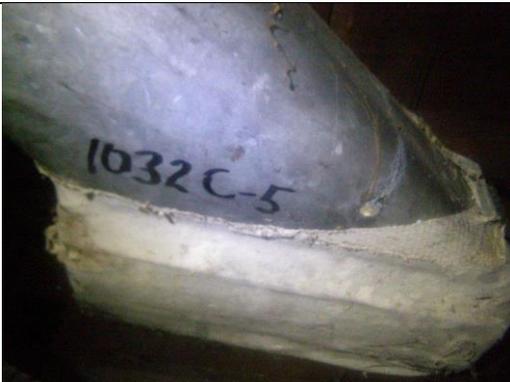
Photo 5: Duct Work (1032C-5) Basement, Ceiling.  
55% Chrysotile Asbestos Detected.

Confirmed or assumed asbestos-containing materials, which will be disturbed during demolition activities, are regulated under current Federal and State regulations. Hart Environmental Resources recommends the removal of these materials by a licensed asbestos abatement contractor. It is also strongly recommended that the specifications for the removal program be

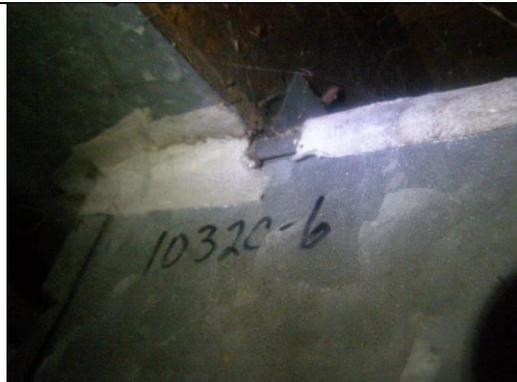
Photo 6: Seam Tape (1032C-6) Basement, Ceiling.  
55% Chrysotile Asbestos Detected.

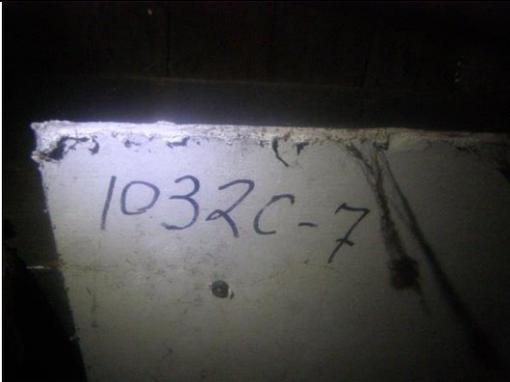
Photo 7: Furnace Board (1032C-7) Basement, Ceiling.  
45% Chrysotile Asbestos Detected.

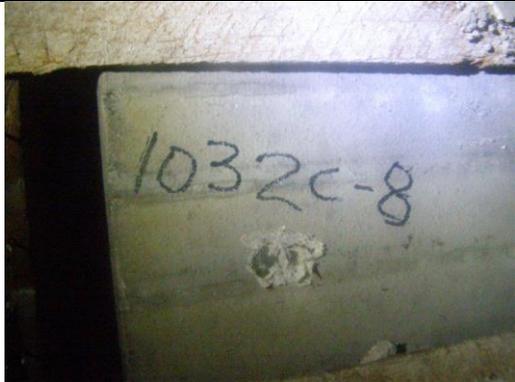
Photo 8: Duct Work Boots (1032C-8) Living Room,  
Wall A. 55% Chrysotile Asbestos Detected.

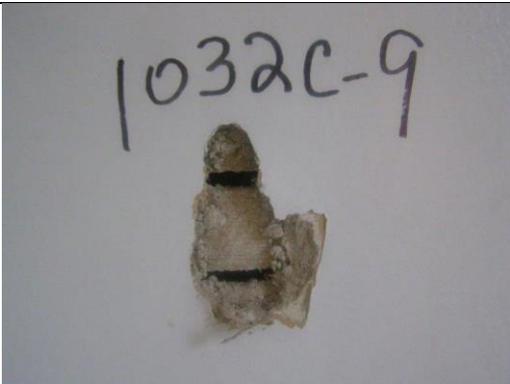
Photo 9: Plaster (1032C-9) Bedroom 1.  
No Asbestos Detected.

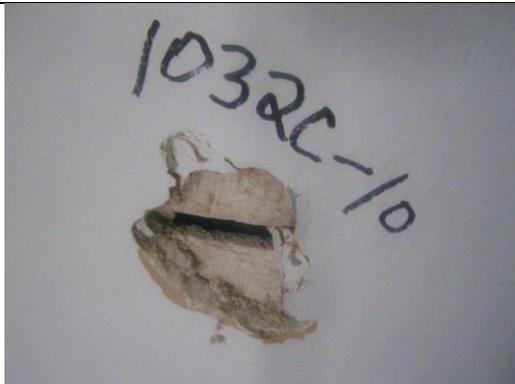
Photo 10: Plaster (1032C-10) Bedroom 2.  
No Asbestos Detected.

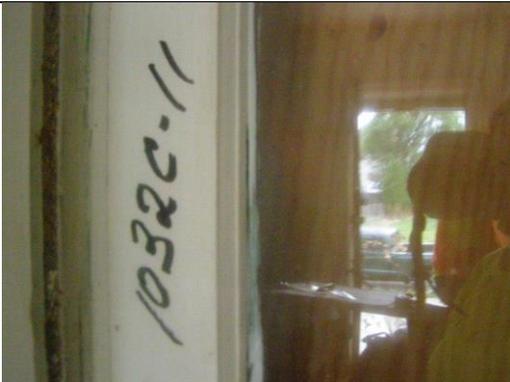
Photo 11: Window Glazing (1032C-11).  
No Asbestos Detected.

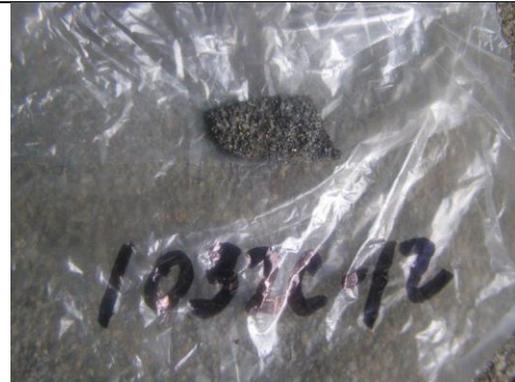
Photo 12: Roof Shingle (1032C-12) Roof.  
No Asbestos Detected.

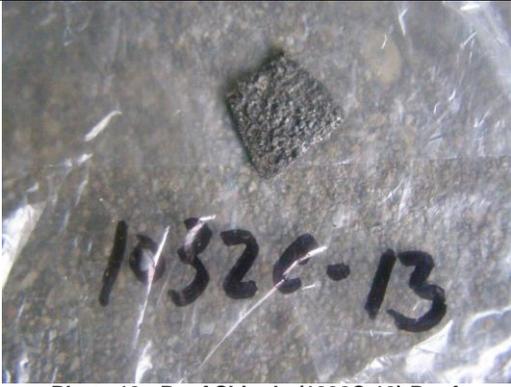
**Photo 13: Roof Shingle (1032C-13) Roof.  
No Asbestos Detected.**
