ASBESTOS INSPECTION REPORT

**2922 E. Fifth St.
Dayton, Ohio 45403**

**Lynda M. Hart
Asbestos Hazards Evaluation Specialist
Ohio #ES-32558
August 20, 2015**

Re: Asbestos Inspection
2922 E. Fifth St.
Dayton, Ohio 45403

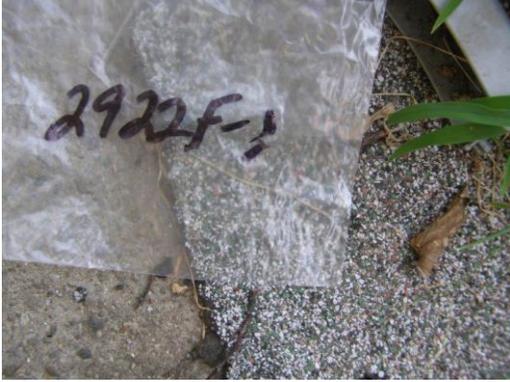
Photo 1: Roof Shingle (2922F-1) Roof.
No Asbestos Detected.

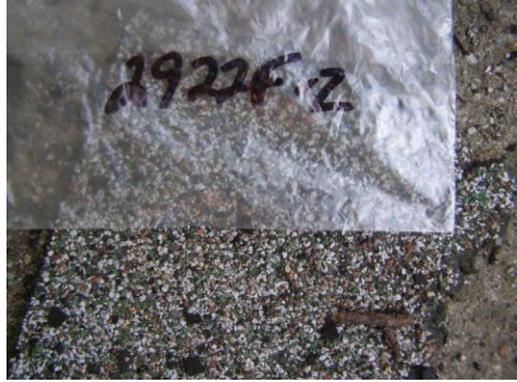
Photo 2: Roof Shingle (2922F-2) Roof.
No Asbestos Detected.

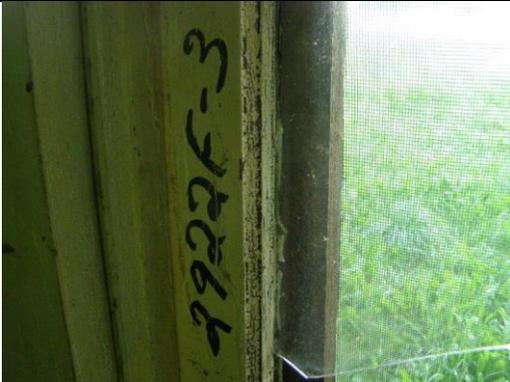
Photo 3: Window Glazing (2922F-3) Utility Room, Wall D.
No Asbestos Detected.

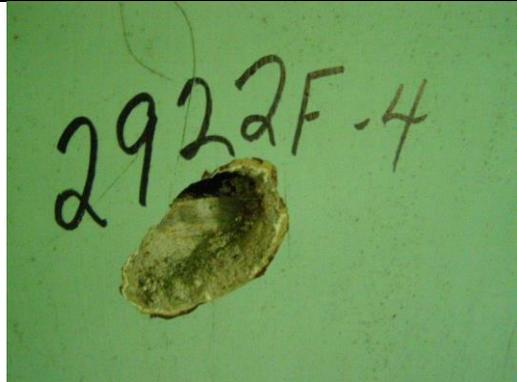
Photo 4: Plaster (2922F-4) Utility Room, Wall C.
No Asbestos Detected.

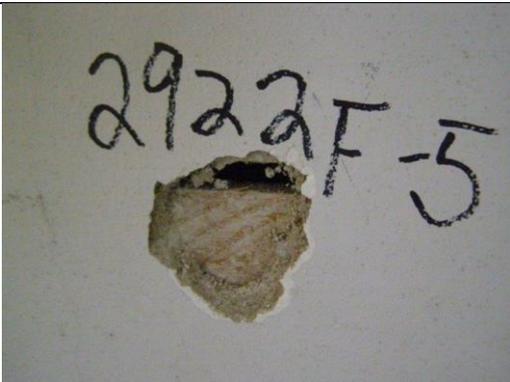
Photo 5: Plaster (2922F-5) Family Room, Wall D.
No Asbestos Detected.

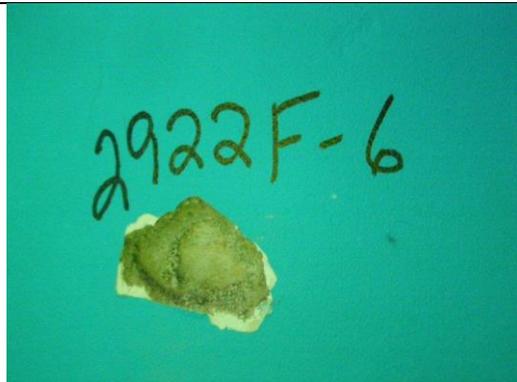
Photo 6: Plaster (2922F-6) Living Room, Wall A.
No Asbestos Detected.

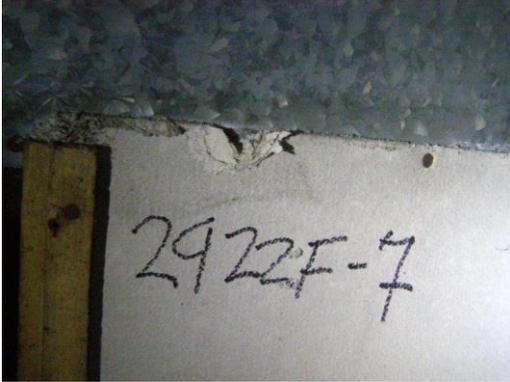
- Furnace Board, Basement
- Seam Tape, Basement
- Attic Wrap, Attic

Photo 7: Furnace Board (2922F-7) Basement, Ceiling.
65% Chrysotile Asbestos Detected.

Confirmed or assumed asbestos-containing materials, which will be disturbed during demolition activities, are regulated under current Federal and State regulations. Hart Environmental Resources recommends the removal of these materials by a licensed asbestos abatement contractor. It is also strongly recommended that the specifications for the removal program be

<u>Material</u>	<u>Est. Qty.</u>	<u>Est. Unit Cost</u>	<u>Est. Cost</u>
Furnace Board	28 sq ft	\$ 20/sq ft	\$ 560
Seam Tape	1 sq ft	\$ 20/sq ft	\$ 20
Attic Wrap	4 sq ft	\$ 20/sq ft	\$ 80
Total			\$ 660

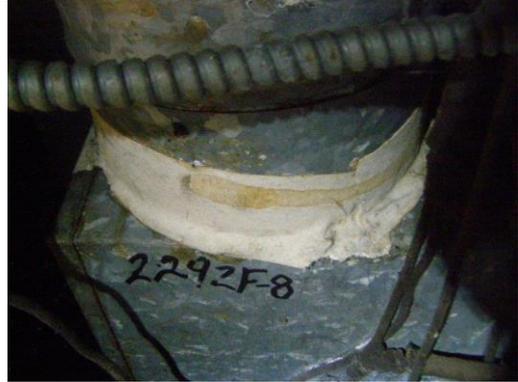
Photo 8: Seam Tape (2922F-8) Basement, Ceiling.
55% Chrysotile Asbestos Detected.

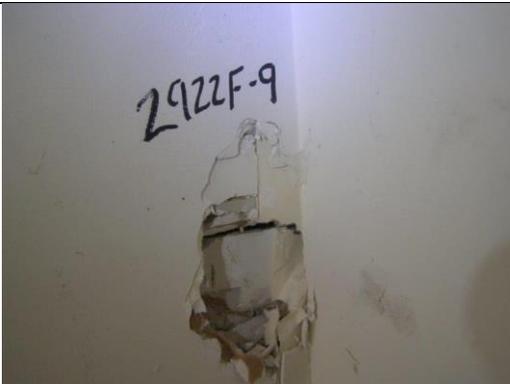
Photo 9: Drywall/J.C. (2922F-9) Kitchen, Wall C.
No Asbestos Detected.

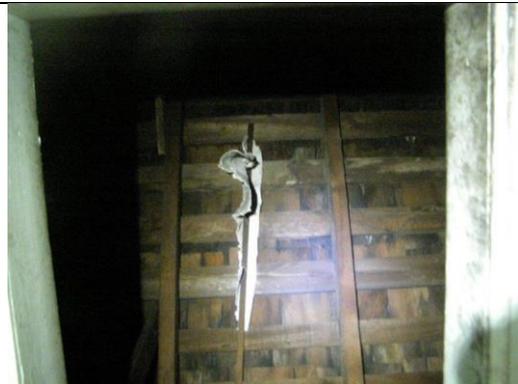
2922F-10 15-08-02441-010	4 sq ft.	1	Attic Wrap, Attic, Ceiling, Homogeneous	Friable	65% Chrysotile Asbestos Detected
2922F-11 15-08-02441-011	-	2	Drywall, Bath 2, Wall D, Inhomogeneous	Non-friable	None Detected
2922F-12 15-08-02441-012	-	1	Plaster, Bedroom 1, Wall B, Inhomogeneous	Non-friable	None Detected
2922F-13 15-08-02441-013	-	1	Plaster, Bedroom 2, Wall C, Inhomogeneous	Non-friable	None Detected
2922F-14 15-08-02441-014	-	2	Window Glazing, Bedroom 2, Wall A, Inhomogeneous	Friable	None Detected

Photo 10: Attic Wrap (2922F-10) Attic, Ceiling.
65% Chrysotile Asbestos Detected.

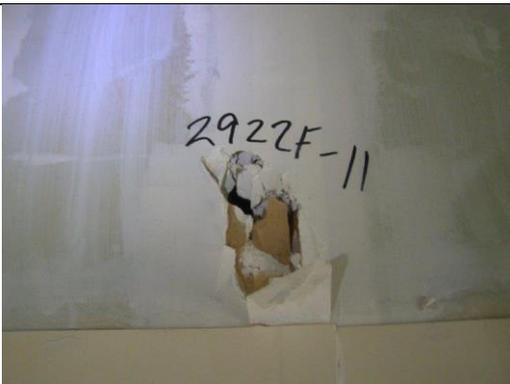
Photo 11: Drywall (2922F-11) Bath 2, Wall D.
No Asbestos Detected.

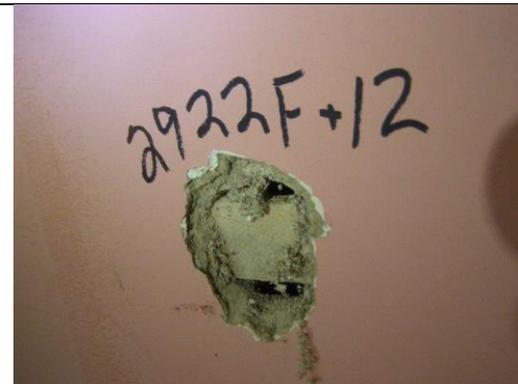
Photo 12: Plaster (2922F-12) Bedroom 1, Wall B.
No Asbestos Detected.

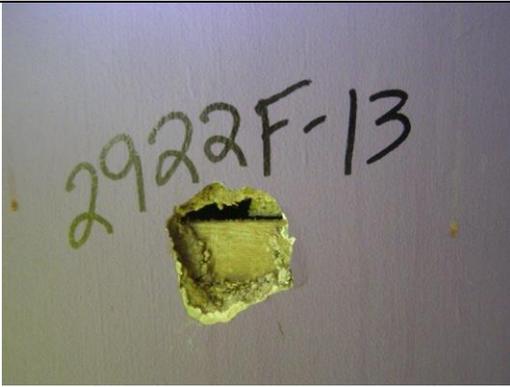
**Photo 13: Plaster (2922F-13) Bedroom 2, Wall C.
No Asbestos Detected.**

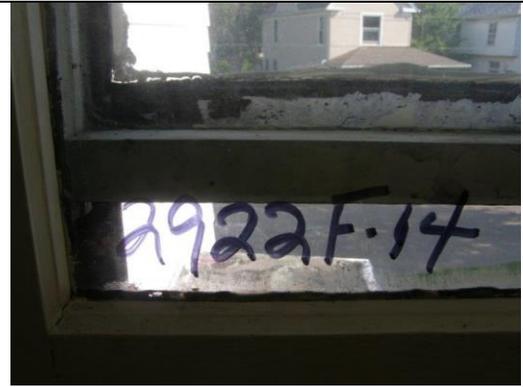
**Photo 14: Window Glazing (2922F-14) Bedroom 2, Wall A.
No Asbestos Detected.**
