ASBESTOS INSPECTION REPORT

**362 Quitman St.
Dayton, Ohio 45410**

Re: Asbestos Inspection
362 Quitman St.
Dayton, Ohio 45410

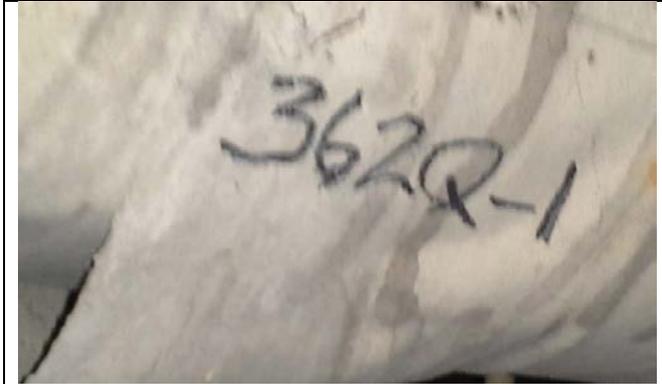
Photo 1: Round Duct Wrap (362Q-1) Basement, Ceiling.
65% Chrysotile Asbestos Detected.

Confirmed or assumed asbestos-containing materials, which will be disturbed during demolition activities, are regulated under current Federal and State regulations. Hart Environmental Resources recommends the removal of these materials by a licensed asbestos abatement

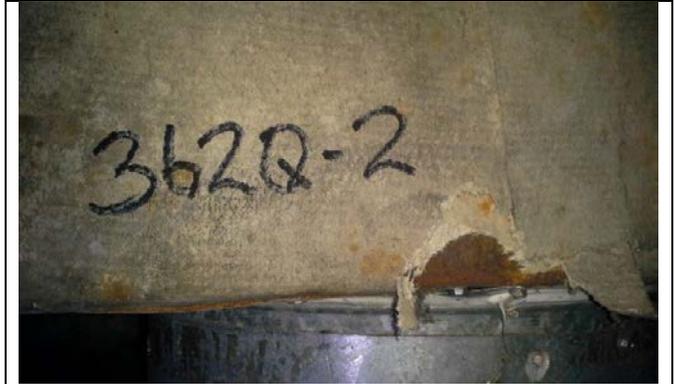
Photo 2: Box Duct Wrap (362Q-2) Basement, Ceiling.
65% Chrysotile Asbestos Detected.

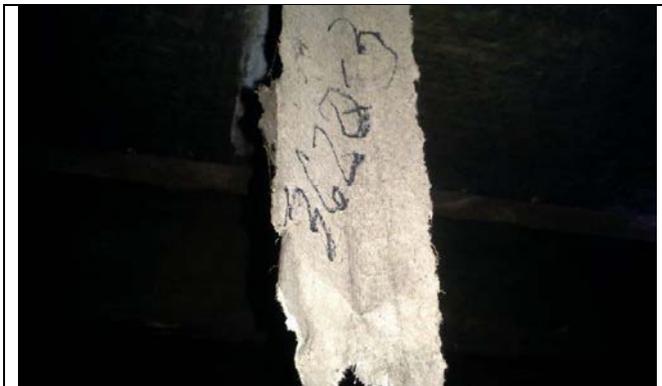
Photo 3: Seam Tape (362Q-3) Basement, Ceiling.
65% Chrysotile Asbestos Detected.

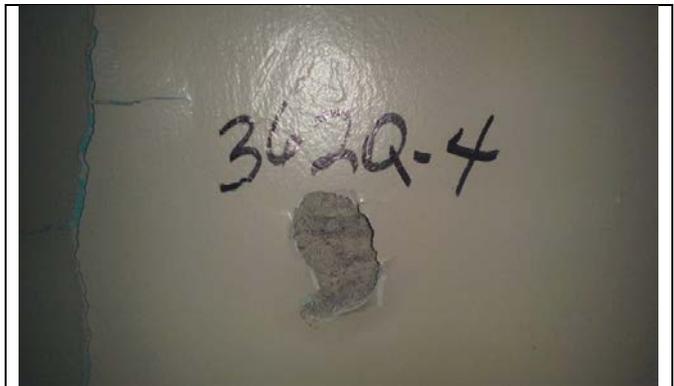
Photo 4: Plaster (362Q-4) Living Room, Wall D.
No Asbestos Detected.

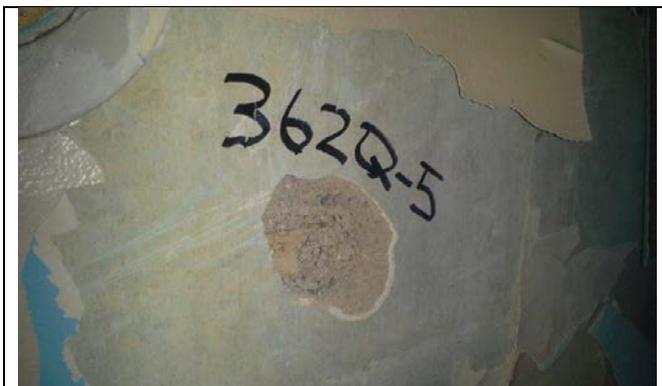
Photo 5: Plaster (362Q-5) Family Room, Wall A.
No Asbestos Detected.

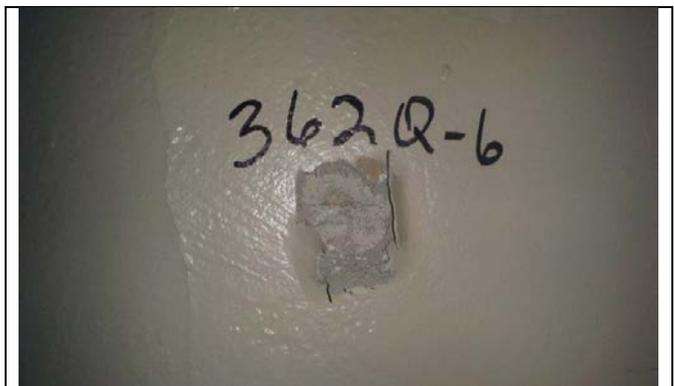
Photo 6: Plaster (362Q-6) Dining Room, Wall D.
No Asbestos Detected.

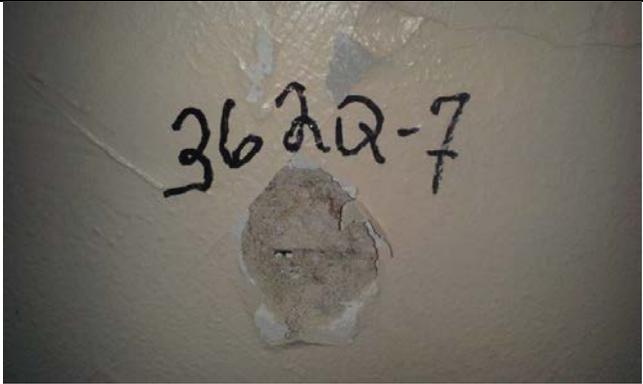
Photo 7: Plaster (362Q-7) Bedroom 2, Wall B.
No Asbestos Detected.

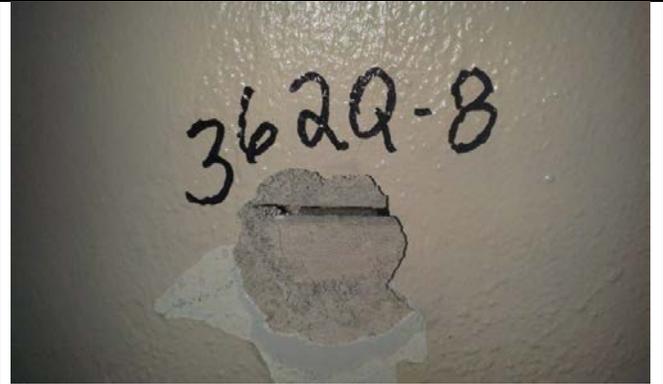
Photo 8: Plaster (362Q-8) Bedroom 1, Wall C.
No Asbestos Detected.

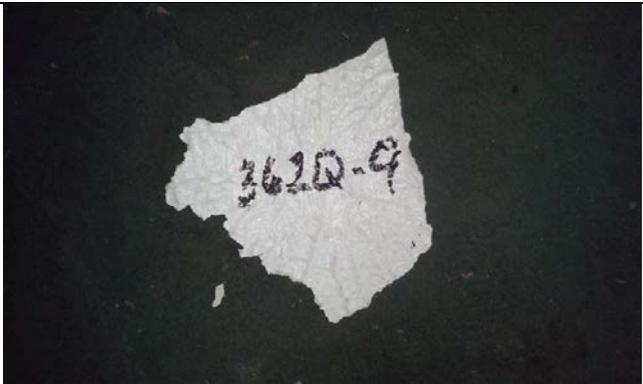
Photo 9: Txt Pt (362Q-9) Bedroom 2, Ceiling.
No Asbestos Detected.

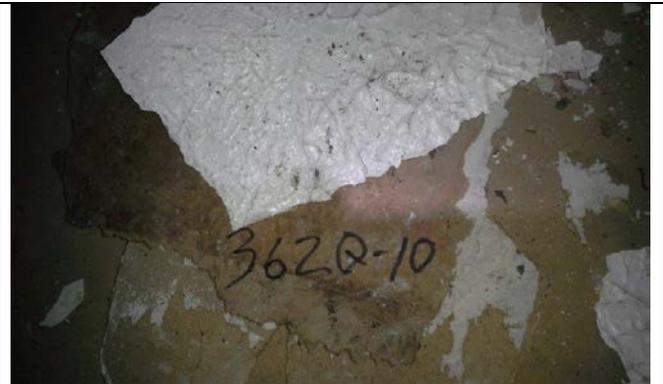
Photo 10: Drywall/Txt Pt (362Q-10) Dining Room, On Floor.
No Asbestos Detected.

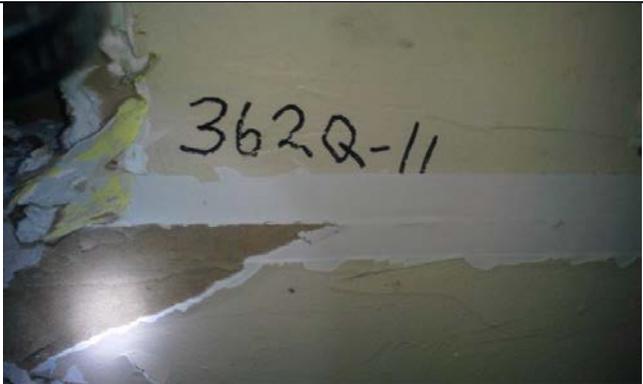
Photo 11: Drywall/Txt Pt (362Q-11) Dining Room, On Floor.
No Asbestos Detected.

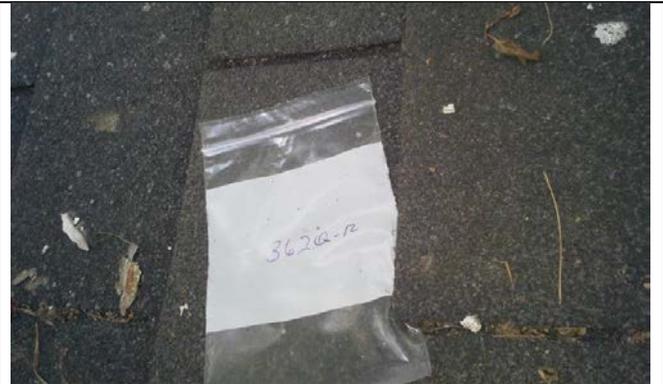
Photo 12: Roof Shingle (362Q-12) Exterior.
No Asbestos Detected.

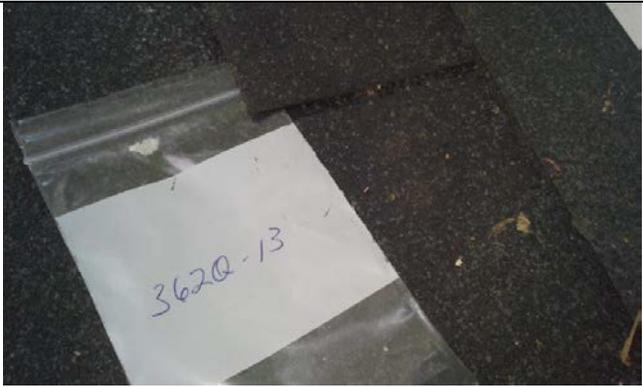
**Photo 13: Roof Shingle (362Q-13) Exterior.
No Asbestos Detected.**

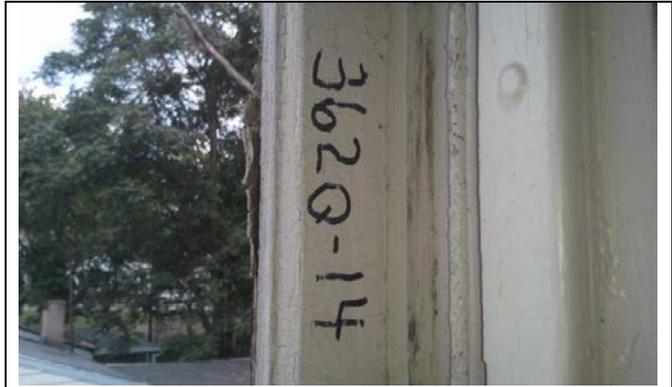
**Photo 14: Window Glazing (362Q-14) Bedroom 3, Wall B.
3% Chrysotile Asbestos Detected.**

Lab Sample Number	Client Sample Number	Lab Gross Description	% Asbestos	Narrative ID
15-08-02856-001	362Q-14	Tan Granular; Gray Paint-Like	1.25 % Chrysotile	
15-08-02856-002	362Q-15	Tan Granular; Gray Paint-Like	1.50 % Chrysotile

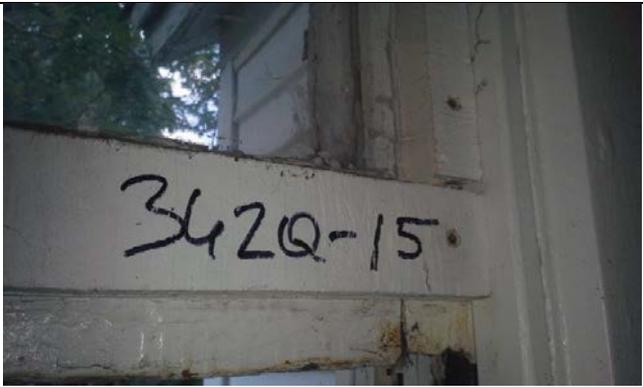
**Photo 15: Window Glazing (362Q-15) Bedroom 3, Wall C.
3% Chrysotile Asbestos Detected.**
