*Turn-Key Environmental Consultants, Inc.*

August 28, 2015

RE: Comprehensive Pre-Demolition Asbestos Survey, NOP TK-7amended, Vacant Residence, 4100 Melgrove Ave., Dayton, OH, TKEC Project #TK-7aG

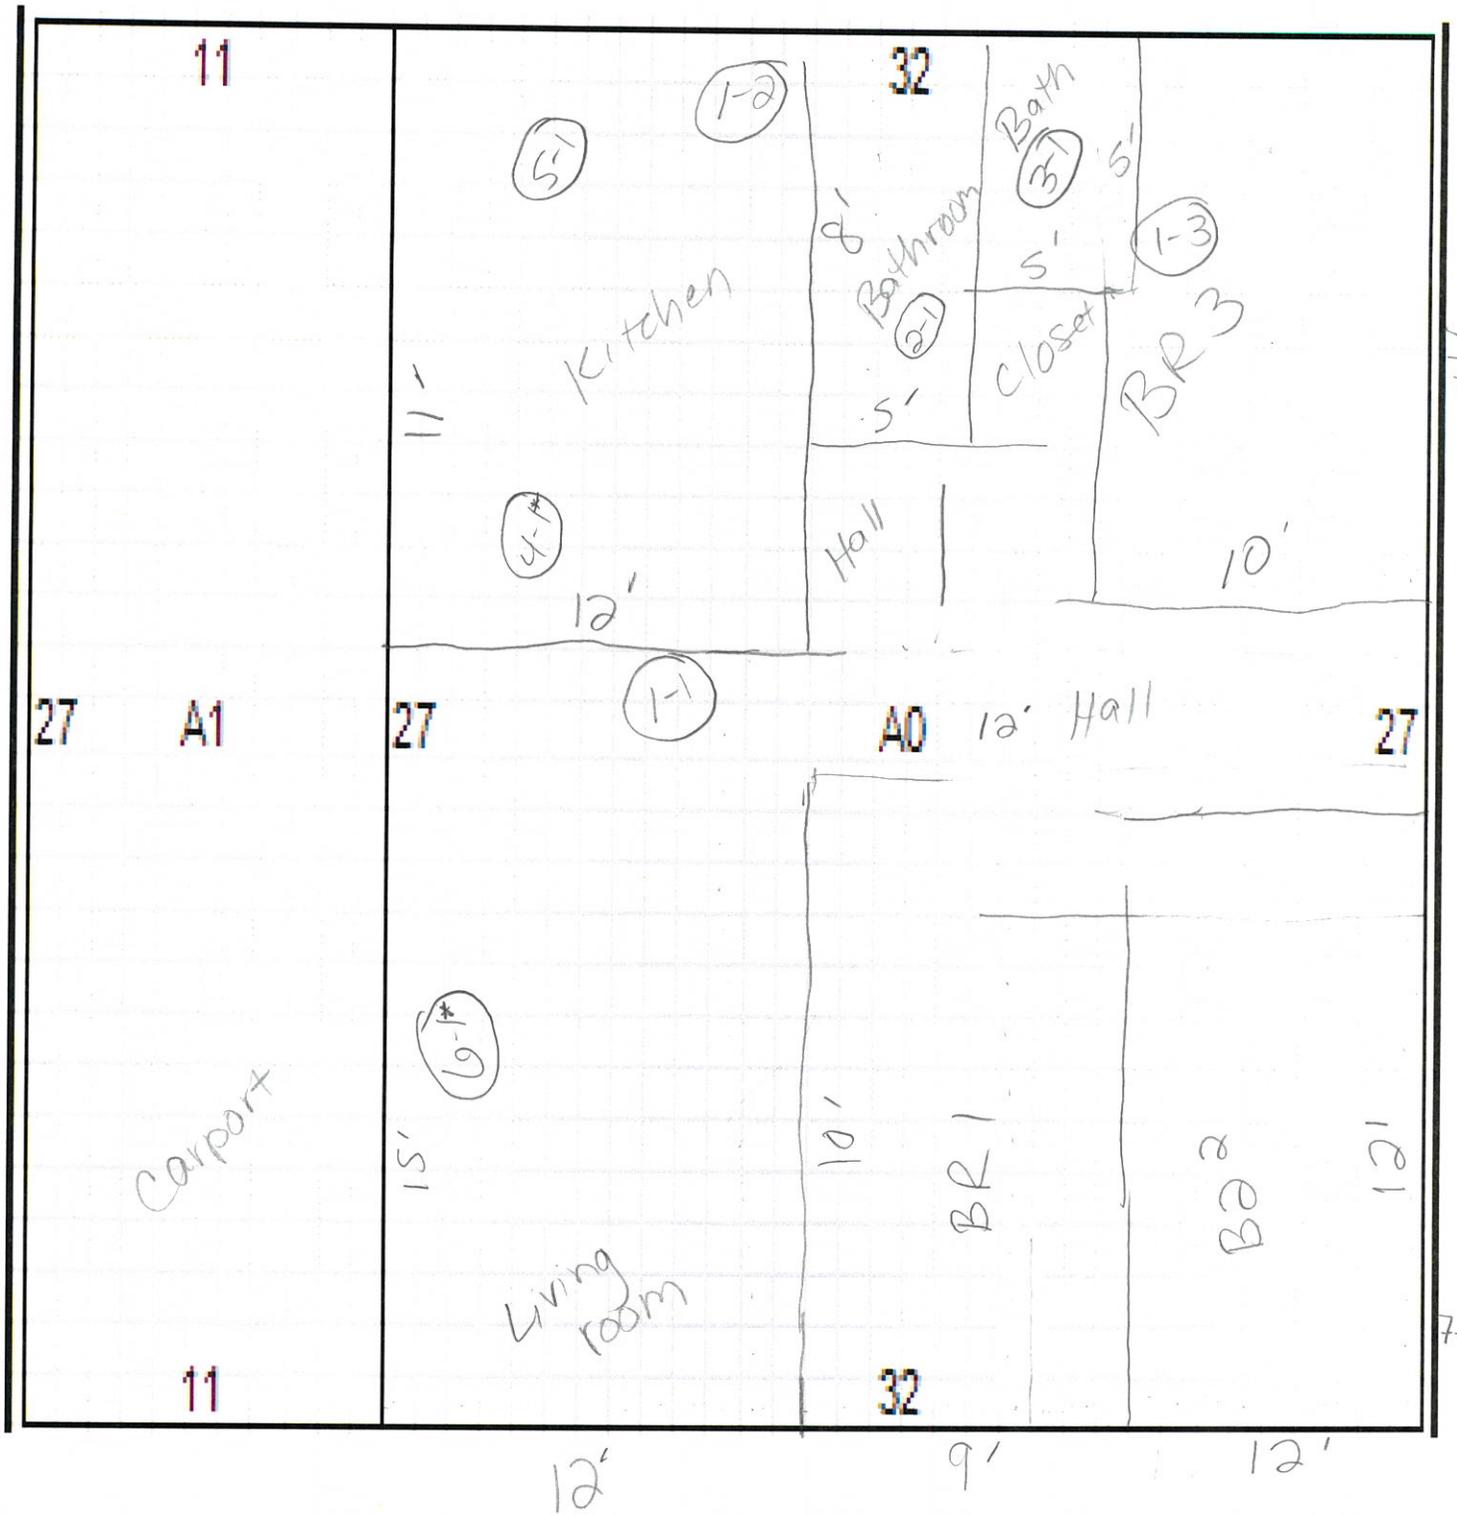
Floor \_\_\_\_  
4100 Melgrove Ave.  
TK-7aG

1-1 Approximate  
Sample Location  
1-1\* Asbestos > 1%

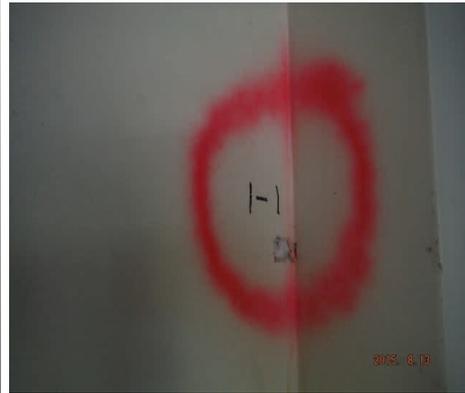
SanAir ID / Description	Stereoscopic Appearance	Components		Asbestos Fibers
		% Fibrous	% Non-Fibrous	
1-1 / 15026333-001 Drywall/ Joint Compound Living Room Wall	Beige Non-Fibrous Homogeneous		99.25% Other	0.75% Chrysotile

Sample 1-1 Drywall/Joint Compound

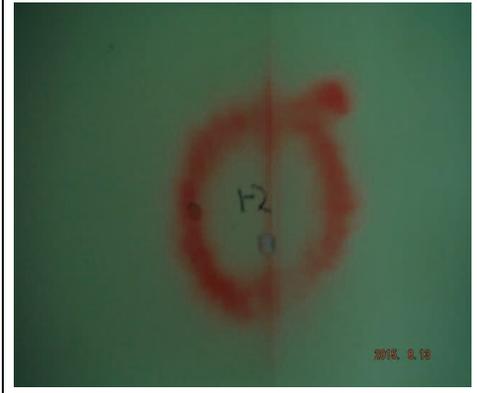
SanAir ID / Description	Stereoscopic Appearance	Components		Asbestos Fibers
		% Fibrous	% Non-Fibrous	
1-2 / 15026333-002 Drywall/ Joint Compound Kitchen Wall	White Non-Fibrous Homogeneous		99.25% Other	0.75% Chrysotile

Sample 1-2 Drywall/Joint Compound

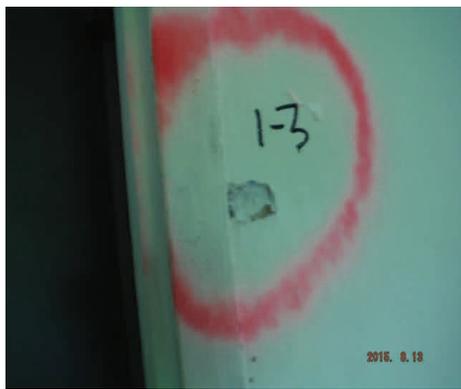
SanAir ID / Description	Stereoscopic Appearance	Components		Asbestos Fibers
		% Fibrous	% Non-Fibrous	
1-3 / 15026333-003 Drywall/ Joint Compound Bedroom 3	White Non-Fibrous Homogeneous		99.5% Other	0.5% Chrysotile

Sample 1-3 Drywall/Joint Compound

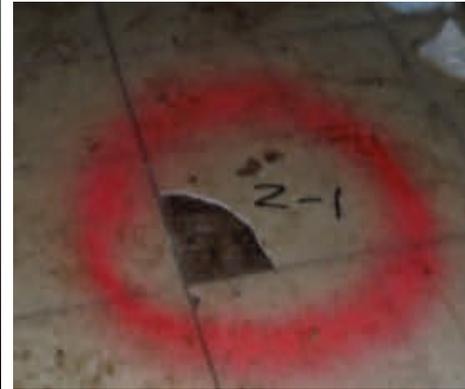
SanAir ID / Description	Stereoscopic Appearance	Components		Asbestos Fibers
		% Fibrous	% Non-Fibrous	
2-1 / 15025199-004 12" Floor Tile Bathroom (8x5), Floor Tile	Cream Non-Fibrous Homogeneous		100% Other	None Detected
2-1 / 15025199-004 12" Floor Tile Bathroom (8x5), Mastic	Yellow Non-Fibrous Homogeneous		100% Other	None Detected

Sample 2-1 12" Floor Tile

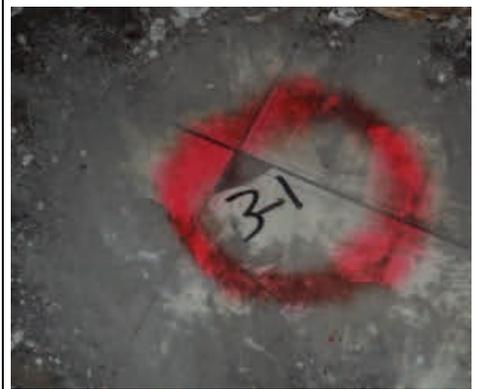
SanAir ID / Description	Stereoscopic Appearance	Components		Asbestos Fibers
		% Fibrous	% Non-Fibrous	
3-1 / 15025199-005 12" Floor Tile Back Bathroom (5x5), Floor Tile	Cream Non-Fibrous Homogeneous		100% Other	None Detected
3-1 / 15025199-005 12" Floor Tile Back Bathroom (5x5), Mastic	Yellow Non-Fibrous Homogeneous		100% Other	None Detected

Sample 3-1 12" Floor Tile

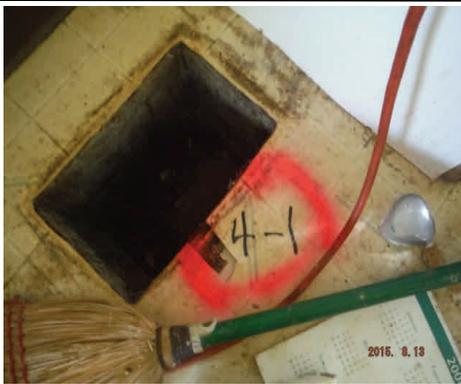
SanAir ID / Description	Stereoscopic Appearance	Components		Asbestos Fibers
		% Fibrous	% Non-Fibrous	
4-1 / 15025199-006 Linoleum Flooring Kitchen (11x12), Linoleum	Cream Non-Fibrous Homogeneous	10% Cellulose	90% Other	None Detected
4-1 / 15025199-006 Linoleum Flooring Kitchen (11x12), Mastic	Black Non-Fibrous Homogeneous		96% Other	4% Chrysotile

Sample 4-1 Linoleum Flooring

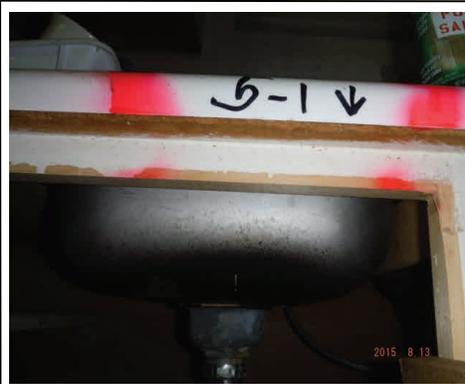
SanAir ID / Description	Stereoscopic Appearance	Components		Asbestos Fibers
		% Fibrous	% Non-Fibrous	
5-1 / 15025199-007 Sink Undercoating Kitchen	Black Non-Fibrous Homogeneous		100% Other	None Detected

Sample 5-1 Sink Undercoating

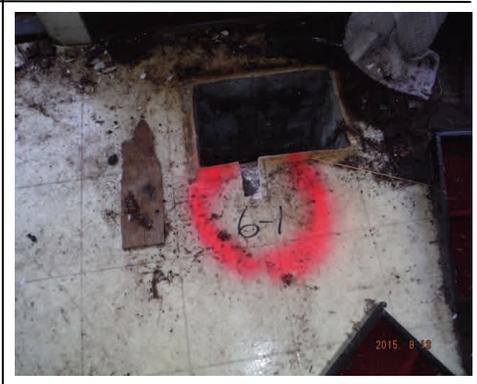
SanAir ID / Description	Stereoscopic Appearance	Components		Asbestos Fibers
		% Fibrous	% Non-Fibrous	
6-1 / 15025199-008 Linoleum Flooring Living Room, Linoleum	Cream Non-Fibrous Homogeneous	10% Cellulose	90% Other	None Detected
6-1 / 15025199-008 Linoleum Flooring Living Room, Leveling Cmpd.	Grey Non-Fibrous Homogeneous		100% Other	None Detected
6-1 / 15025199-008 Linoleum Flooring Living Room, Mastic	Black Non-Fibrous Homogeneous		97% Other	3% Chrysotile

Sample 6-1 Linoleum Flooring

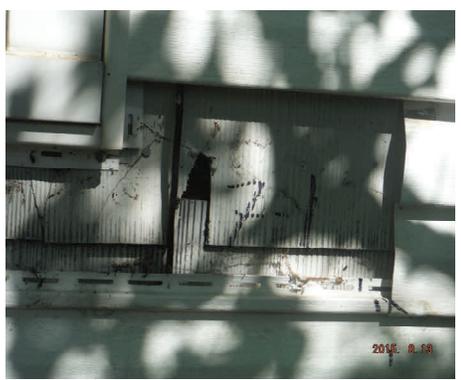
Approximately 1,328 SF of transite siding on the house will need to be abated prior to demolition.

SanAir ID / Description	Stereoscopic Appearance	Components		Asbestos Fibers
		% Fibrous	% Non-Fibrous	
7-1 / 15025199-009 Transite Siding Exterior Of Home	Grey Non-Fibrous Homogeneous		80% Other	20% Chrysotile

Sample 7-1 Transite Siding

<b><u>Material</u></b>	<b><u>Estimated Quantity</u></b>	<b><u>Estimated Unit Costs</u></b>	<b><u>Estimated Costs</u></b>
<b>Transite Siding</b>	<b>1,328 SF</b>	<b>\$4.00/SF</b>	<b>\$5,312.00</b>

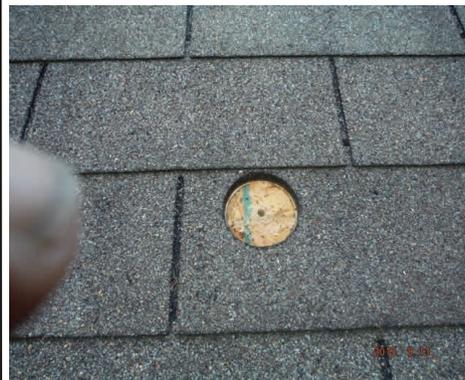
SanAir ID / Description	Stereoscopic Appearance	Components		Asbestos Fibers
		% Fibrous	% Non-Fibrous	
8-1 / 15025199-010 Roof Shingles/ Felt Roof (3 Layers Total), Shingle	Grey Non-Fibrous Heterogeneous	5% Glass	95% Other	None Detected
8-1 / 15025199-010 Roof Shingles/ Felt Roof (3 Layers Total), Shingle	Black Non-Fibrous Heterogeneous	5% Glass	95% Other	None Detected
8-1 / 15025199-010 Roof Shingles/ Felt Roof (3 Layers Total), Felt	Black Fibrous Homogeneous	45% Cellulose	55% Other	None Detected

Sample 8-1 Roof Shingles/Felt

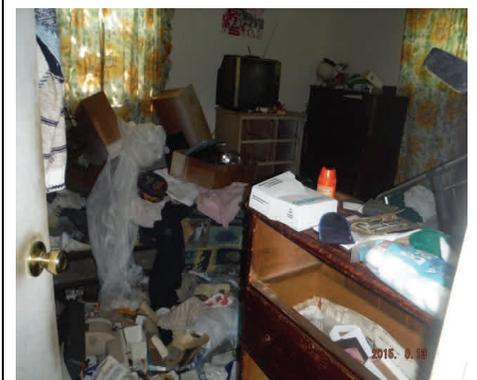
Clutter in House
