## **ASBESTOS INSPECTION REPORT**

**1011 W. Second St.  
Dayton, OH 45402**

**Lynda M. Hart  
Asbestos Hazards Evaluation Specialist  
Ohio #ES-32558  
September 17, 2015**

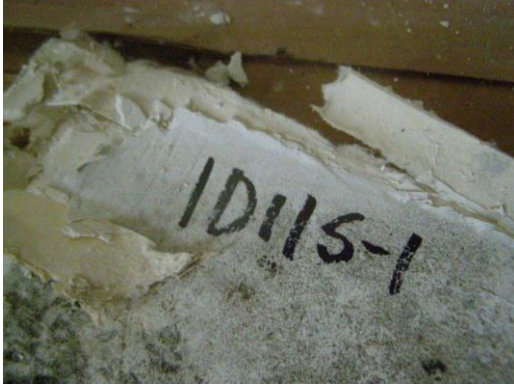
Photo 1: Drywall/J.C. (1011S-1) Family Room, Ceiling.  
No Asbestos Detected.

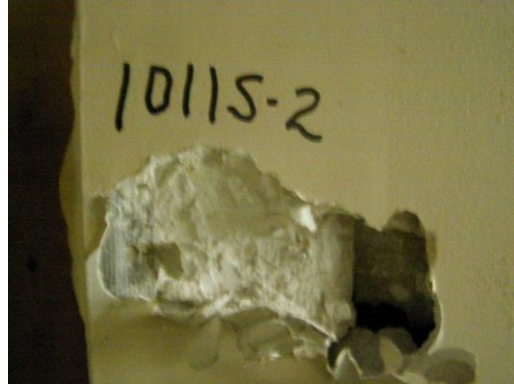
Photo 2: Drywall/J.C. (1011S-2) Kitchen, Wall A.  
No Asbestos Detected.

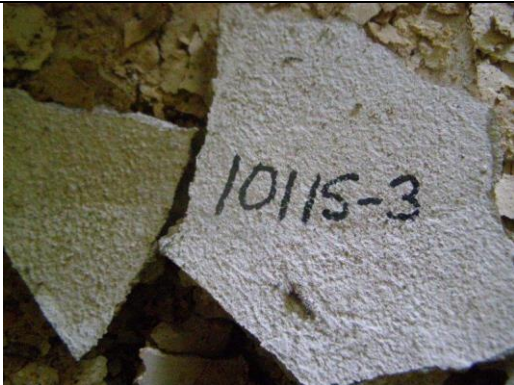
Photo 3: Plaster (1011S-3) Family Room, Ceiling.  
No Asbestos Detected.

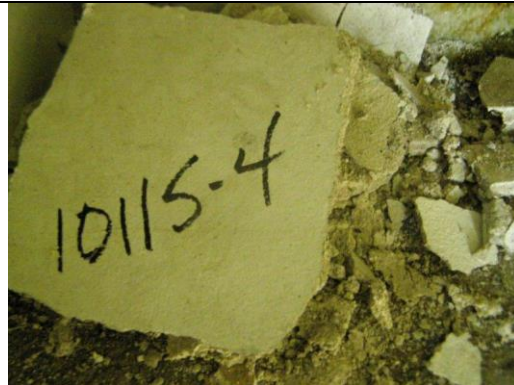
Photo 4: Plaster (1011S-4) Entry Stairs.  
No Asbestos Detected.

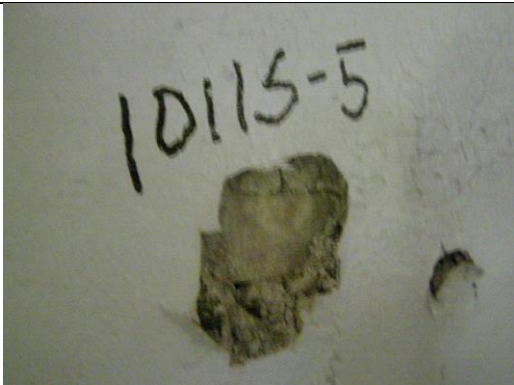
Photo 5: Plaster (1011S-5) Living Room, Wall C.  
No Asbestos Detected.

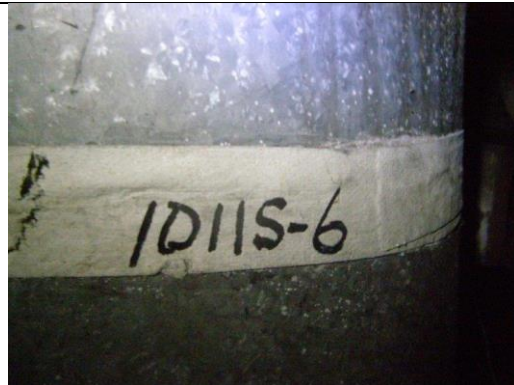
Photo 6: Seam Tape (1011S-6) Basement.  
65% Chrysotile Asbestos Detected.

Confirmed or assumed asbestos-containing materials, which will be disturbed during demolition activities, are regulated under current Federal and State regulations. Hart Environmental Resources recommends the removal of these materials by a licensed asbestos abatement contractor. It is also strongly recommended that the specifications for the removal program be developed by a licensed Asbestos Project Designer to ensure that all regulatory requirements are satisfied. The work should be properly documented in the event of future litigation.

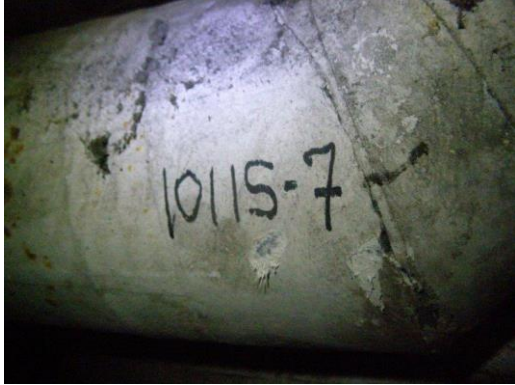
**Photo 7: Duct Work Wrap (1011S-7) Basement.  
45% Chrysotile Asbestos Detected.**

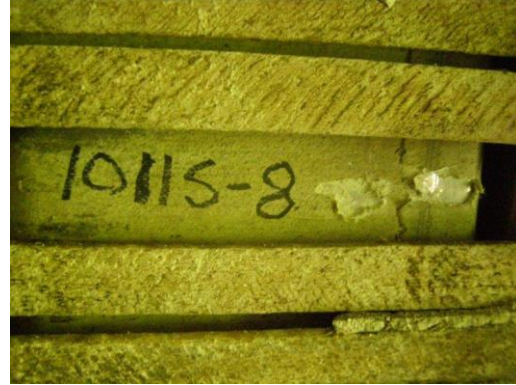
**Photo 8: Duct Work Wrap (1011S-8) Entry.  
65% Chrysotile Asbestos Detected.**

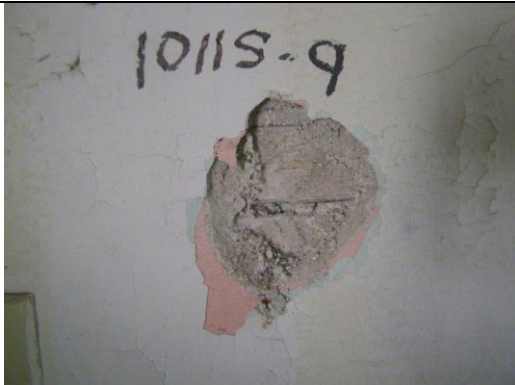
**Photo 9: Plaster (1011S-9) Bedroom 2, Wall D.  
No Asbestos Detected.**

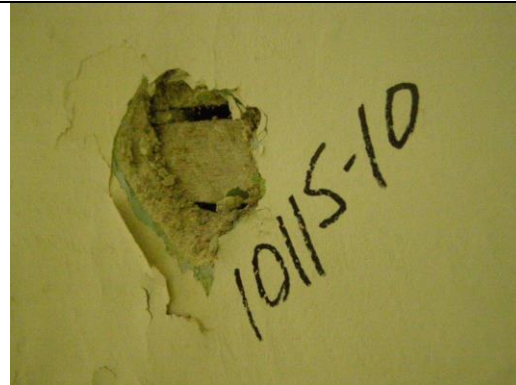
**Photo 10: Plaster (1011S-10) Bedroom 2, Wall B.  
No Asbestos Detected.**

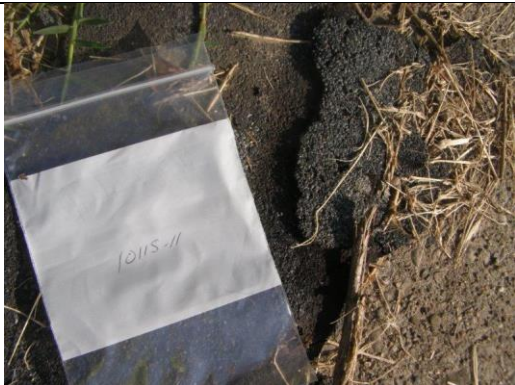
**Photo 11: Roof Shingle (1011S-11) Exterior.  
No Asbestos Detected.**

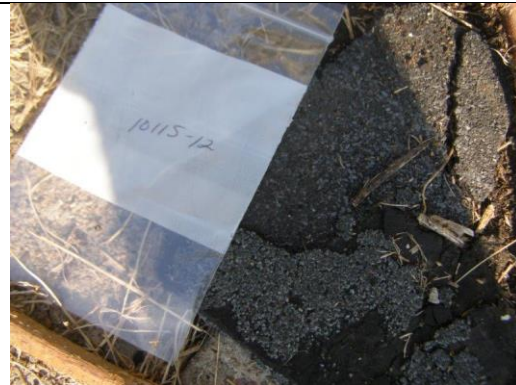
**Photo 12: Roof Shingle (1011S-12) Exterior.  
No Asbestos Detected.**
