ASBESTOS INSPECTION REPORT

**1025-1027 W. Second St.
Dayton, OH 45402**

Re: Asbestos Inspection
1025-1027 W. Second St.
Dayton, OH 45402

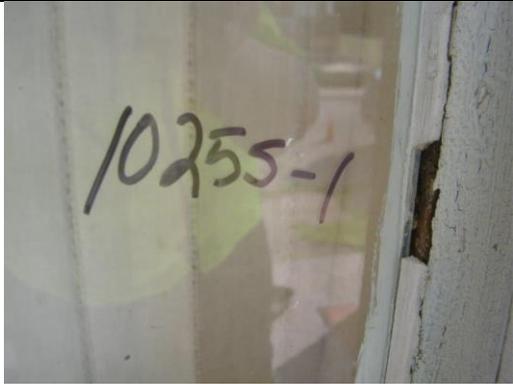
Photo 1: Window Glazing (1025S-1) Living Room, Wall A. No Asbestos Detected.

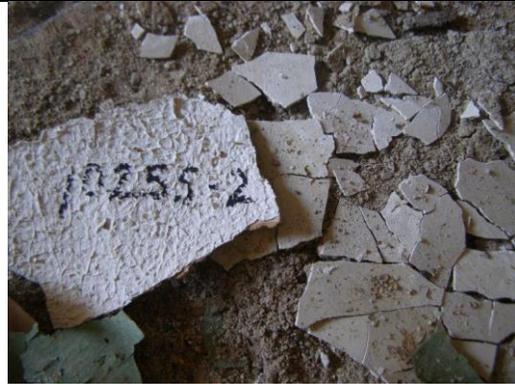
Photo 2: Txt Pt. (1025S-2) Living Room, Ceiling. Trace <1% Chrysotile Asbestos Detected (PC=0.25%).

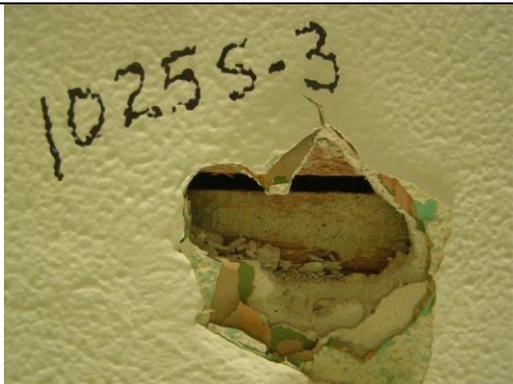
Photo 3: Plaster (1025S-3) Living Room, Wall A. No Asbestos Detected.

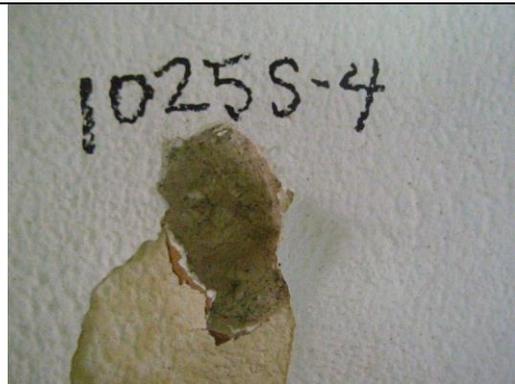
Photo 4: Plaster (1025S-4) Dining Room, Wall B. Trace <1% Chrysotile Asbestos Detected (PC=0.50%).

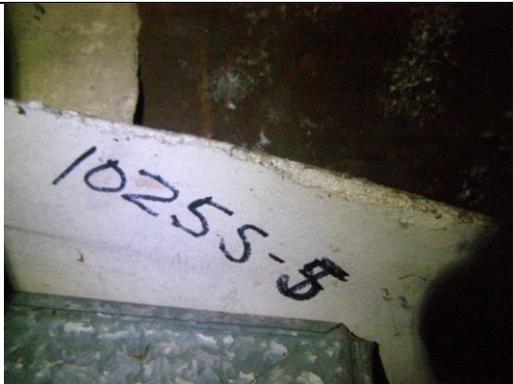
Photo 5: Furnace Board (1025S-5) Basement, Ceiling. No Asbestos Detected.

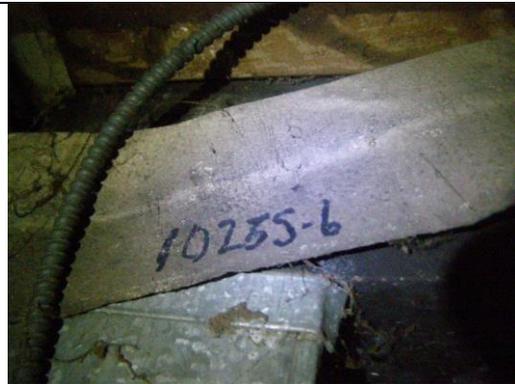
Photo 6: Seam Tape (1025S-6) Basement. 65% Chrysotile Asbestos Detected.

Confirmed or assumed asbestos-containing materials, which will be disturbed during demolition activities, are regulated under current Federal and State regulations. Hart Environmental Resources recommends the removal of these materials by a licensed asbestos abatement contractor. It is also strongly recommended that the specifications for the removal program be developed by a licensed Asbestos Project Designer to ensure that all regulatory requirements are satisfied. The work should be properly documented in the event of future litigation.

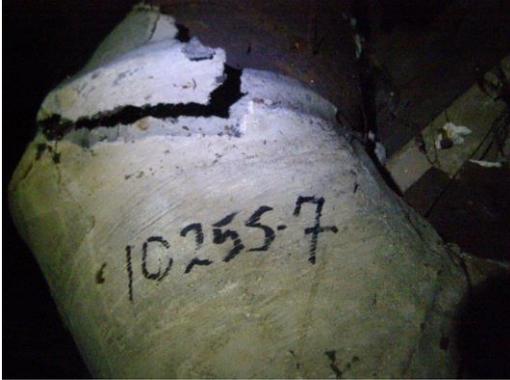
**Photo 7: Boot Wrap (1025S-7) Basement, Ceiling.
65% Chrysotile Asbestos Detected.**

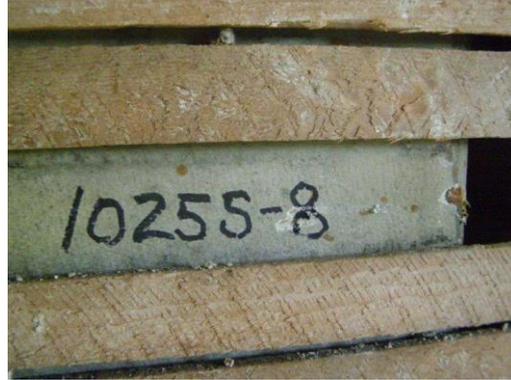
**Photo 8: Duct Work Wrap (1025S-8) Dining Room,
Wall C. 65% Chrysotile Asbestos Detected.**

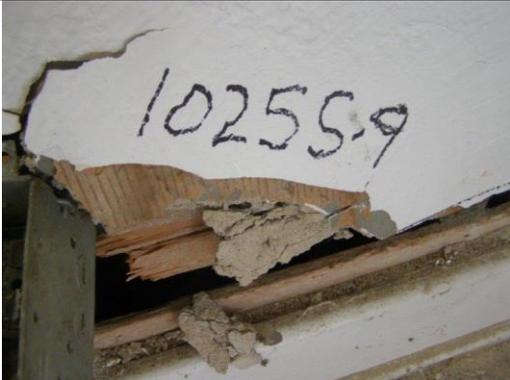
**Photo 9: Plaster (1025S-9) Bedroom 1, Wall D.
No Asbestos Detected.**

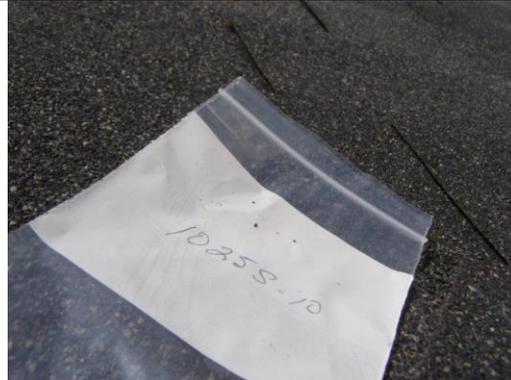
**Photo 10: Roof Shingle (1025S-10) Exterior.
No Asbestos Detected.**

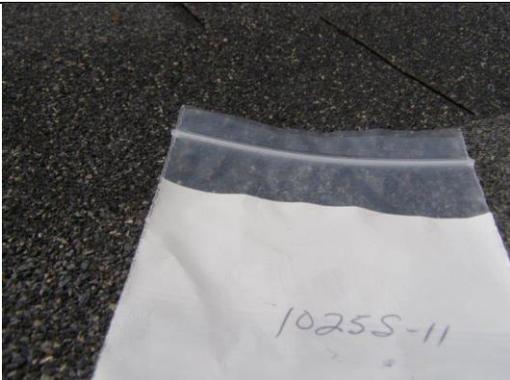
**Photo 11: Roof Shingle (1025S-11) Exterior.
No Asbestos Detected.**

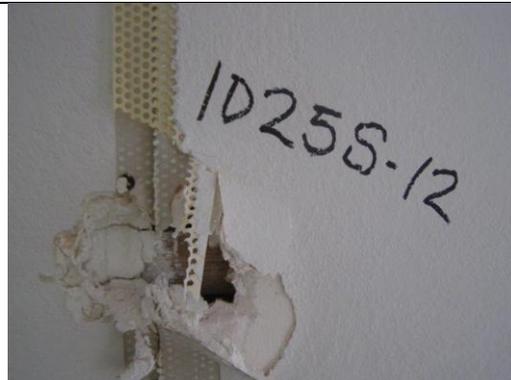
**Photo 12: Drywall/J.C. (1025S-12) Bedroom 1, Wall D.
No Asbestos Detected.**

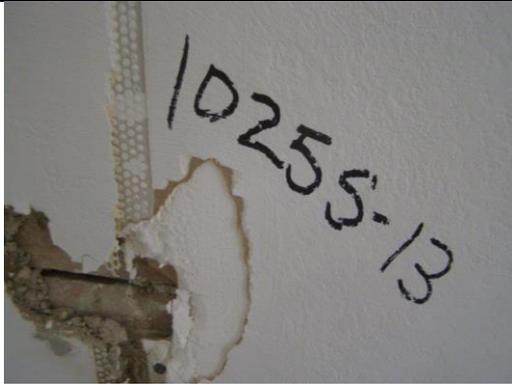
Photo 13: Drywall/J.C. (1025S-13) Bedroom 2, Wall D. No Asbestos Detected.

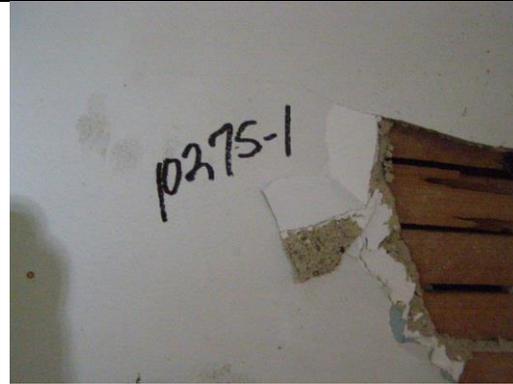
Photo 14: Plaster (1027S-1) Living Room, Wall B. No Asbestos Detected.

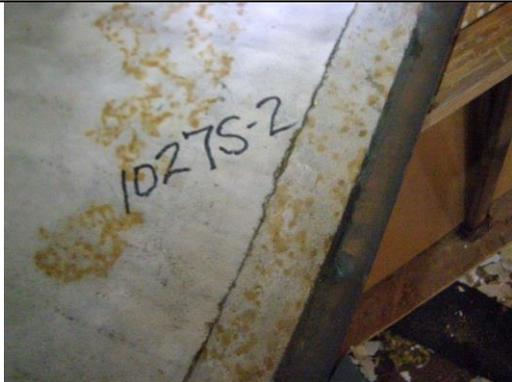
Photo 15: Grate Cover with Wrap (1027S-2) Basement Entry. 65% Chrysotile Asbestos Detected.

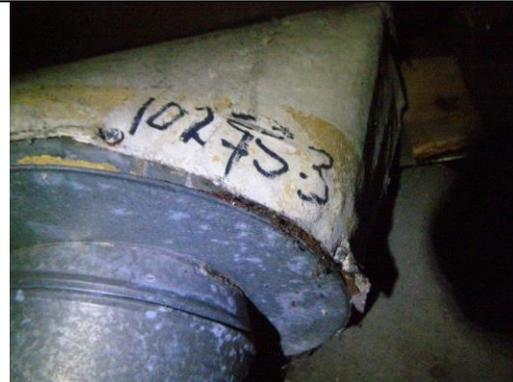
Photo 16: Boot Wrap (1027S-3) Basement. 65% Chrysotile Asbestos Detected.

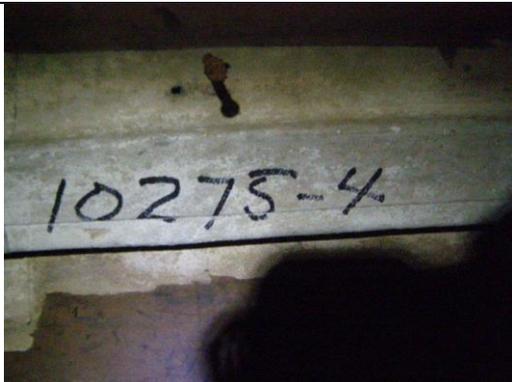
Photo 17: Seam Tape (1027S-4) Basement. 65% Chrysotile Asbestos Detected.

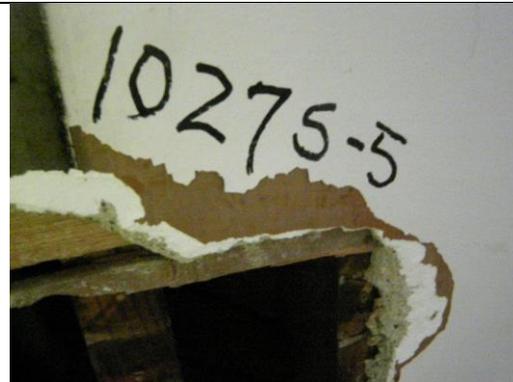
Photo 18: Plaster (1027S-5) Bedroom 2, Wall B. No Asbestos Detected.

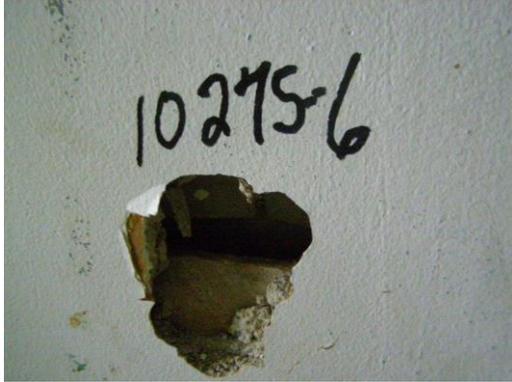
Photo 19: Plaster (1027S-6) Bedroom 3, Wall D.
No Asbestos Detected.

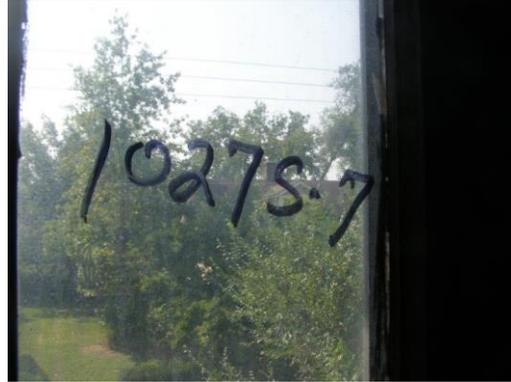
Photo 20: Window Glazing (1027S-7) Bedroom 1,
Wall A. No Asbestos Detected.

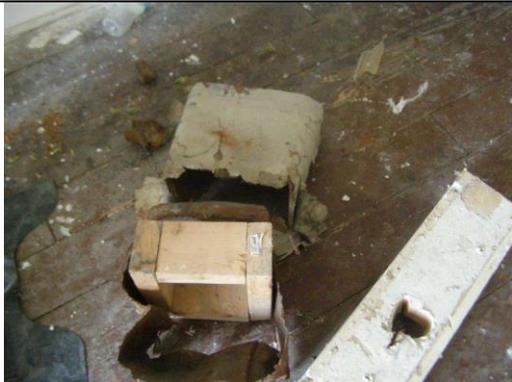
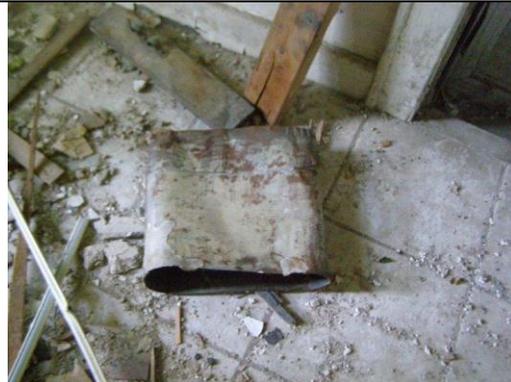
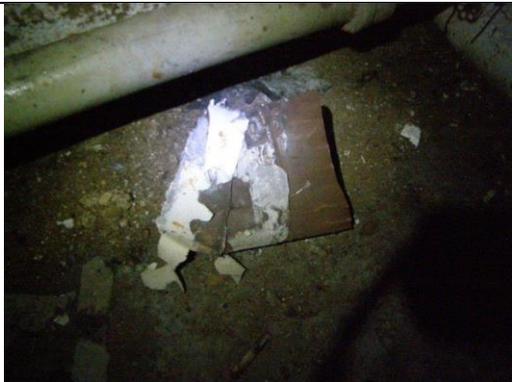
- Furnace Board, Basement, 1025 W. Second St.
- Seam Tape, Basement, Both Units
- Duct Work Wrap, Walls Both Units
- Grate Cover with Wrap, Entry 1027 W. Second St.
- Boot Wrap, Basement, Both Units.
- Ground Debris, Basement, Kitchen, Bedroom 1 (1025), Basement (1027)

Photo 21: Ground Debris, view 1.

Photo 22: Ground Debris, view 2.

Photo 23: Ground Debris, view 3.
