## **ASBESTOS INSPECTION REPORT**

**1132 W. Second St.  
Dayton, OH 45402**

**Lynda M. Hart  
Asbestos Hazards Evaluation Specialist  
Ohio #ES-32558  
September 17, 2015**

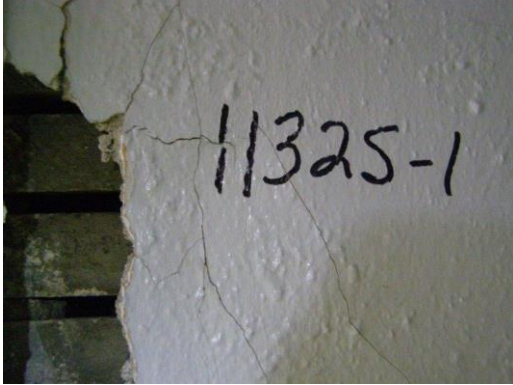
| <b>HER Sample #<br/>Lab Sample #</b> | <b>Amount</b> | <b>Layers</b> | <b>Description/Sample<br/>Location</b> | <b>Condition</b> | <b>PLM Result<br/>(% Asbestos)</b> |
|---|---|---|---|---|---|
| 1132S-1<br>15-09-01277-001 | - | 2 | Plaster, Entry,<br>Wall A, Inhomogeneous | | None Detected |

Photo 1: Plaster (1132S-1) Entry, Wall A.  
No Asbestos Detected.

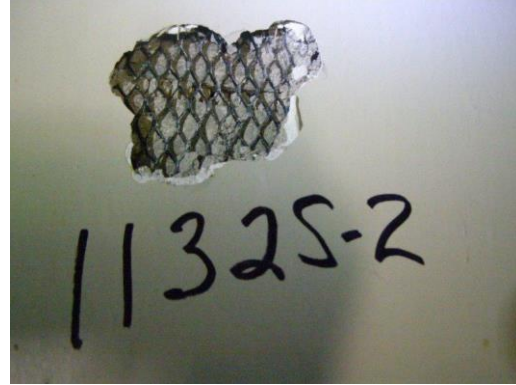
| <b>HER Sample #<br/>Lab Sample #</b> | <b>Amount</b> | <b>Layers</b> | <b>Description/Sample<br/>Location</b> | <b>Condition</b> | <b>PLM Result<br/>(% Asbestos)</b> |
|---|---|---|---|---|---|
| 1132S-2<br>15-09-01277-002 | - | 1 | Plaster, Kitchen,<br>Wall C, Inhomogeneous | | None Detected |

Photo 2: Plaster (1132S-2) Kitchen, Wall C.  
No Asbestos Detected.

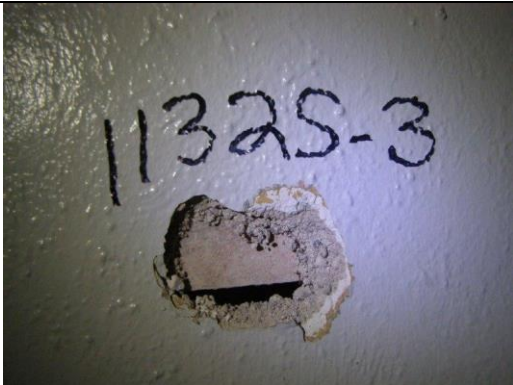
| <b>HER Sample #<br/>Lab Sample #</b> | <b>Amount</b> | <b>Layers</b> | <b>Description/Sample<br/>Location</b> | <b>Condition</b> | <b>PLM Result<br/>(% Asbestos)</b> |
|---|---|---|---|---|---|
| 1132S-3<br>15-09-01277-003 | - | 1 | Plaster, Living Room,<br>Wall D, Inhomogeneous | | None Detected |

Photo 3: Plaster (1132S-3) Living Room, Wall D.  
No Asbestos Detected.

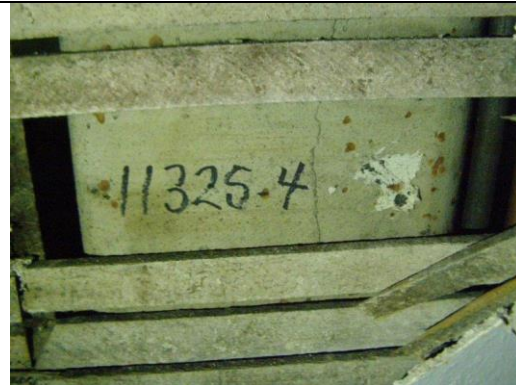
| <b>HER Sample #<br/>Lab Sample #</b> | <b>Amount</b> | <b>Layers</b> | <b>Description/Sample<br/>Location</b> | <b>Condition</b> | <b>PLM Result<br/>(% Asbestos)</b> |
|---|---|---|---|---|---|
| 1132S-4<br>15-09-01277-004 | 50 sq. ft. | 1 | Duct Work Wrap, Living Room,<br>Wall B, Homogeneous | | <b>65% Chrysotile<br/>Asbestos Detected</b> |

Photo 4: Duct Work Wrap (1132S-4) Living Room,  
Wall B. 65% Chrysotile Asbestos Detected.

| Lab Sample Number | Client Sample Number | Layer Type | Lab Gross Description | Asbestos | Other Materials |
|---|---|---|---|---|---|
| 15-09-01277-004 | 1132S-4 | | White Fibrous;<br>Homogeneous | 65% Chrysotile | 10% Cellulose<br>25% Non-Fibrous |

Confirmed or assumed asbestos-containing materials, which will be disturbed during demolition activities, are regulated under current Federal and State regulations. Hart Environmental Resources recommends the removal of these materials by a licensed asbestos abatement contractor. It is also strongly recommended that the specifications for the removal program be developed by a licensed Asbestos Project Designer to ensure that all regulatory requirements are satisfied. The work should be properly documented in the event of future litigation.

| <u>Material</u> | <u>Est. Qty.</u> | <u>Est. Unit Cost</u> | <u>Est. Cost</u> |
|---|---|---|---|
| Ductwork Wrap | 50 sq. ft. | \$ 20 sq. ft. | \$ 1,000 |

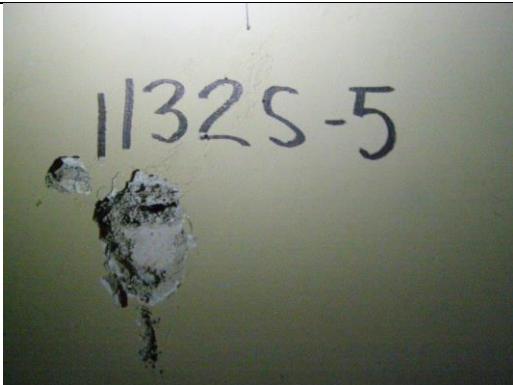
| <b>HER Sample #<br/>Lab Sample #</b> | <b>Amount</b> | <b>Layers</b> | <b>Description/Sample<br/>Location</b> | <b>Condition</b> | <b>PLM Result<br/>(% Asbestos)</b> |
|---|---|---|---|---|---|
| 1132S-5<br>15-09-01277-005 | - | 1 | Plaster, Bedroom 1,<br>Wall A, Inhomogeneous | | None Detected |

Photo 5: Plaster (1132S-5) Bedroom 1, Wall A.  
No Asbestos Detected.

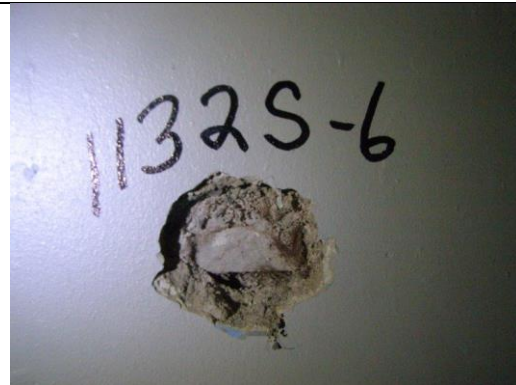
| <b>HER Sample #<br/>Lab Sample #</b> | <b>Amount</b> | <b>Layers</b> | <b>Description/Sample<br/>Location</b> | <b>Condition</b> | <b>PLM Result<br/>(% Asbestos)</b> |
|---|---|---|---|---|---|
| 1132S-6<br>15-09-01277-006 | - | 1 | Plaster, Bedroom 3,<br>Wall B , Inhomogeneous | | None Detected |

Photo 6: Plaster (1132S-6) Bedroom 3, Wall B.  
No Asbestos Detected.

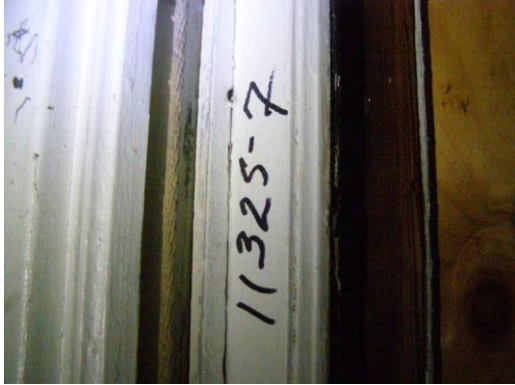
| <b>HER Sample #<br/>Lab Sample #</b> | <b>Amount</b> | <b>Layers</b> | <b>Description/Sample<br/>Location</b> | <b>Condition</b> | <b>PLM Result<br/>(% Asbestos)</b> |
|---|---|---|---|---|---|
| 1132S-7<br>15-09-01277-007 | - | 2 | Window Glazing, Bedroom 1,<br>Wall D, Inhomogeneous | | None Detected |

Photo 7: Window Glazing (1132S-7) Bedroom 1, Wall D.  
No Asbestos Detected.

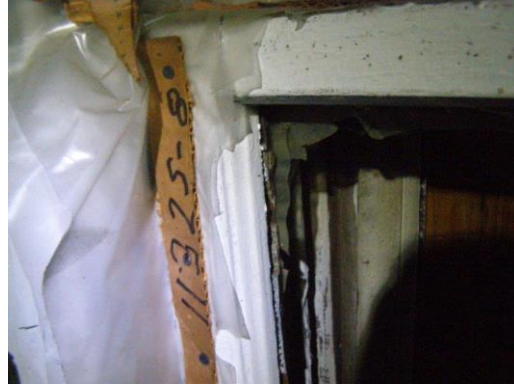
| <b>HER Sample #<br/>Lab Sample #</b> | <b>Amount</b> | <b>Layers</b> | <b>Description/Sample<br/>Location</b> | <b>Condition</b> | <b>PLM Result<br/>(% Asbestos)</b> |
|---|---|---|---|---|---|
| 1132S-8<br>15-09-01277-008 | - | 2 | Window Glazing, Bedroom 3,<br>Wall D, Inhomogeneous | | None Detected |

Photo 8: Window Glazing (1132S-8) Bedroom 3, Wall D.  
No Asbestos Detected.

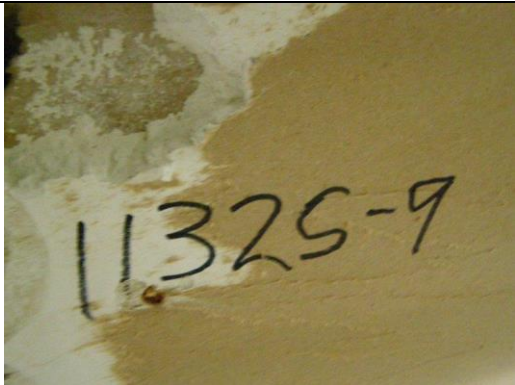
| <b>HER Sample #<br/>Lab Sample #</b> | <b>Amount</b> | <b>Layers</b> | <b>Description/Sample<br/>Location</b> | <b>Condition</b> | <b>PLM Result<br/>(% Asbestos)</b> |
|---|---|---|---|---|---|
| 1132S-9<br>15-09-01277-009 | - | 1 | Drywall/J.C., Entry,<br>Ceiling, Homogeneous | | None Detected |

Photo 9: Drywall/J.C. (1132S-9) Entry, Ceiling.  
No Asbestos Detected.

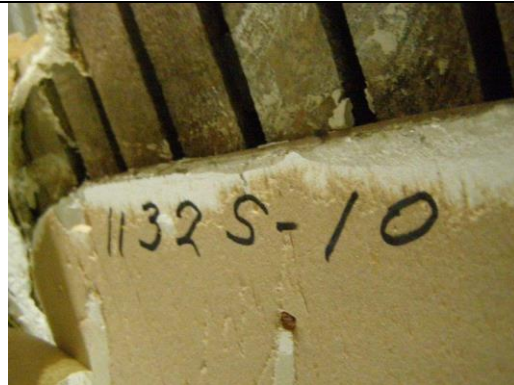
| <b>HER Sample #<br/>Lab Sample #</b> | <b>Amount</b> | <b>Layers</b> | <b>Description/Sample<br/>Location</b> | <b>Condition</b> | <b>PLM Result<br/>(% Asbestos)</b> |
|---|---|---|---|---|---|
| 1132S-10<br>15-09-01277-010 | - | 2 | Drywall/J.C., Entry,<br>Ceiling, Inhomogeneous | | None Detected |

Photo 10: Drywall/J.C. (1132S-10) Entry, Ceiling.  
No Asbestos Detected.

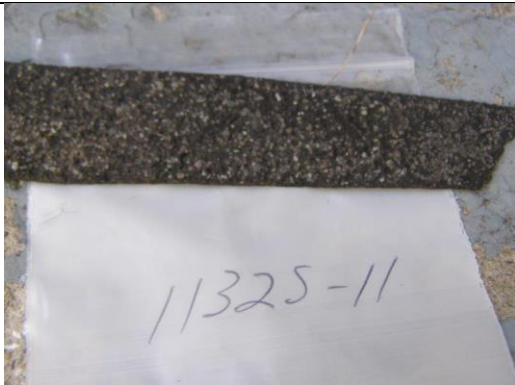
| <b>HER Sample #<br/>Lab Sample #</b> | <b>Amount</b> | <b>Layers</b> | <b>Description/Sample<br/>Location</b> | <b>Condition</b> | <b>PLM Result<br/>(% Asbestos)</b> |
|---|---|---|---|---|---|
| 1132S-11<br>15-09-01277-011 | - | 2 | Shingle, Roof,<br>Inhomogeneous | | None Detected |

Photo 11: Roof Shingle (1132S-11) Exterior.  
No Asbestos Detected.

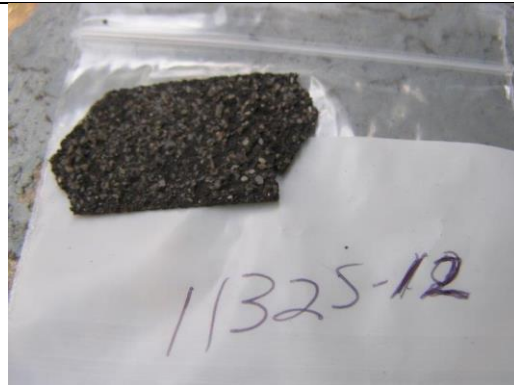
| <b>HER Sample #<br/>Lab Sample #</b> | <b>Amount</b> | <b>Layers</b> | <b>Description/Sample<br/>Location</b> | <b>Condition</b> | <b>PLM Result<br/>(% Asbestos)</b> |
|---|---|---|---|---|---|
| 1132S-12<br>15-09-01277-012 | - | 2 | Shingle, Roof,<br>Inhomogeneous | | None Detected |

Photo 12: Roof Shingle (1132S-12) Exterior.  
No Asbestos Detected.
