## **ASBESTOS INSPECTION REPORT**

**1135 W. Second St.  
Dayton, OH 45402**

**Lynda M. Hart  
Asbestos Hazards Evaluation Specialist  
Ohio #ES-32558  
September 17, 2015**

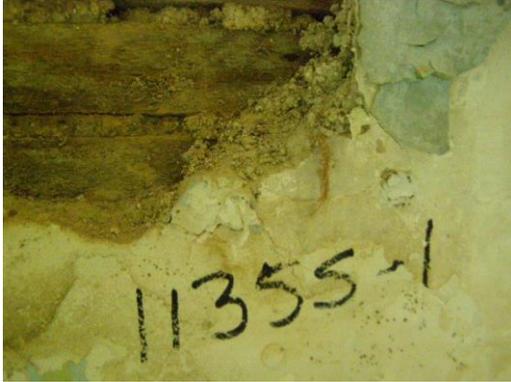
Photo 1: Plaster (1135S-1) Kitchen, Wall D.  
No Asbestos Detected.

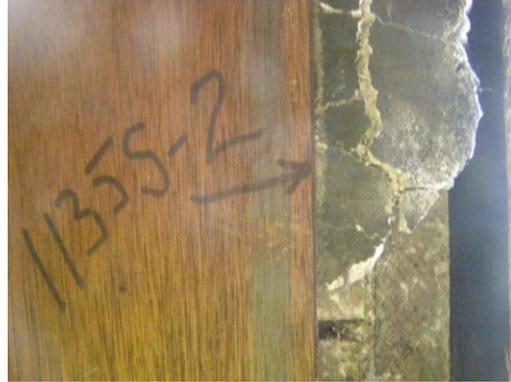
Photo 2: Plaster (1135S-2) Family Room, Wall D.  
No Asbestos Detected.

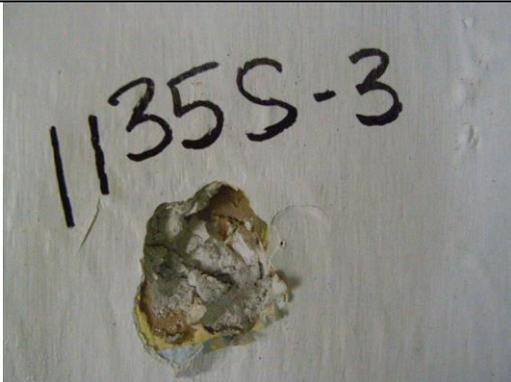
Photo 3: Drywall/J.C. (1135S-3) Family Room, Wall B.  
Trace <1% Chrysotile Asbestos (PC=0.25%) Detected.

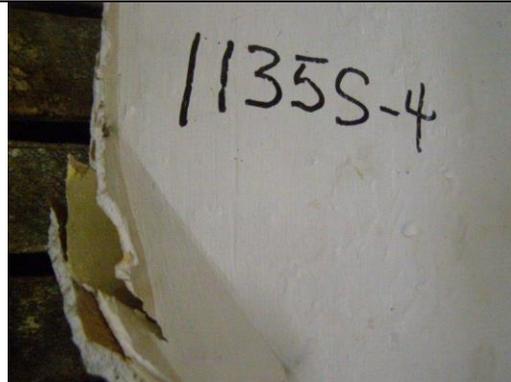
Photo 4: Drywall/J.C. (1135S-4) Family Room,  
Wall A. No Asbestos Detected.

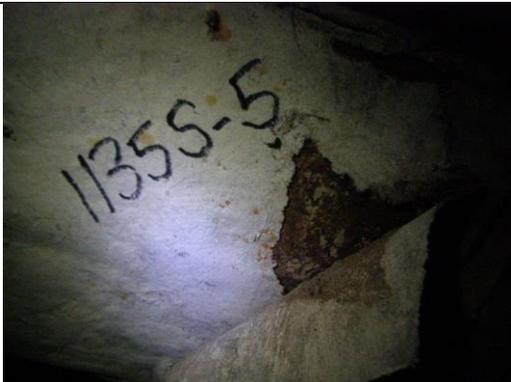
Photo 5: Duct Work Wrap (1135S-5) Basement, Ceiling.  
55% Chrysotile Asbestos Detected.

Confirmed or assumed asbestos-containing materials, which will be disturbed during demolition activities, are regulated under current Federal and State regulations. Hart Environmental Resources recommends the removal of these materials by a licensed asbestos abatement contractor. It is also strongly recommended that the specifications for the removal program be developed by a licensed Asbestos Project Designer to ensure that all regulatory requirements are satisfied. The work should be properly documented in the event of future litigation.

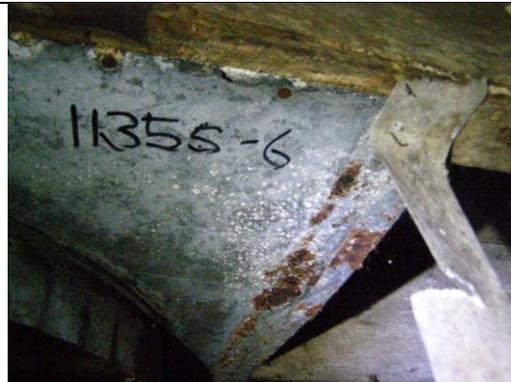
Photo 6: Seam Tape (1135S-6) Basement.  
55% Chrysotile Asbestos Detected.

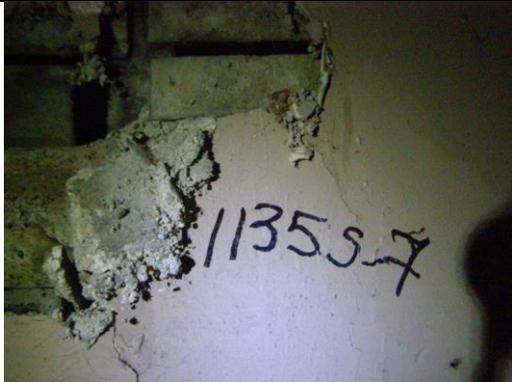
Photo 7: Plaster (1135S-7) Basement Stairs, Wall A.  
No Asbestos Detected.

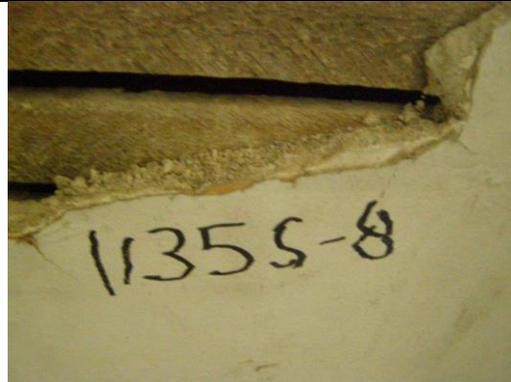
Photo 8: Plaster (1135S-8) Bedroom 2, Wall D.  
No Asbestos Detected.

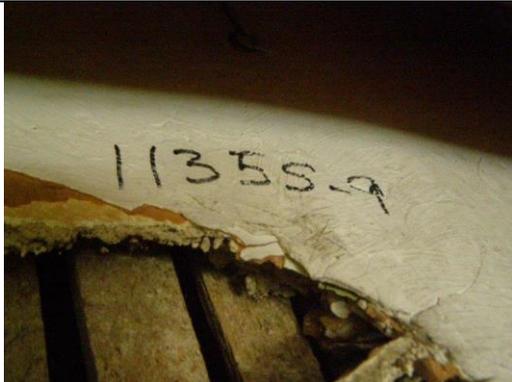
Photo 9: Plaster (1135S-9) Bedroom 3, Wall B.  
No Asbestos Detected.

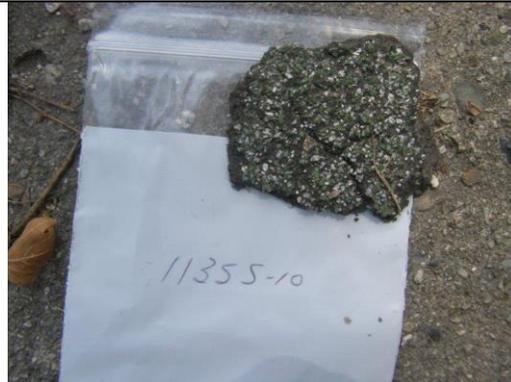
Photo 10: Roof Shingle (1135S-10) Exterior.  
No Asbestos Detected.

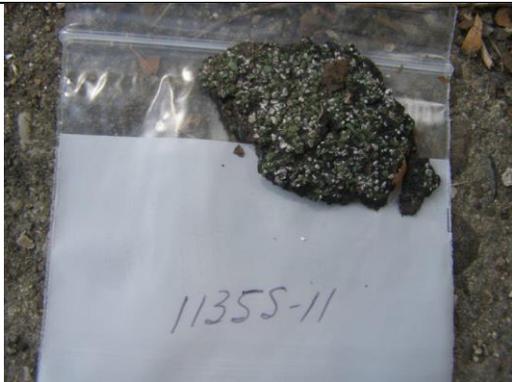
Photo 11: Roof Shingle (1135S-11) Exterior.  
No Asbestos Detected.

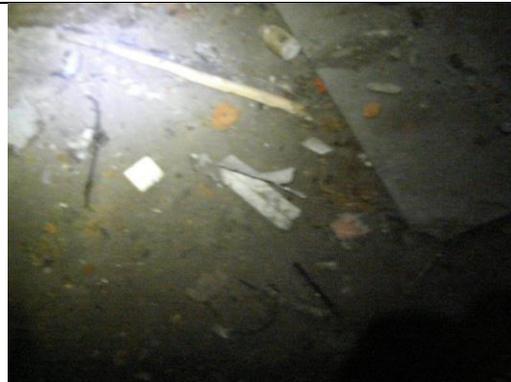
Photo 12: Ground Debris.
