ASBESTOS INSPECTION REPORT

**1327 W. Second St.
Dayton, OH 45402**

**Lynda M. Hart
Asbestos Hazards Evaluation Specialist
Ohio #ES-32558
September 17, 2015**

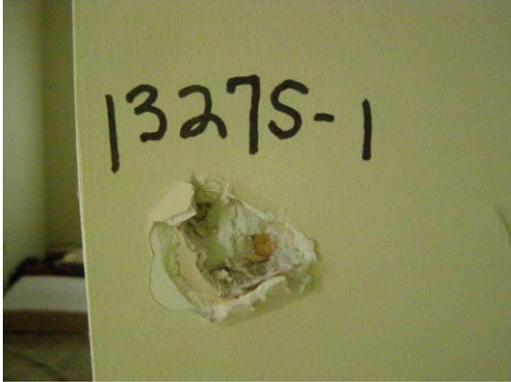
Photo 1: Drywall/J.C. (1327S-1) Family Room, Wall A.
No Asbestos Detected.

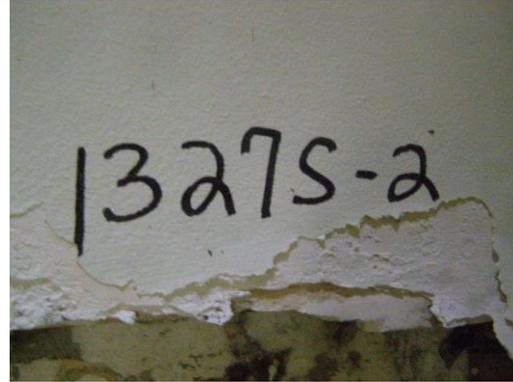
Photo 2: Drywall/J.C. (1327S-2) Dining Room, Wall B.
No Asbestos Detected.

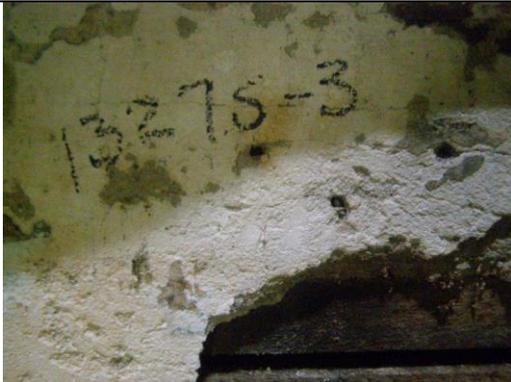
Photo 3: Plaster (1327S-3) Dining Room, Wall B.
No Asbestos Detected.

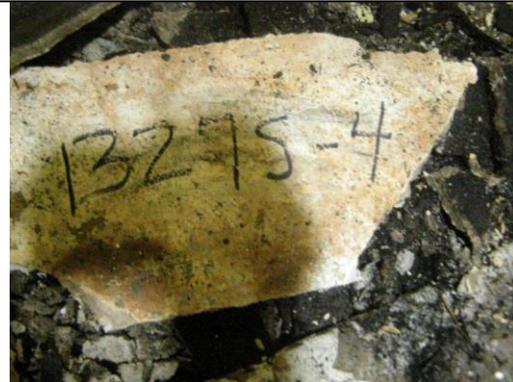
Photo 4: Plaster (1327S-4) Dining Room, Ceiling.
No Asbestos Detected.

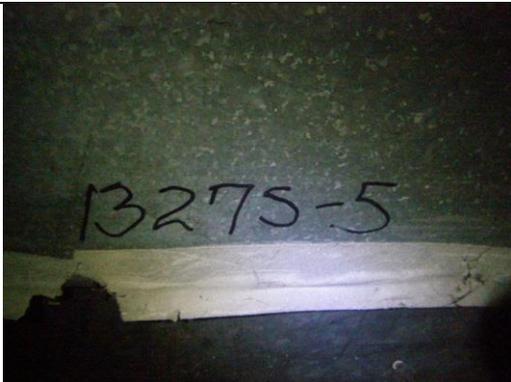
- Seam Tape, Basement

Photo 5: Seam Tape (1327S-5) Basement, Ceiling.
65% Chrysotile Asbestos Detected.

Confirmed or assumed asbestos-containing materials, which will be disturbed during demolition activities, are regulated under current Federal and State regulations. Hart Environmental Resources recommends the removal of these materials by a licensed asbestos abatement contractor. It is also strongly recommended that the specifications for the removal program be developed by a licensed Asbestos Project Designer to ensure that all regulatory requirements are satisfied. The work should be properly documented in the event of future litigation.

<u>Material</u>	<u>Est. Qty.</u>	<u>Est. Unit Cost</u>	<u>Est. Cost</u>
Seam Tape	4 sq ft	\$ 20/sq ft.	\$ 80

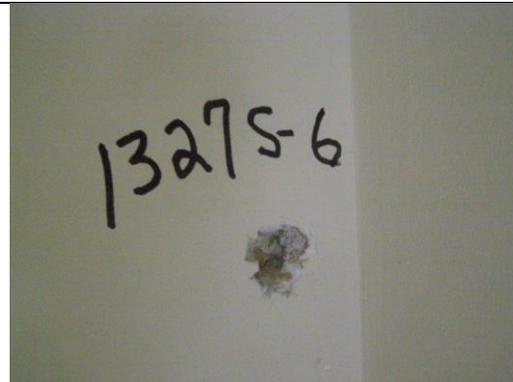
Photo 6: Drywall/J.C. (1327S-6) Bedroom 1, Wall C.
No Asbestos Detected.

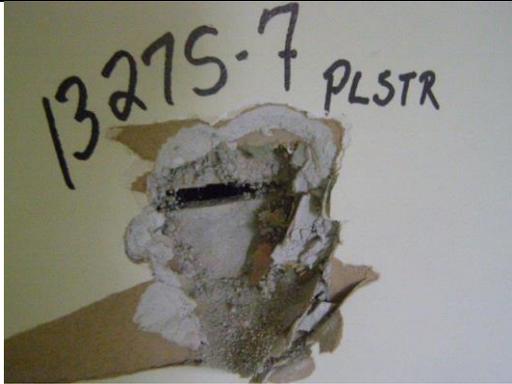
Photo 7: Plaster (1327S-7) Bedroom 1, Wall C.
No Asbestos Detected.

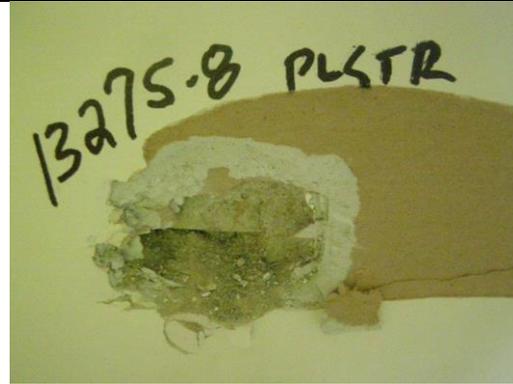
Photo 8: Plaster (1327S-8) Bedroom 2, Wall D.
No Asbestos Detected.

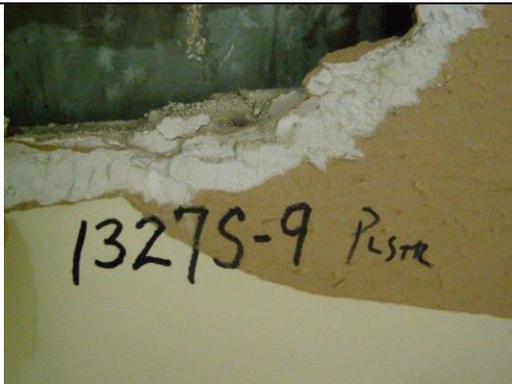
Photo 9: Plaster (1327S-9) Living Room, Wall C.
No Asbestos Detected.

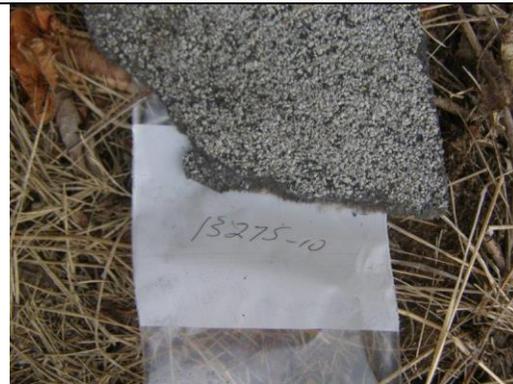
Photo 10: Roof Shingle (1327S-10) Exterior.
No Asbestos Detected.

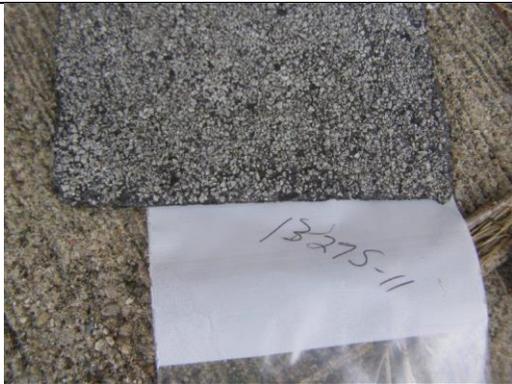
Photo 11: Roof Shingle (1327S-11) Exterior.
No Asbestos Detected.
