ASBESTOS INSPECTION REPORT

**1633 W. Second St.
Dayton, OH 45402**

Re: Asbestos Inspection
1633 W. Second St.
Dayton, OH 45402

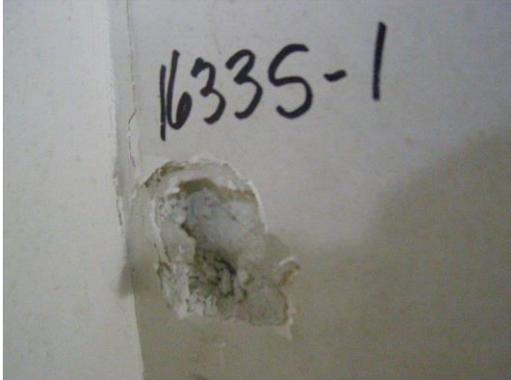
Photo 1: Drywall/J.C. (1633S-1) Family Room, Wall D.
No Asbestos Detected.

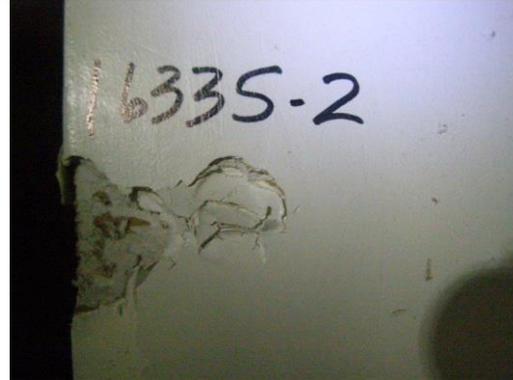
Photo 2: Drywall/J.C. (1633S-2) Dining Room, Wall C.
No Asbestos Detected.

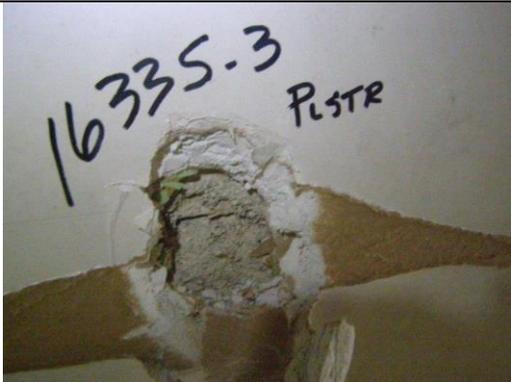
Photo 3: Plaster (1633S-3) Family Room, Wall D.
No Asbestos Detected.

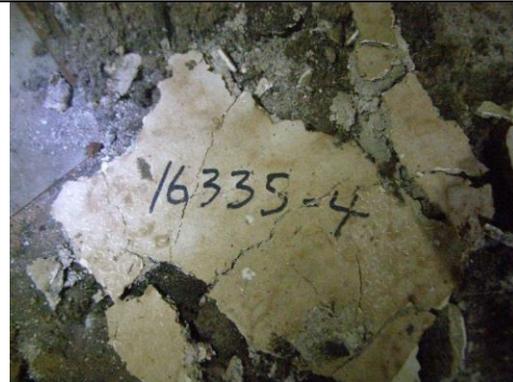
Photo 4: Plaster (1633S-4) Dining Room,
Ceiling. No Asbestos Detected.

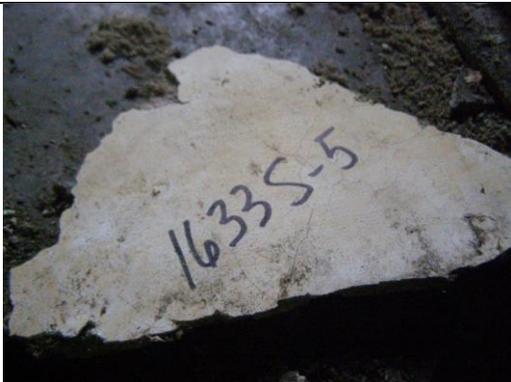
Photo 5: Plaster (1633S-5) Kitchen, Ceiling.
No Asbestos Detected.

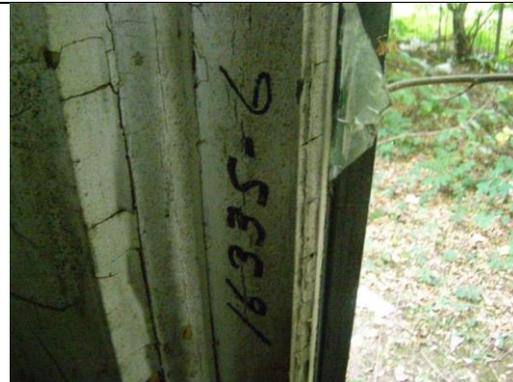
Photo 6: Window Glazing (1633S-6) Dining Room,
Wall D. No Asbestos Detected.

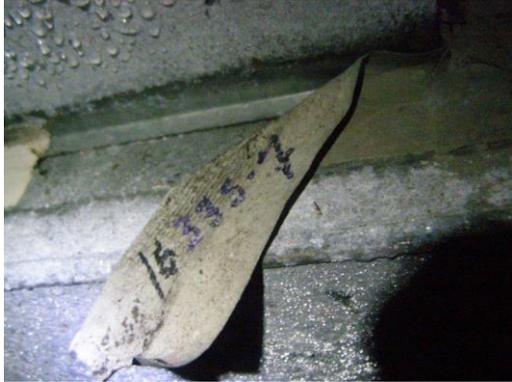
**Photo 7: Seam Tape (1633S-7) Basement.
65% Chrysotile Asbestos Detected.**

Confirmed or assumed asbestos-containing materials, which will be disturbed during demolition activities, are regulated under current Federal and State regulations. Hart Environmental Resources recommends the removal of these materials by a licensed asbestos abatement contractor. It is also strongly recommended that the specifications for the removal program be developed by a licensed Asbestos Project Designer to ensure that all regulatory requirements are satisfied. The work should be properly documented in the event of future litigation.

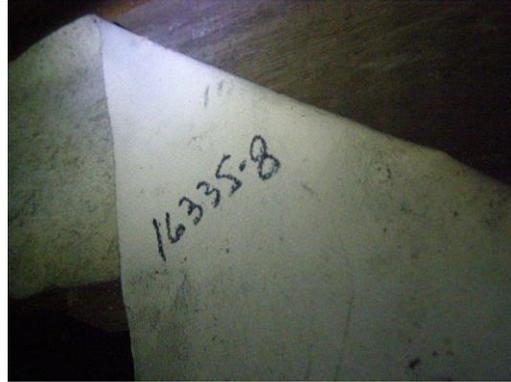
**Photo 8: Duct Wrap (1633S-8) Basement.
65% Chrysotile Asbestos Detected.**

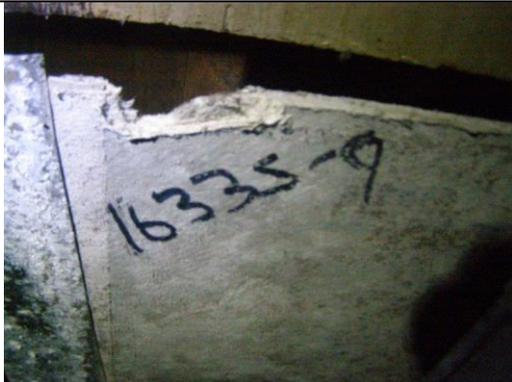
**Photo 9: Furnace Board (1633S-9) Basement.
65% Chrysotile and 3% Amosite Asbestos Detected.**

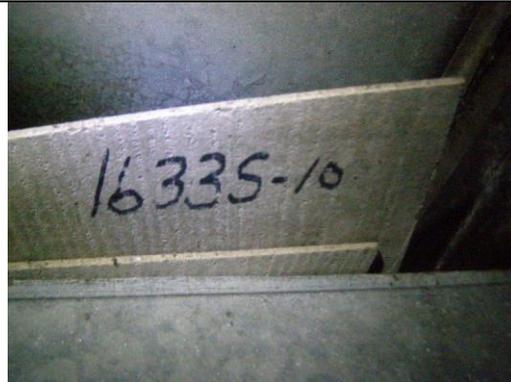
**Photo 10: Transite Shingle (1633S-10) Basement.
18% Chrysotile Asbestos Detected.**

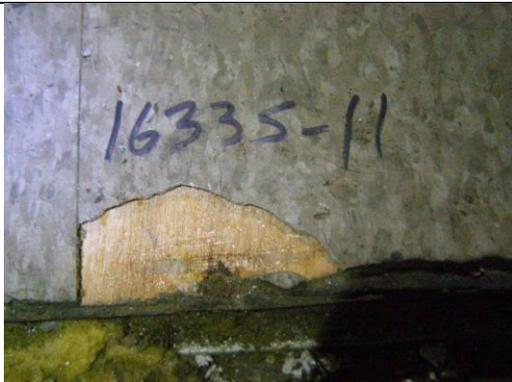
**Photo 11: Floor Tile (1633S-11) Kitchen.
No Asbestos Detected.**

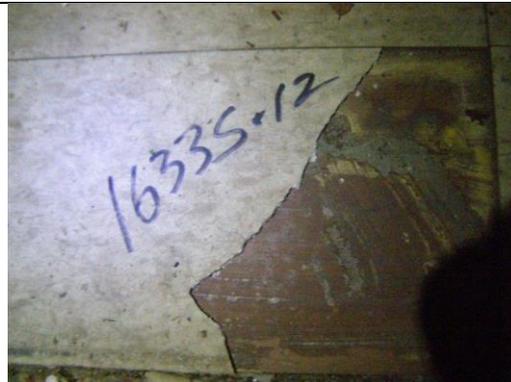
**Photo 12: Floor Tile (1633S-12) Utility Room.
No Asbestos Detected.**

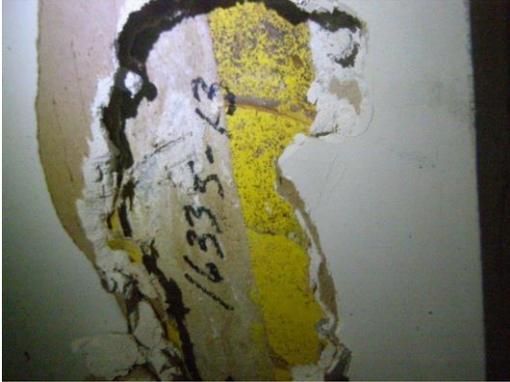
Photo 13: Duct Wrap Run (1633S-13) Kitchen, Wall C. 65% Chrysotile Asbestos Detected.

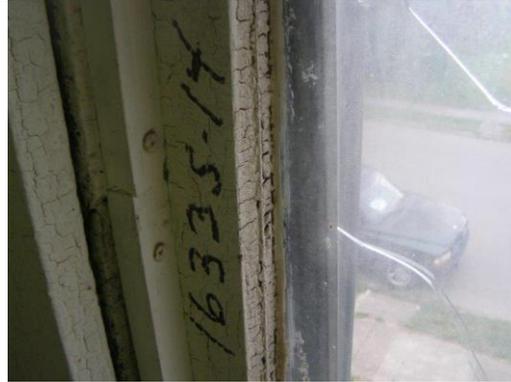
Photo 14: Window Glazing (1633S-14) Bedroom 1, Wall A. No Asbestos Detected.

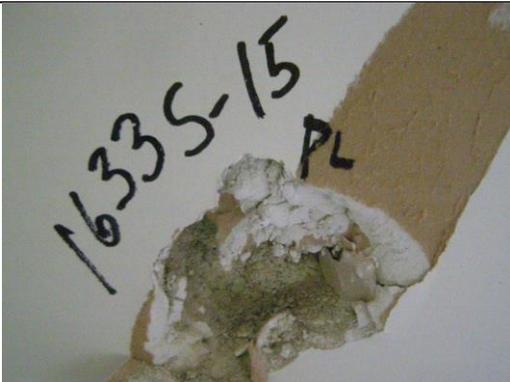
Photo 15: Plaster (1633S-15) Bedroom 1, Wall A. No Asbestos Detected.

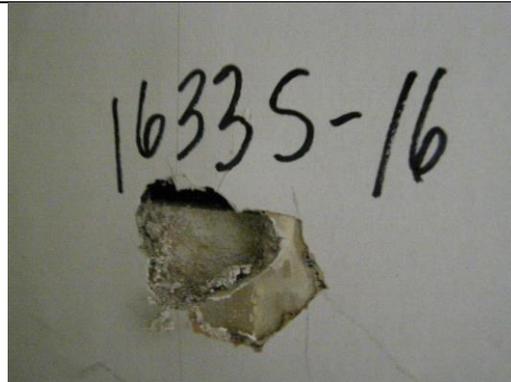
Photo 16: Plaster (1633S-16) Hall Closet, Wall C. No Asbestos Detected.

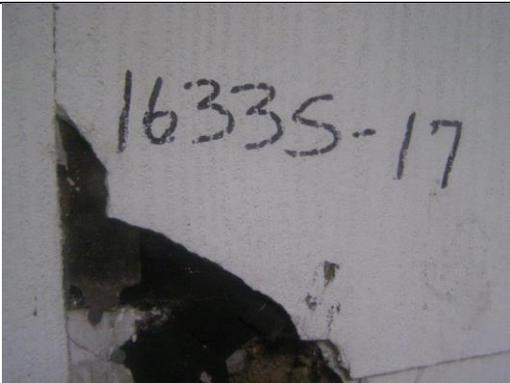
Photo 17: Transite Shingle (1633S-17) Exterior, Wall C. 15% Chrysotile Asbestos Detected.

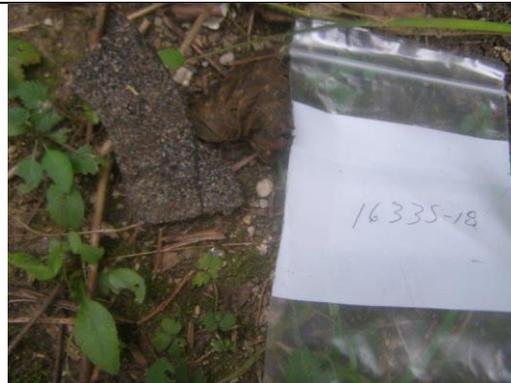
Photo 18: Roof Shingle (1633S-18) Exterior. No Asbestos Detected.

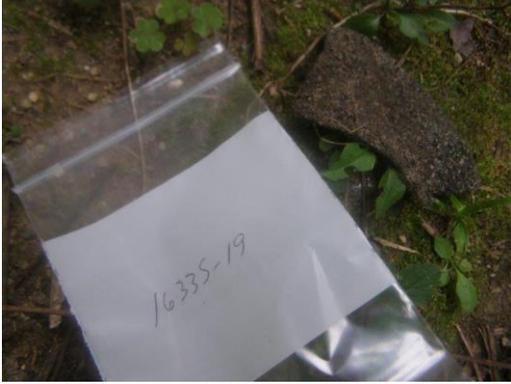
**Photo 19: Roof Shingle (1633S-19) Exterior.
No Asbestos Detected.**
