## **ASBESTOS INSPECTION REPORT**

**2417 W. Second St.  
Dayton, OH 45417**

**Lynda M. Hart  
Asbestos Hazards Evaluation Specialist  
Ohio #ES-32558  
September 17, 2015**

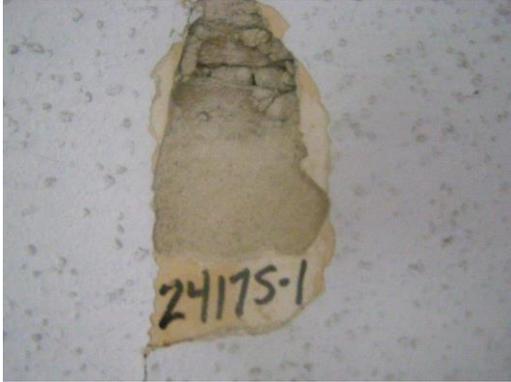
**Photo 1: Plaster (2417S-1) Living Room, Wall B.  
No Asbestos Detected.**

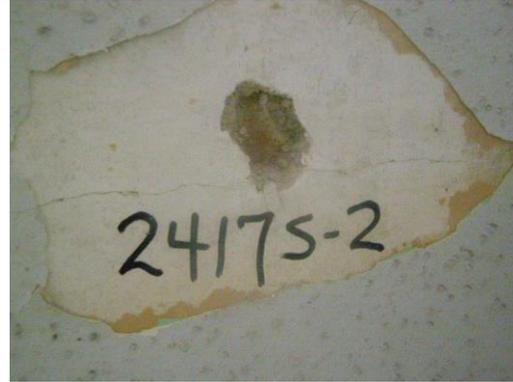
**Photo 2: Plaster (2417S-2) Bedroom 1, Wall D.  
No Asbestos Detected.**

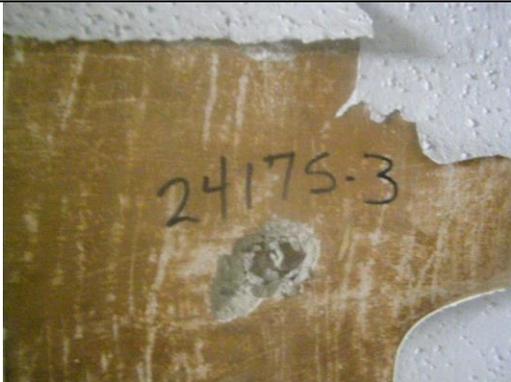
**Photo 3: Plaster (2417S-3) Hall, Wall A.  
No Asbestos Detected.**

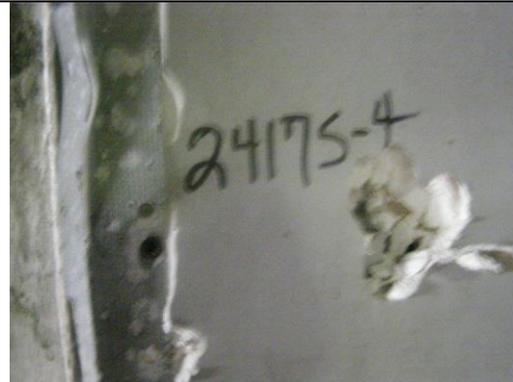
**Photo 4: Drywall/J.C. (2417S-4) Bath 1, Wall A.  
No Asbestos Detected.**

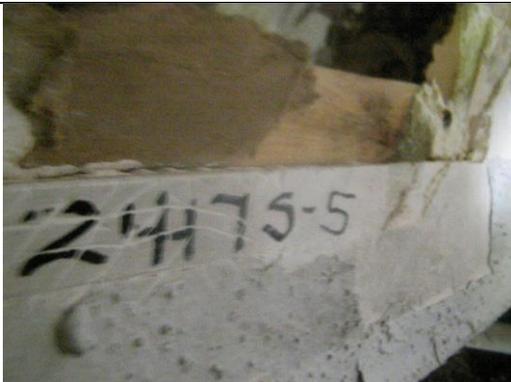
**Photo 5: Drywall/J.C. (2417S-5) Kitchen, Wall A.  
No Asbestos Detected.**

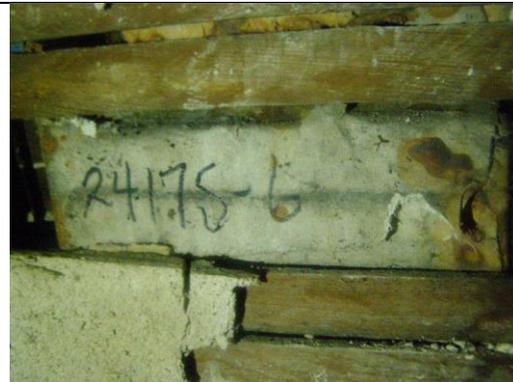
- Duct Work Wrap, Boots in Basement

**Photo 6: Duct Work Wrap (2417S-6) Basement  
Landing, Wall D. 65% Chrysotile Asbestos Detected.**

Confirmed or assumed asbestos-containing materials, which will be disturbed during demolition activities, are regulated under current Federal and State regulations. Hart Environmental Resources recommends the removal of these materials by a licensed asbestos abatement contractor. It is also strongly recommended that the specifications for the removal program be developed by a licensed Asbestos Project Designer to ensure that all regulatory requirements are satisfied. The work should be properly documented in the event of future litigation.

<u>Material</u>	<u>Est. Qty.</u>	<u>Est. Unit Cost</u>	<u>Est. Cost</u>
Duct Wrap Boots	3 ea	\$ 25/ea	\$ 75
Duct Wrap	60 sq. ft.	\$ 20/ea	<u>\$ 1,200</u>
		<b>Total</b>	<b>\$ 1,275</b>

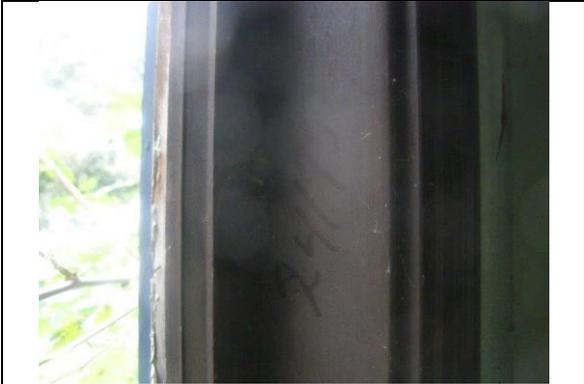
Photo 7: Window Glazing (2417S-7) Living Room, Wall D. No Asbestos Detected.

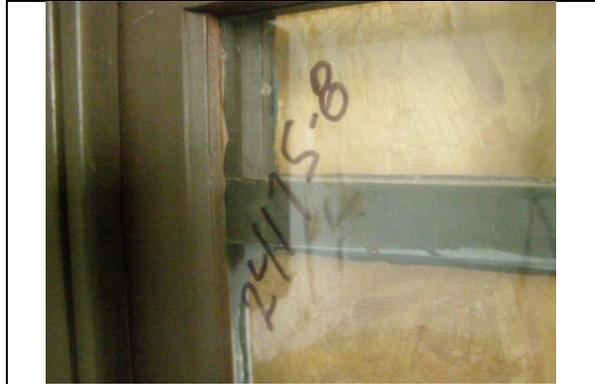
Photo 8: Window Glazing (2417S-8) Bedroom 1, Wall A. No Asbestos Detected.

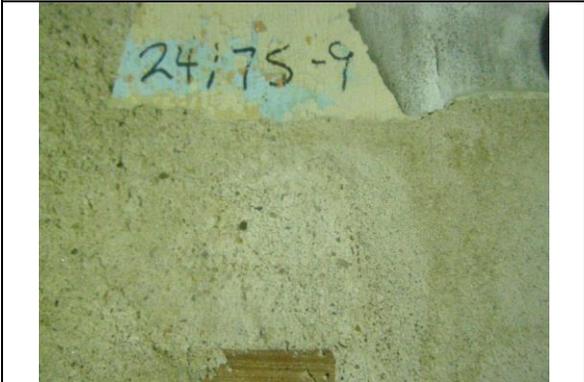
Photo 9: Plaster (2417S-9) Basement Landing, Wall D. No Asbestos Detected.

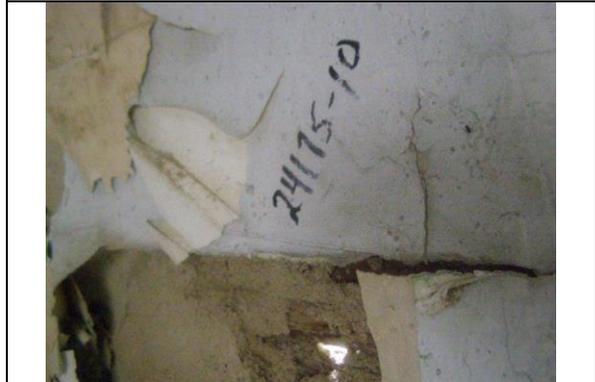
Photo 10: Plaster (2417S-10) Living Room, Wall C. No Asbestos Detected.

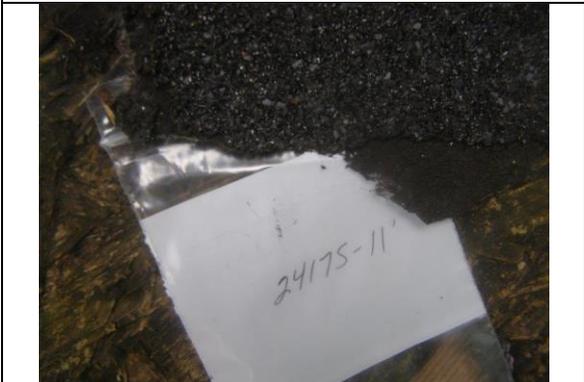
Photo 11: Roof Shingle (2417S-11) Exterior. No Asbestos Detected.

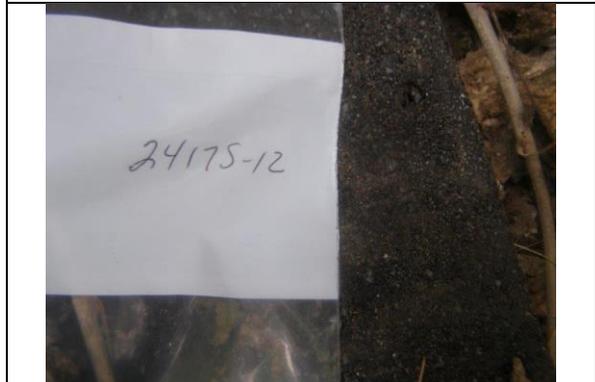
Photo 12: Roof Shingle (2417S-12) Exterior. No Asbestos Detected.
