ASBESTOS INSPECTION REPORT

**441 N. Woodward Ave.
Dayton, OH 45417**

Re: Asbestos Inspection
441 N. Woodward Ave.
Dayton, OH 45417

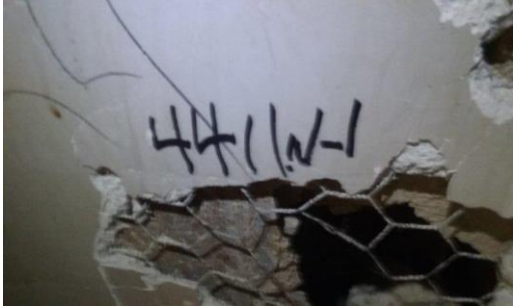
| HER Sample # Lab Sample # | Amount | Layers | Description/Sample Location | Condition | PLM Result (% Asbestos) |
|---|---|---|---|---|--|
| 441W-1 15-09-02029-001 15-09-02300-001 | - | 1 | Plaster, Kitchen, Wall C, Inhomogeneous | Non-friable | Trace <1% Chrysotile Asbestos Detected (PC=0.50%) |

Photo 1: Plaster (441W-1) Kitchen, Wall C.
Trace <1% Chrysotile Asbestos Detected (PC=0.50%).

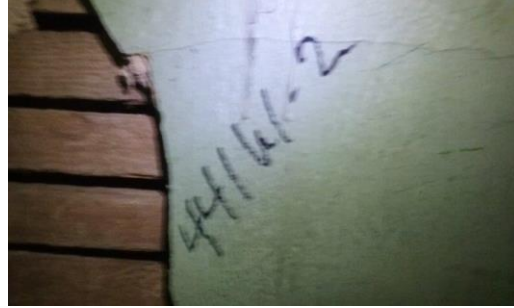
| HER Sample # Lab Sample # | Amount | Layers | Description/Sample Location | Condition | PLM Result (% Asbestos) |
|---|---|---|---|---|--|
| 441W-2 15-09-02029-002 15-09-02300-002 | - | 2 | Plaster, Basement Steps, Wall C, Inhomogeneous | Non-friable | Trace <1% Chrysotile Asbestos Detected (PC=0.25%) |

Photo 2: Plaster (441W-2) Basement Steps, Wall C.
Trace <1% Chrysotile Asbestos Detected (PC=0.25%).

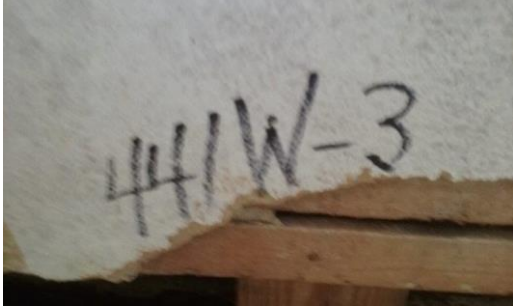
| HER Sample # Lab Sample # | Amount | Layers | Description/Sample Location | Condition | PLM Result (% Asbestos) |
|---|---|---|---|---|--|
| 441W-3 15-09-02029-003 15-09-02300-003 | - | 3 | Plaster, Living Room Closet, Wall C, Inhomogeneous | Non-friable | Trace <1% Chrysotile Asbestos Detected (PC=0.25%) |

Photo 3: Plaster (441W-3) Living Room Closet, Wall C.
Trace <1% Chrysotile Asbestos Detected (PC=0.25%).

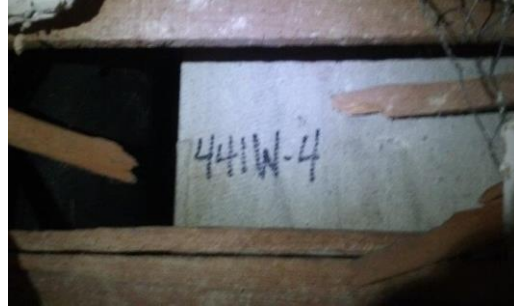
| HER Sample # Lab Sample # | Amount | Layers | Description/Sample Location | Condition | PLM Result (% Asbestos) |
|---|---|---|---|---|--|
| 441W-4 15-09-02029-004 | 50 sq ft 2 boots | 1 | Duct Work with Wrap, Kitchen, Wall A, Homogeneous | Non-friable | 65% Chrysotile Asbestos Detected |

- Duct Work with Wrap, Kitchen & Living Room

Photo 4: Duct Work with Wrap (441W-4) Kitchen,
Wall A. 65% Chrysotile Asbestos Detected.

Confirmed or assumed asbestos-containing materials, which will be disturbed during demolition activities, are regulated under current Federal and State regulations. Hart Environmental Resources recommends the removal of these materials by a licensed asbestos abatement contractor. It is also strongly recommended that the specifications for the removal program be

| <u>Material</u> | <u>Est. Qty.</u> | <u>Est. Unit Cost</u> | <u>Est. Cost</u> |
|---|---|---|---|
| Duct Work Wrap | 50 sq ft. | \$20/sq ft. | \$ 1000 |
| Duct Work Boots | 2 ea | \$ 25/ea | \$ 50 |

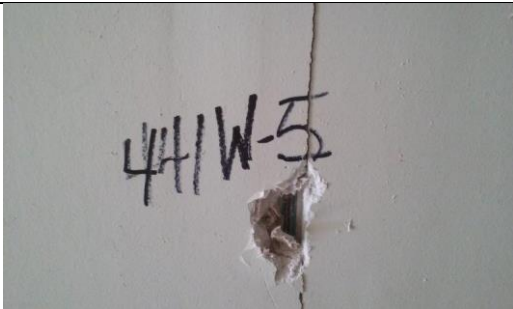
| HER Sample # Lab Sample # | Amount | Layers | Description/Sample Location | Condition | PLM Result (% Asbestos) |
|---|---|---|---|---|--|
| 441W-5 15-09-02029-005 | - | 2 | Drywall/J.C., Living Room, Wall B, Inhomogeneous | Non-friable | None Detected |

Photo 5: Drywall/J.C. (441W-5) Living Room, Wall B.
No Asbestos Detected.

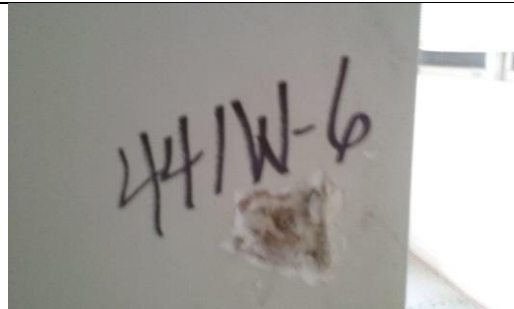
| HER Sample # Lab Sample # | Amount | Layers | Description/Sample Location | Condition | PLM Result (% Asbestos) |
|---|---|---|---|---|--|
| 441W-6 15-09-02029-006 | - | 2 | Drywall/J.C., Dining Room, Wall A, Inhomogeneous | Non-friable | None Detected |

Photo 6: Drywall/J.C. (441W-6) Dining Room, Wall A.
No Asbestos Detected.

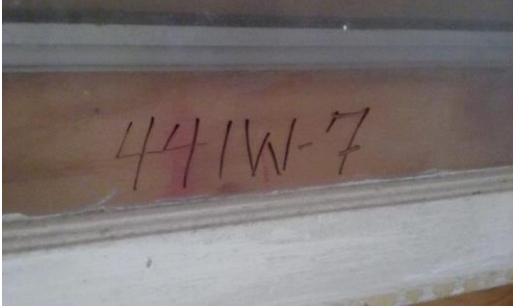
| HER Sample # Lab Sample # | Amount | Layers | Description/Sample Location | Condition | PLM Result (% Asbestos) |
|---|---|---|---|---|--|
| 441W-7 15-09-02029-007 15-09-02300-004 | - | 2 | Window Glazing, Dining Room, Wall B, Inhomogeneous | Friable | 2% Chrysotile Asbestos Detected (PC=1.0%) |

Photo 7: Window Glazing (441W-7) Dining Room, Wall B. 2% Chrysotile Asbestos Detected (PC=1.0%).

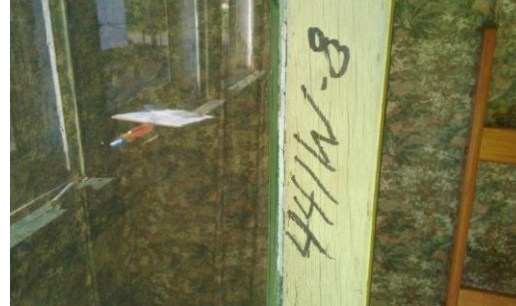
| HER Sample # Lab Sample # | Amount | Layers | Description/Sample Location | Condition | PLM Result (% Asbestos) |
|---|---|---|---|---|--|
| 441W-8 15-09-02029-008 15-09-02300-005 | - | 1 | Window Glazing, Bedroom 1, Wall A, Homogeneous | Friable | Trace <1% Chrysotile Asbestos Detected (PC=<0.25%) |

Photo 8: Window Glazing (441W-8) Bedroom 1, Wall C. Trace <1% Chrysotile Asbestos Detected (PC=0.25%).

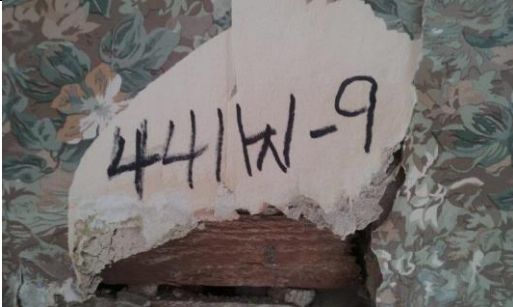
| HER Sample # Lab Sample # | Amount | Layers | Description/Sample Location | Condition | PLM Result (% Asbestos) |
|---|---|---|---|---|--|
| 441W-9 15-09-02029-009 15-09-02300-006 | - | 2 | Plaster, Bedroom 1, Wall C, Inhomogeneous | Non-friable | Trace <1% Chrysotile Asbestos Detected (PC=0.25%) |

Photo 9: Plaster (441W-9) Bedroom 1, Wall C. Trace <1% Chrysotile Asbestos Detected (PC=0.25%).

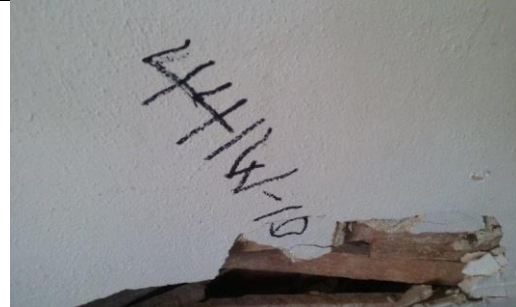
| HER Sample # Lab Sample # | Amount | Layers | Description/Sample Location | Condition | PLM Result (% Asbestos) |
|---|---|---|---|---|--|
| 441W-10 15-09-02029-010 15-09-02300-007 | - | 1 | Plaster, Bedroom 2, Wall D, Inhomogeneous | Non-friable | Trace <1% Chrysotile Asbestos Detected (PC=0.50%) |

Photo 10: Plaster (441W-10) Bedroom 2, Wall D. Trace <1% Chrysotile Asbestos Detected (PC=0.50%).

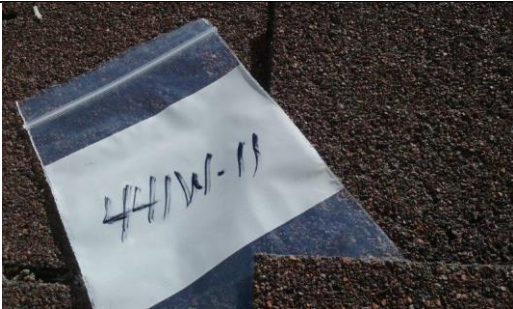
| HER Sample # Lab Sample # | Amount | Layers | Description/Sample Location | Condition | PLM Result (% Asbestos) |
|---|---|---|---|---|--|
| 441W-11 15-09-02029-011 | - | 2 | Roof Shingle, Exterior, Inhomogeneous | Non-friable | None Detected |

Photo 11: Roof Shingle (441W-11) Exterior. No Asbestos Detected.

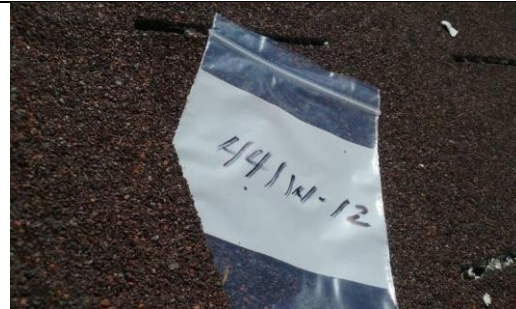
| HER Sample # Lab Sample # | Amount | Layers | Description/Sample Location | Condition | PLM Result (% Asbestos) |
|---|---|---|---|---|--|
| 441W-12 15-09-02029-012 | - | 2 | Roof Shingle, Exterior, Inhomogeneous | Non-friable | None Detected |

Photo 12: Roof Shingle (441W-12) Exterior. No Asbestos Detected.
