ASBESTOS INSPECTION REPORT

**143 N. Marion St.
Dayton, OH 45417**

**Lynda M. Hart
Asbestos Hazards Evaluation Specialist
Ohio #ES-32558
September 17, 2015**

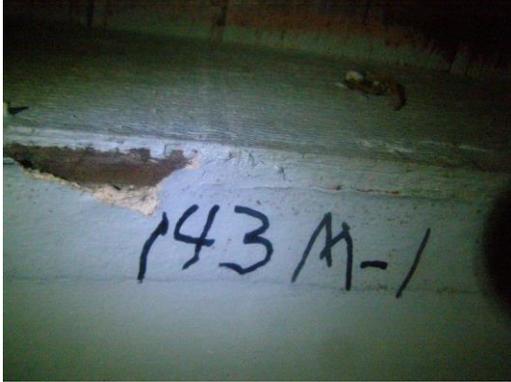
Photo 1: Seam Tape (143M-1) Basement, Ceiling.
65% Chrysotile Asbestos Detected.

Confirmed or assumed asbestos-containing materials, which will be disturbed during demolition activities, are regulated under current Federal and State regulations. Hart Environmental Resources recommends the removal of these materials by a licensed asbestos abatement

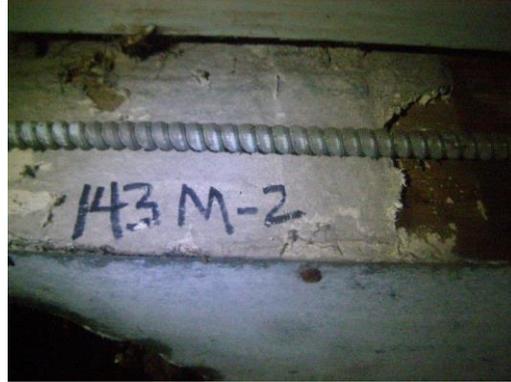
Photo 2: Duct Work Wrap (143M-2) Basement, Ceiling.
65% Chrysotile Asbestos Detected.

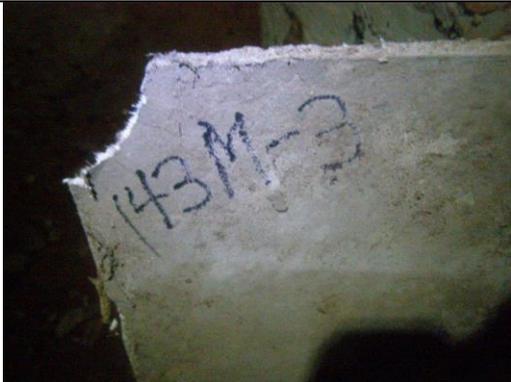
Photo 3: Furnace Board (143M-3) Basement, Floor.
65% Chrysotile Asbestos Detected.

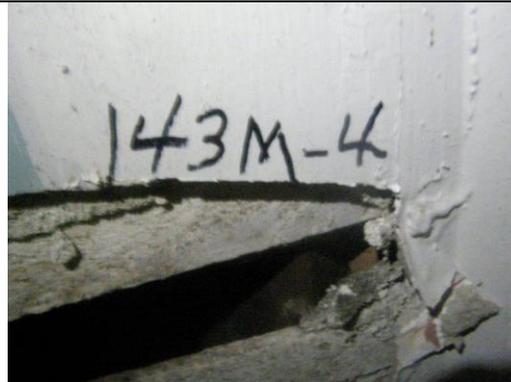
Photo 4: Plaster (143M-4) Living Room, Wall C.
No Asbestos Detected.

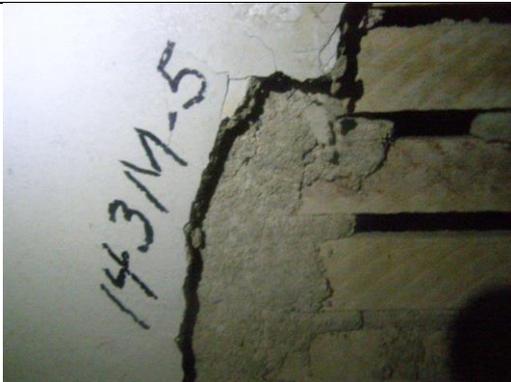
Photo 5: Plaster (143M-5) Dining Room, Wall A.
No Asbestos Detected.

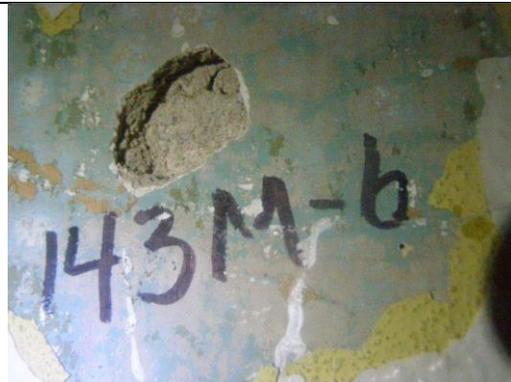
Photo 6: Plaster/Txt Pt. (143M-6) Kitchen, Wall B.
No Asbestos Detected.

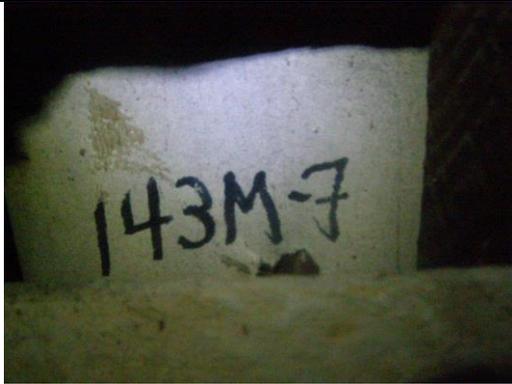
Photo 7: Duct Wrap (143M-7) Entry, Wall D.
75% Chrysotile Asbestos Detected.

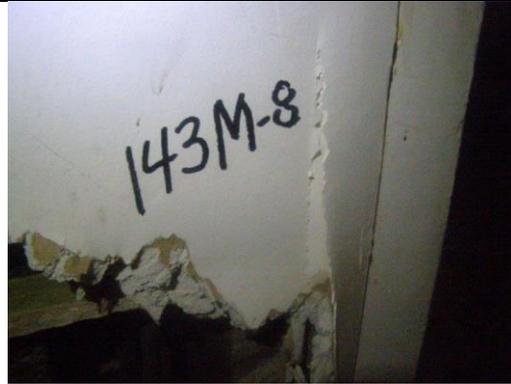
Photo 8: Drywall (143M-8) Entry, Wall D.
No Asbestos Detected.

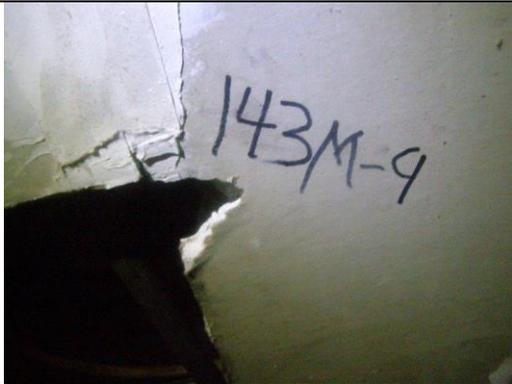
Photo 9: Drywall (143M-9) Kitchen, Wall D.
No Asbestos Detected.

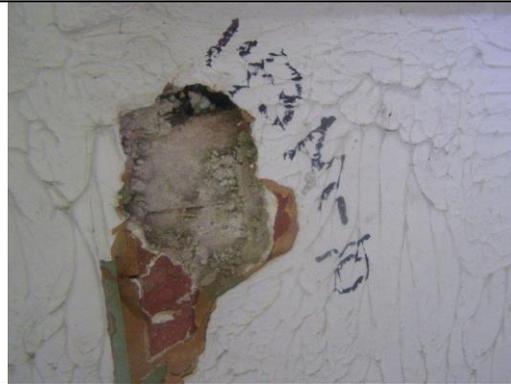
Photo 10: Plaster/Txt Pt. (143M-10) 2nd Floor Landing,
Wall B. No Asbestos Detected.

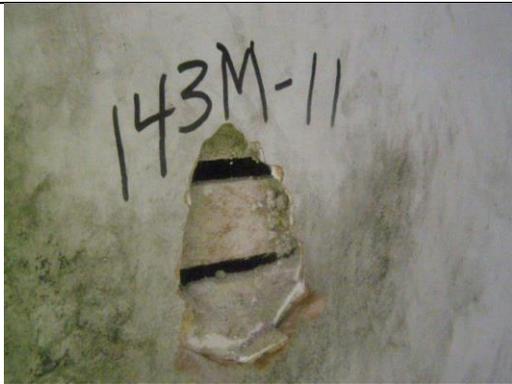
Photo 11: Plaster (143M-11) Bedroom 3 Closet, Wall D.
No Asbestos Detected.

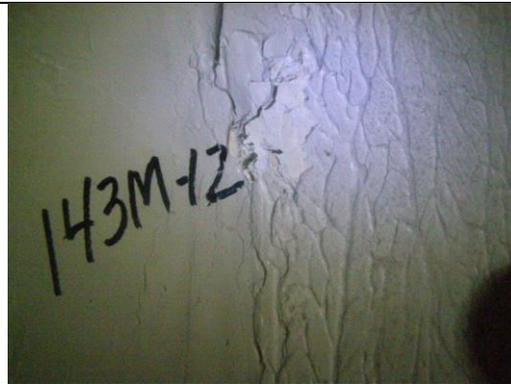
Photo 12: Txt Pt. (143M-12) Entry, Ceiling.
No Asbestos Detected.

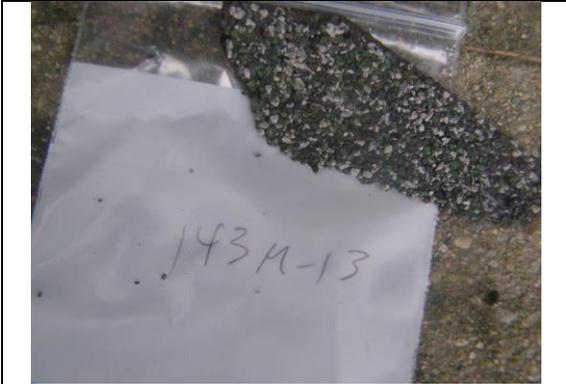
**Photo 13: Roof Shingle (143M-13) Exterior.
No Asbestos Detected.**

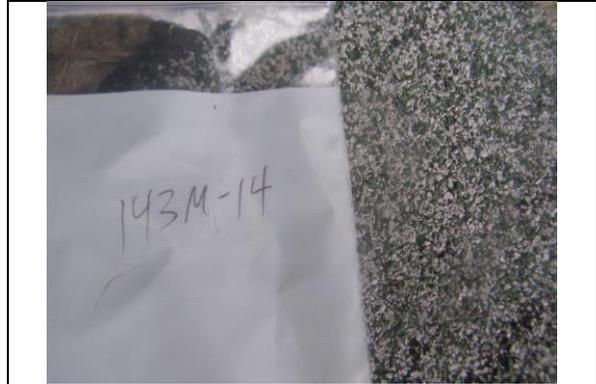
**Photo 14: Roof Shingle (143M-14) Exterior.
No Asbestos Detected.**
