ASBESTOS INSPECTION REPORT

**1629 Oakridge Dr.
Dayton, OH 45417**

Re: Asbestos Inspection
1629 Oakridge Dr.
Dayton, OH 45417

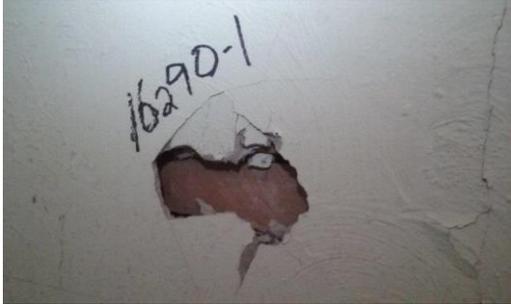
Photo 1: Plaster (16290-1) Living Room, Wall C.
Trace <1% Chrysotile Asbestos Detected (PC=0.25%).

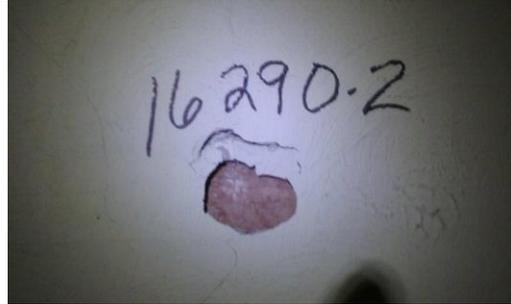
Photo 2: Plaster (16290-2) Dining Room, Wall D.
Trace <1% Chrysotile Asbestos Detected (PC=<0.25%).

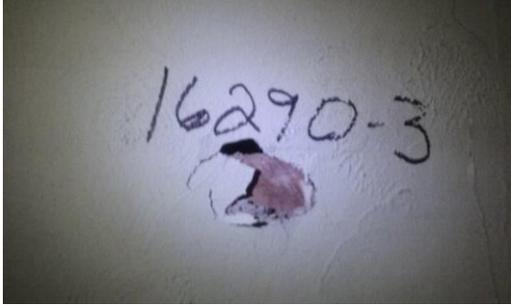
Photo 3: Plaster (16290-3) Second Floor Stairs, Wall B.
Trace <1% Chrysotile Asbestos Detected (PC=0.25%).

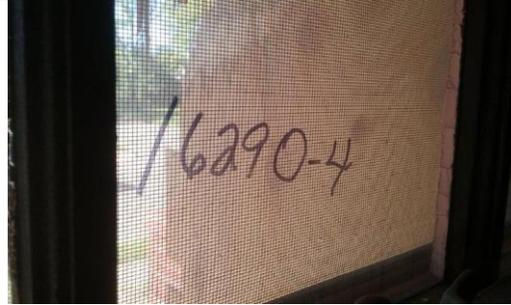
**Photo 4: Window Glazing (16290-4) Living Room,
Wall A. No Asbestos Detected.**

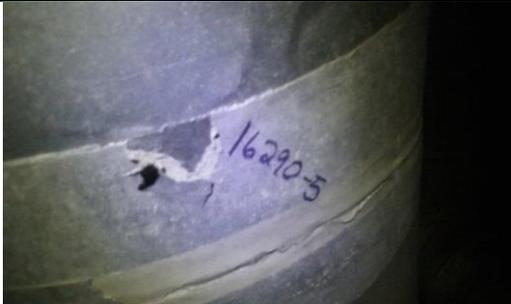
- Duct Work Wrap, Basement & Walls
- Ductwork Boots, Basement
- Seam Tape, Basement
- Floor Tile, Basement

Photo 5: Duct Work Wrap (16290-5) Basement, Ceiling.
65% Chrysotile Asbestos Detected.

Confirmed or assumed asbestos-containing materials, which will be disturbed during demolition activities, are regulated under current Federal and State regulations. Hart Environmental Resources recommends the removal of these materials by a licensed asbestos abatement contractor. It is also strongly recommended that the specifications for the removal program be developed by a licensed Asbestos Project Designer to ensure that all regulatory requirements are satisfied. The work should be properly documented in the event of future litigation.

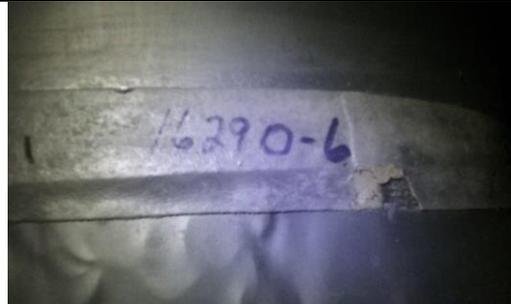
Photo 6: Seam Tape (16290-6) Basement, Ceiling.
65% Chrysotile Asbestos Detected.

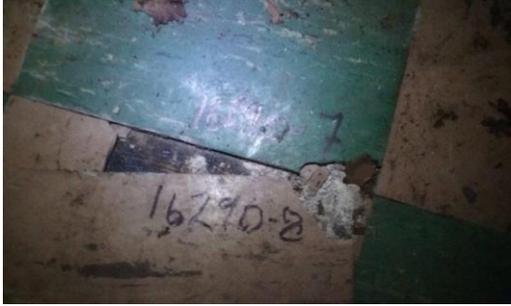
Photo 7: Floor Tile (16290-7 & 16290-8) Basement, Floor. 16290-7: 3% Chrysotile Asbestos Detected (PC=1.25%). 16290-8: 3% Chrysotile Asbestos Detected (PC=1.50%)

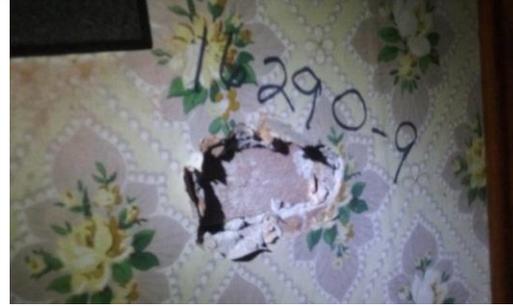
Photo 8: Plaster (16290-9) Bedroom 2, Wall B. No Asbestos Detected.

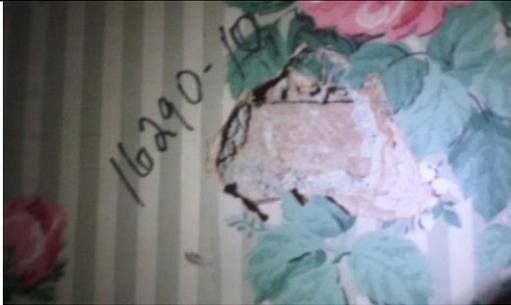
Photo 9: Plaster (16290-10) Bedroom 1, Wall B. No Asbestos Detected.

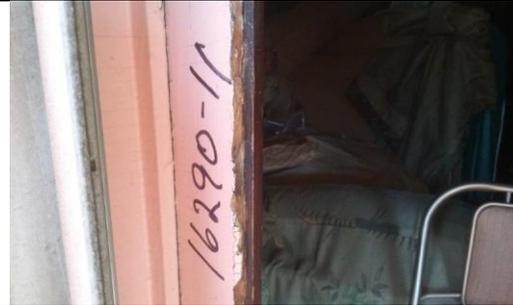
Photo 10: Window Glazing (16290-11) Living Room, Wall A. No Asbestos Detected.

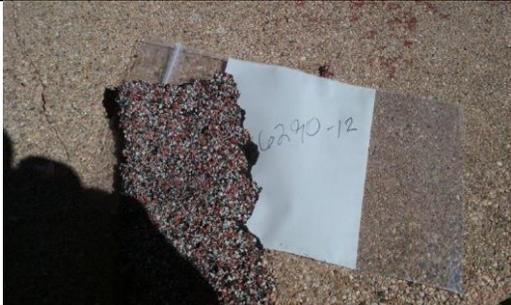
Photo 11: Roof Shingle (16290-12) Exterior. No Asbestos Detected.

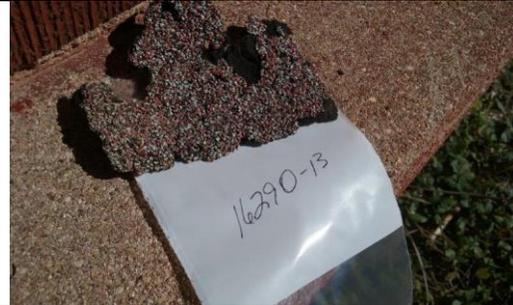
Photo 12: Roof Shingle (16290-13) Exterior. No Asbestos Detected.
