SIERRA ENVIRONMENTAL GROUP, INC.

September 24, 2015

Re: Comprehensive Pre-Demolition Asbestos Inspection
Vacant Residence
24 North Kilmer Street
Dayton, Ohio 45417
Sierra Project Number: MCLB.001

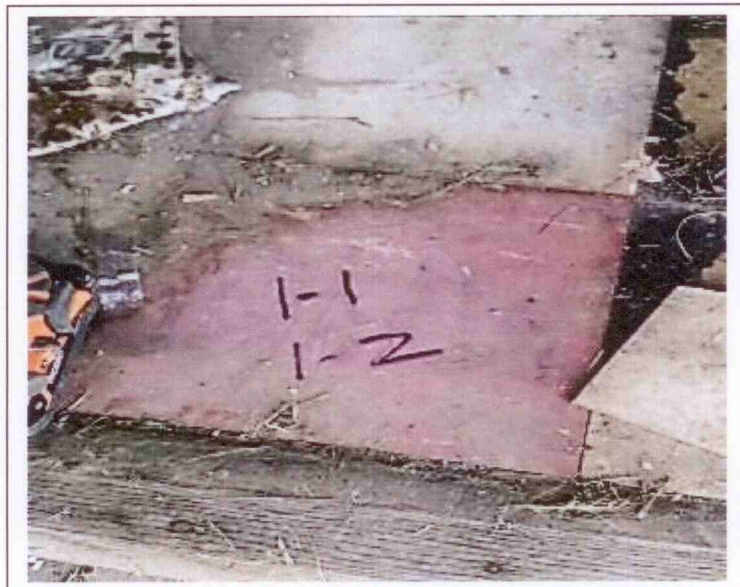
HA #1 - 9"x9" Red floor tile

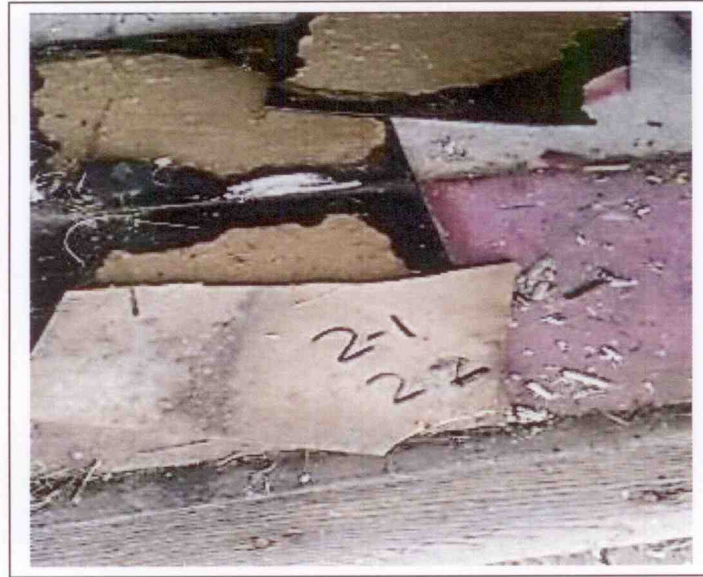
HA #2, #3 – 9”x9” Tan floor tile with black mastic

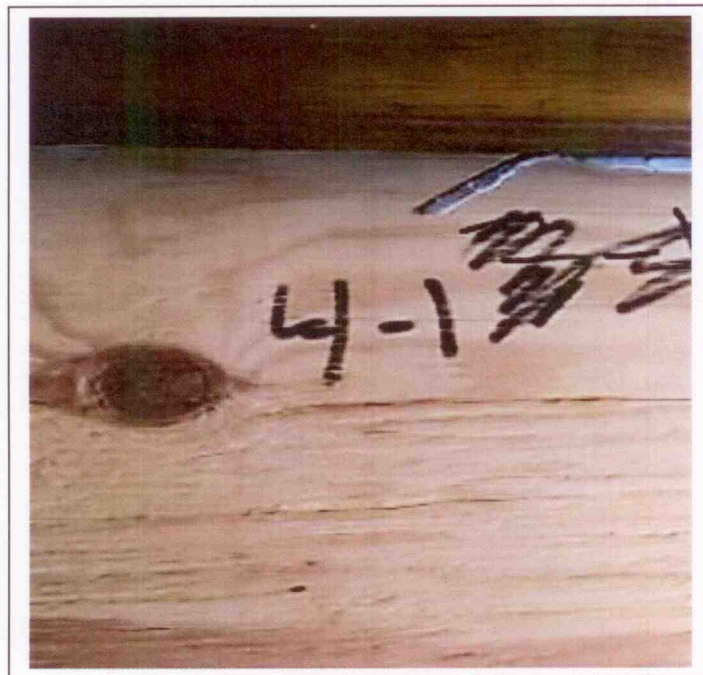
HA #4 – Window glaze

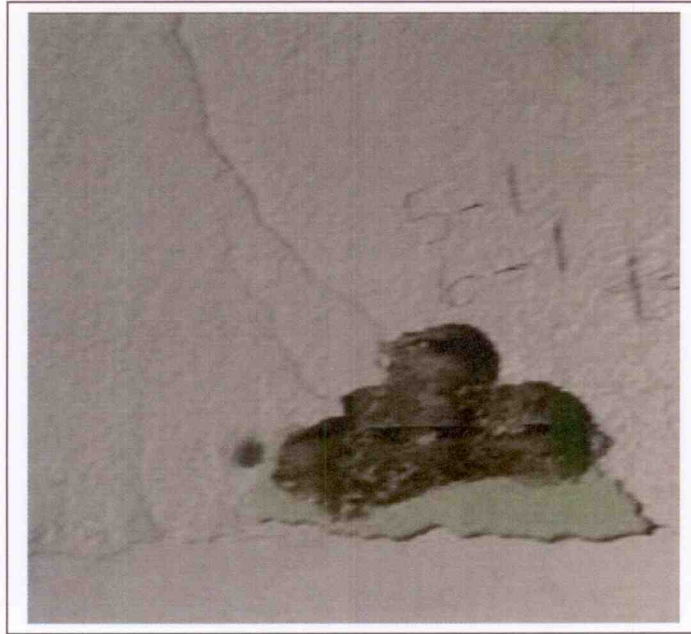
HA #5 & #6 – Hard wall and ceiling plaster

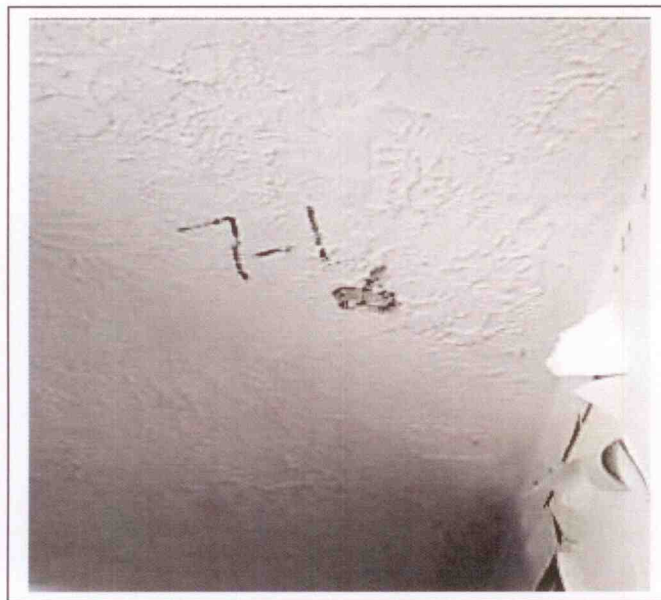
HA #7 – Textured ceiling

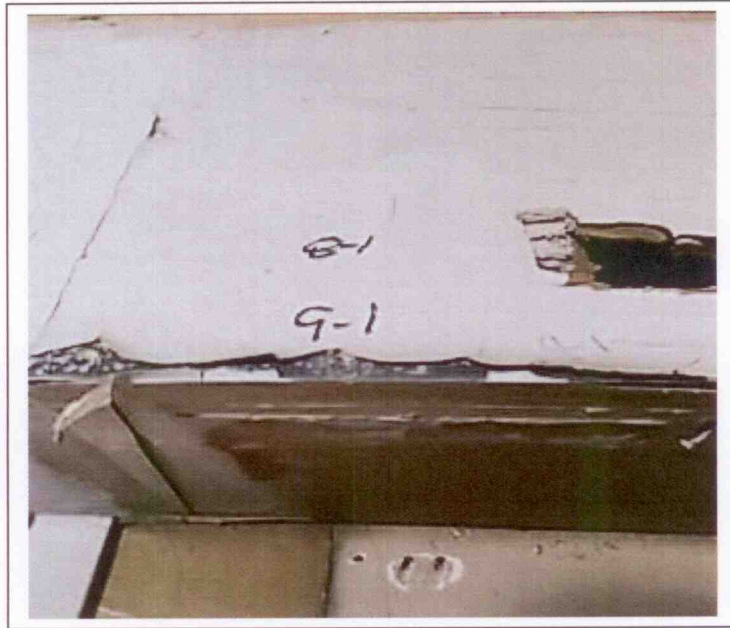
HA #8 & #9 – Drywall and associated joint compound

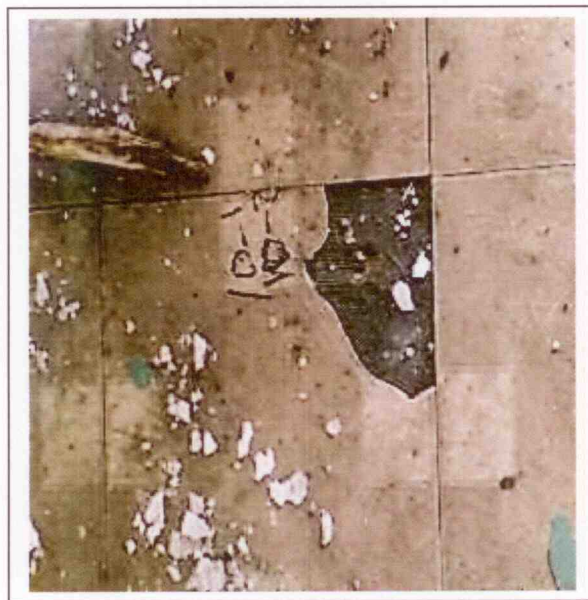
HA #10 – 12"x12" Tan sticky back floor tile

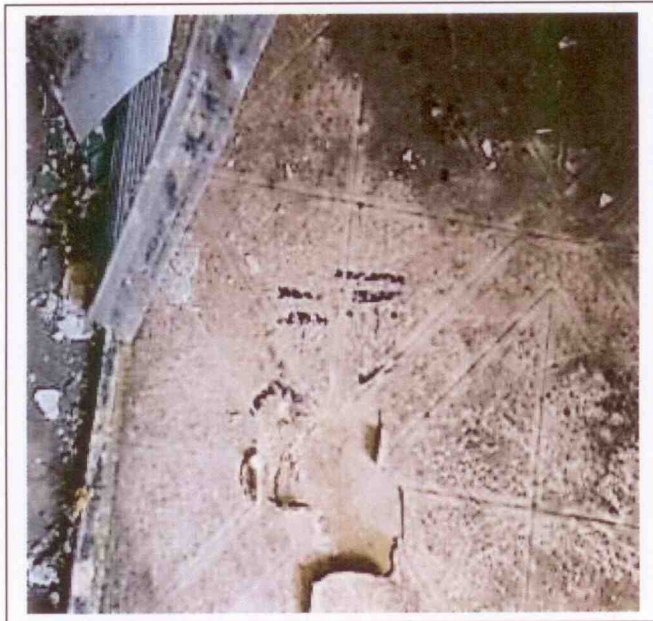
HA #11 – Cream linoleum

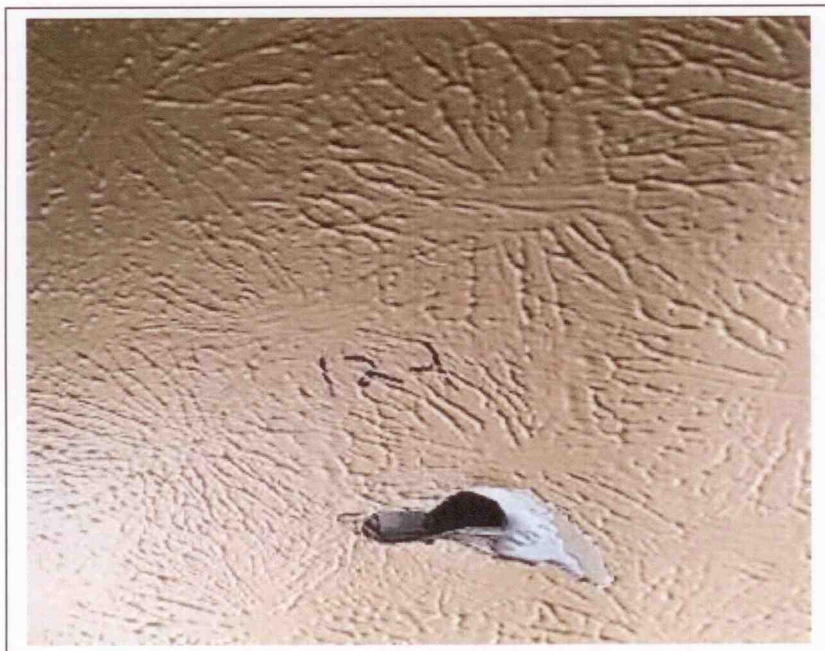
HA #12 – Textured ceiling

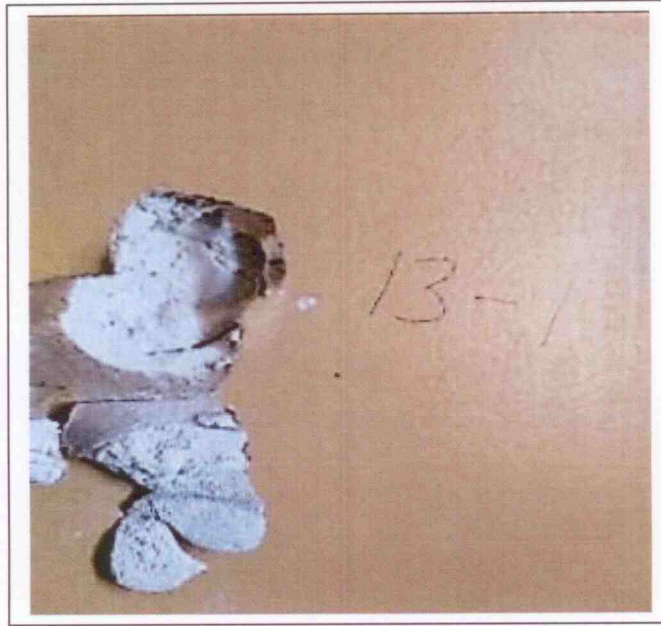
HA #13 – Drywall, new

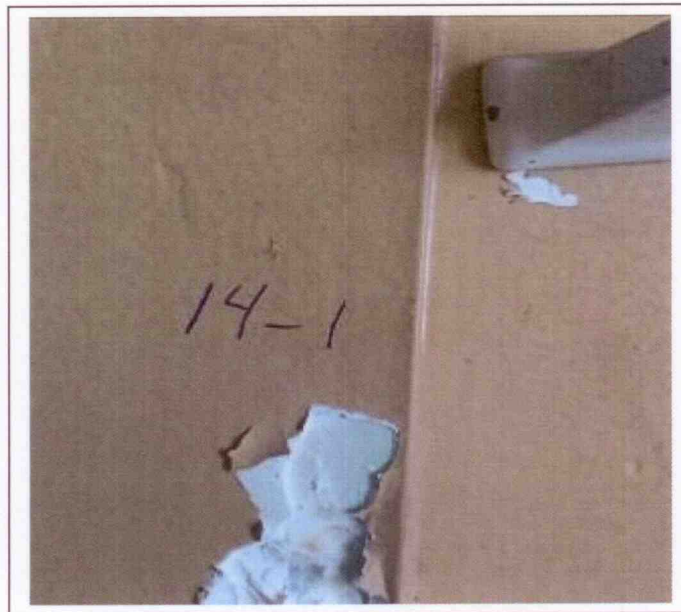
HA #14 – Joint compound

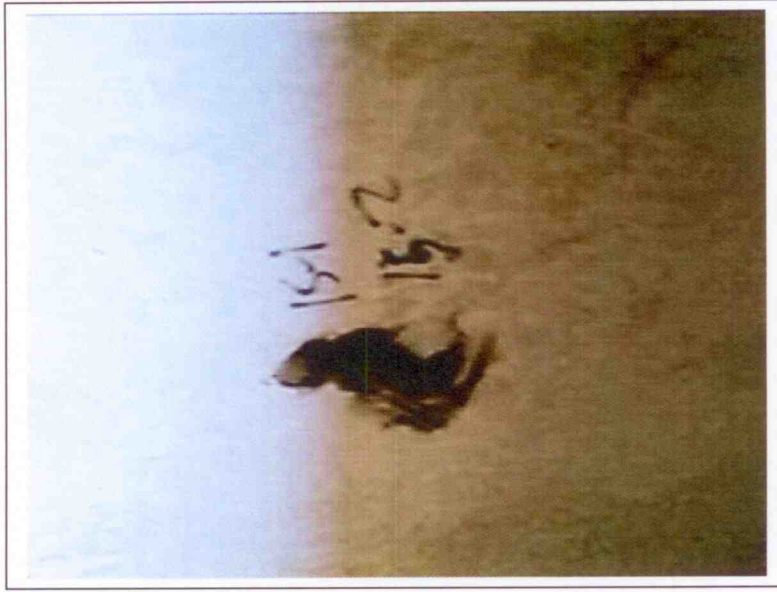
HA #15 – Blown-in insulation

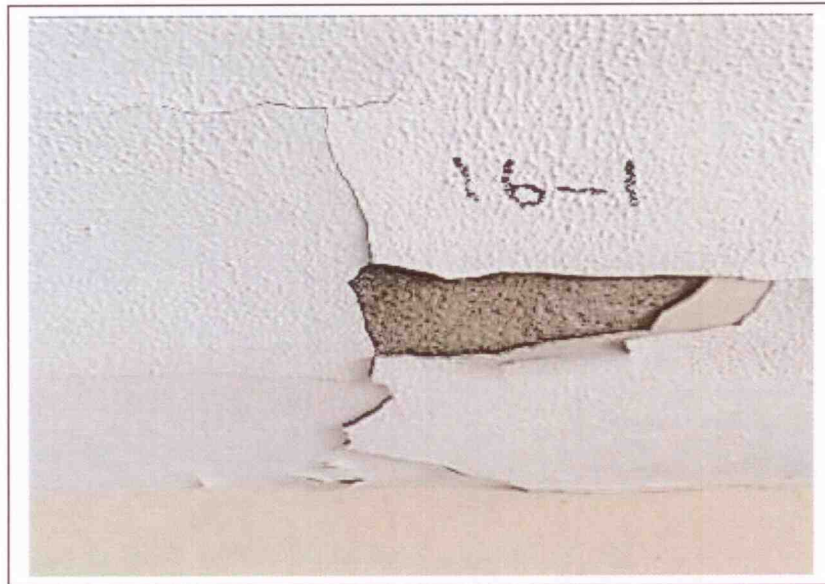
HA #16 – Textured ceiling

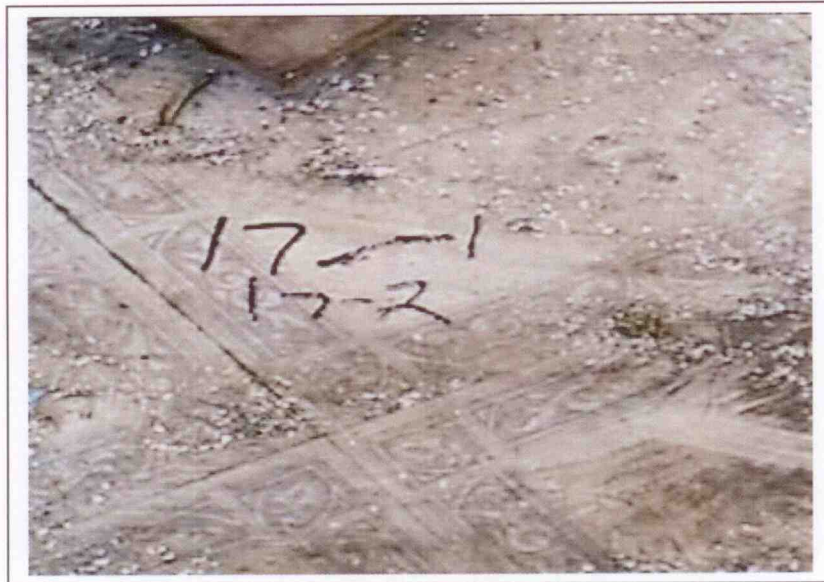
HA #17 – 12"x12" White sticky back floor tile

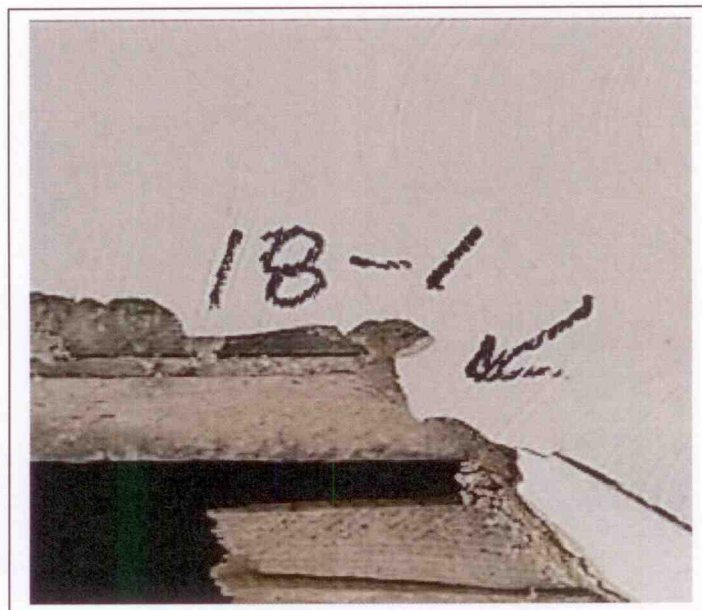
HA #18 – Tar paper behind hard wall plaster

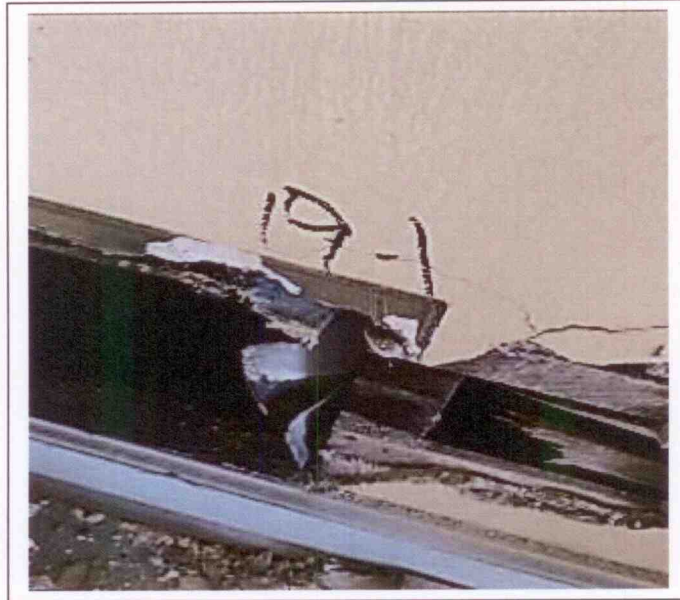
HA #19 – Duct insulation concealed behind hard wall plaster

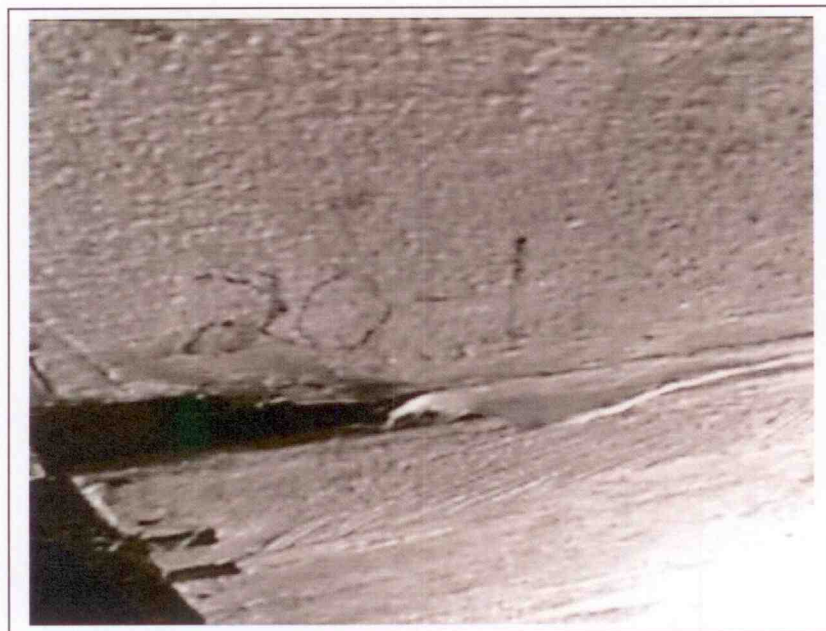
HA #20 – Drywall, old

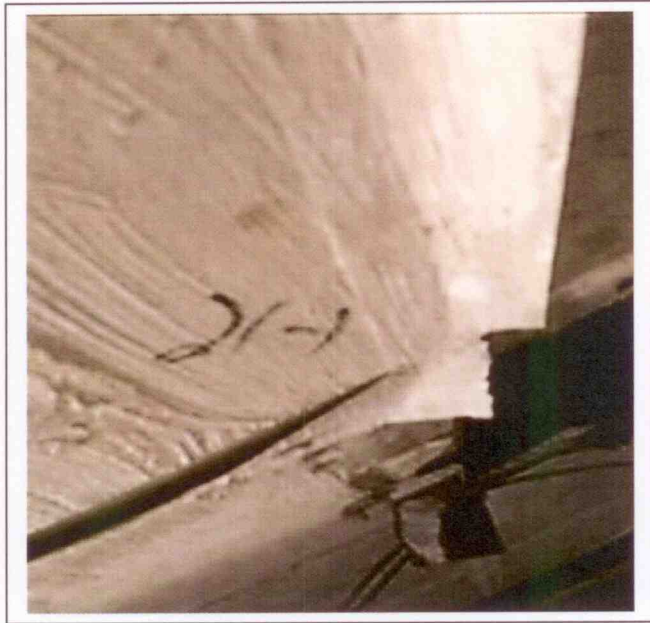
HA #21 – Joint compound, old
