SIERRA ENVIRONMENTAL GROUP, INC.

September 22, 2015

Re: Comprehensive Pre-Demolition Asbestos Inspection
Vacant Residence
1165 Linda Vista Avenue
Dayton, Ohio 45405
Sierra Project Number: MCLB.001

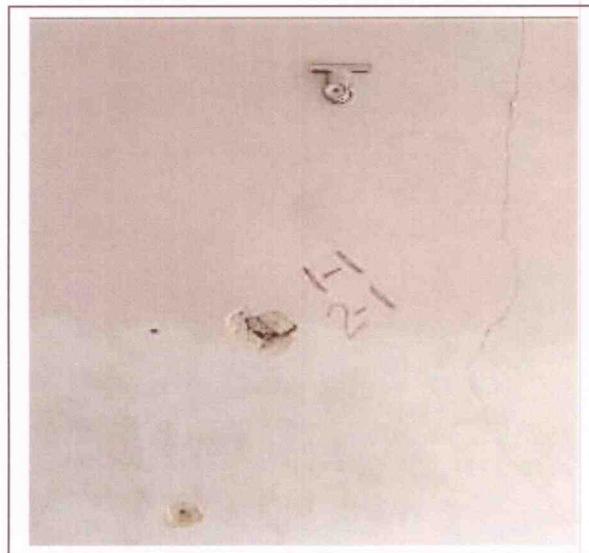
| SAMPLE DESCRIPTION (Material Type) | SAMPLE LOCATION | HOMO AREA # | SAMPLE I.D. NO. | ASBESTOS CONTENT | FRIABLE/ NONFRIABLE |
|---|---|---|---|---|---|
| Brown coat of hard ceiling plaster (Surfacing, >5,000 sf) | Bedroom #1 | 2 | 2-2 | *1.1% Chrysotile | Nonfriable |

| Entire residence | RACM | Hard wall and ceiling plaster | 5,210 sf |

HA #1 & #2 – Hard wall and ceiling plaster

| Entire residence | RACM | Hard wall and ceiling plaster | \$31,260.00 |

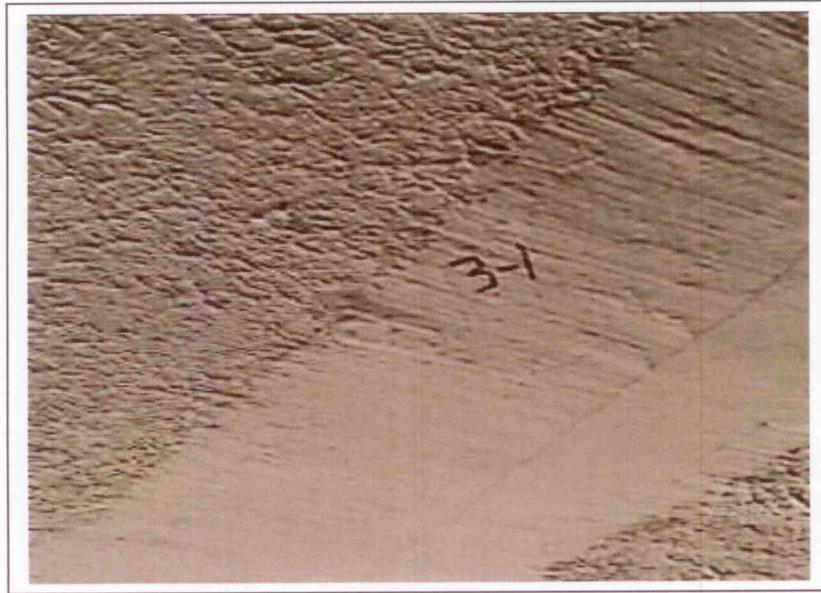
HA #3 – Textured ceiling

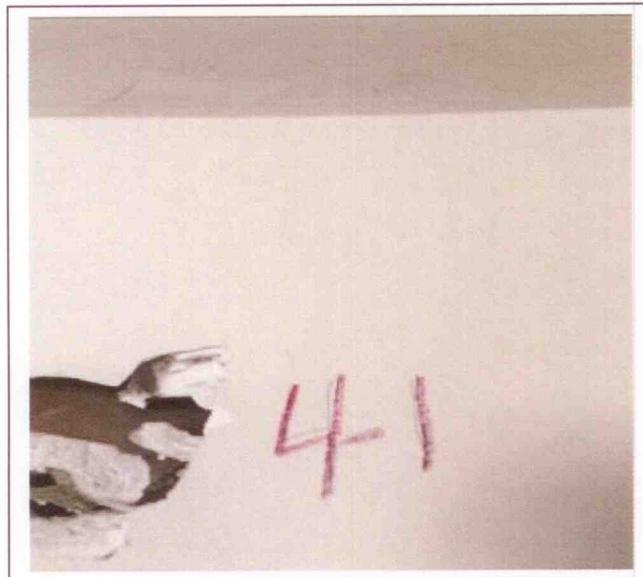
HA #4 - Drywall

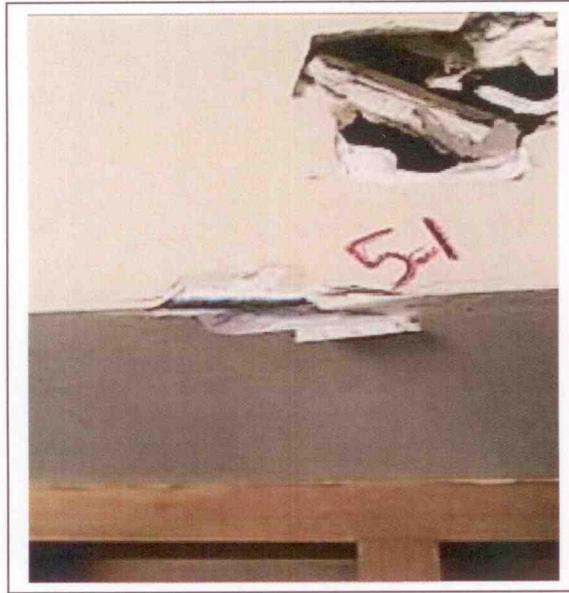
HA #5 – Joint compound

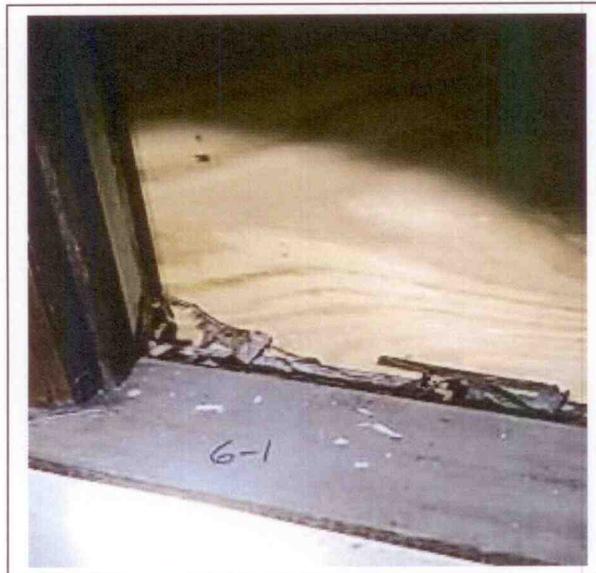
HA #6 – Window glaze

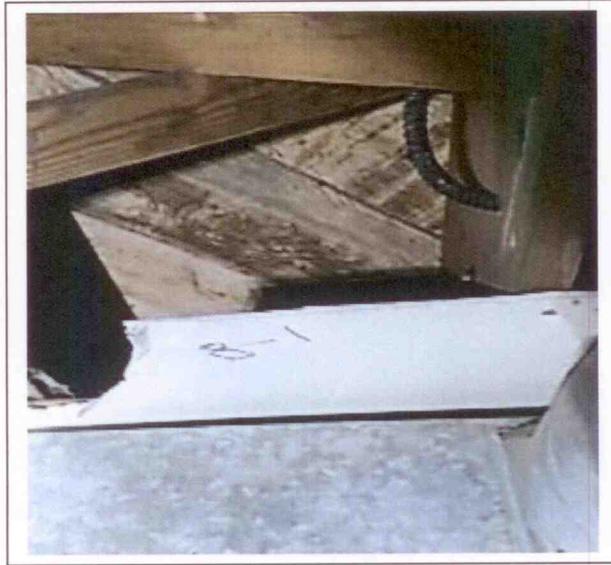
| SAMPLE DESCRIPTION (Material Type) | SAMPLE LOCATION | HOMO AREA # | SAMPLE I.D. NO. | ASBESTOS CONTENT | FRIABLE/ NONFRIABLE |
|---|---|---|---|---|---|
| Duct insulation (Thermal System Insulation) | Basement | 7 | 7-1 | 80% Chrysotile | Friable |
| Heat shield (Thermal System Insulation) | Basement | 8 | 8-1 | 50% Amosite & 10% Chrysotile | Friable |

| Basement | RACM | Duct insulation | 30 sf |
| Basement | RACM | Duct insulation debris | 40 sf |
| Basement | RACM | Heat shield | 15 sf |

HA #7 & #8 – Duct insulation and heat shield

| Basement | RACM | Duct insulation | \$600.00 |
| Basement | RACM | Duct insulation debris | \$800.00 |
| Basement | RACM | Heat shield | \$300.00 |

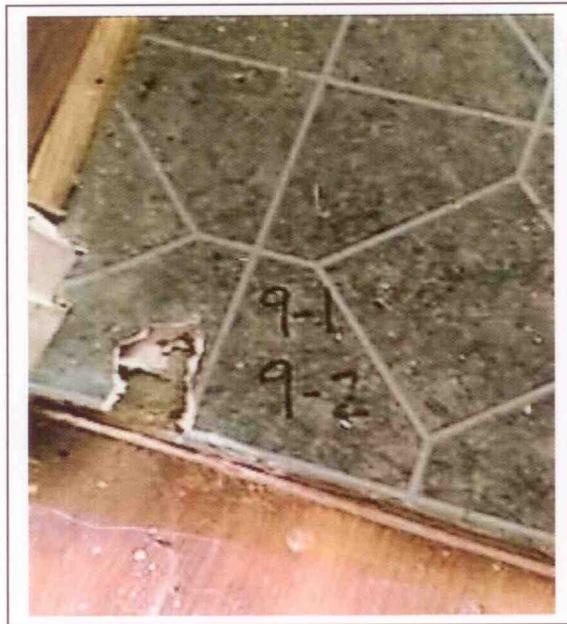
HA #9 – Green sheet flooring

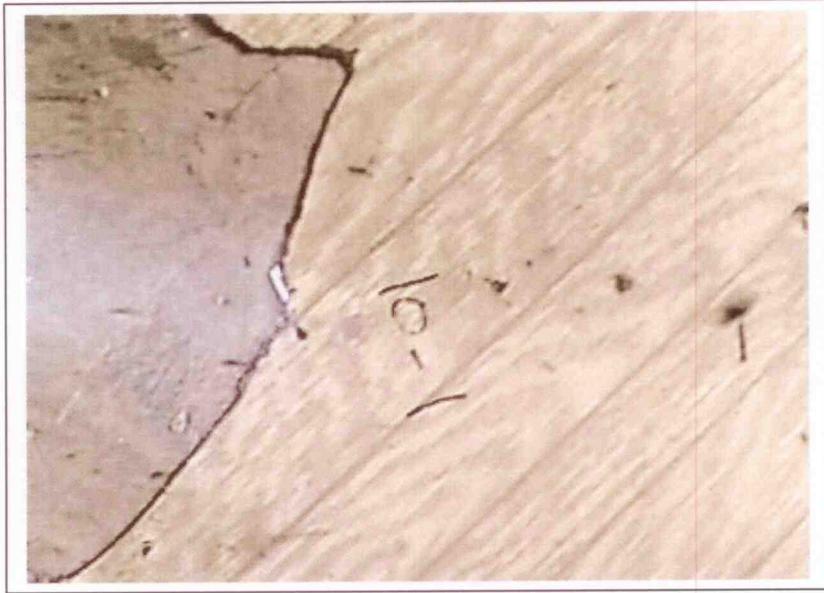
HA #10 – Brown sheet flooring

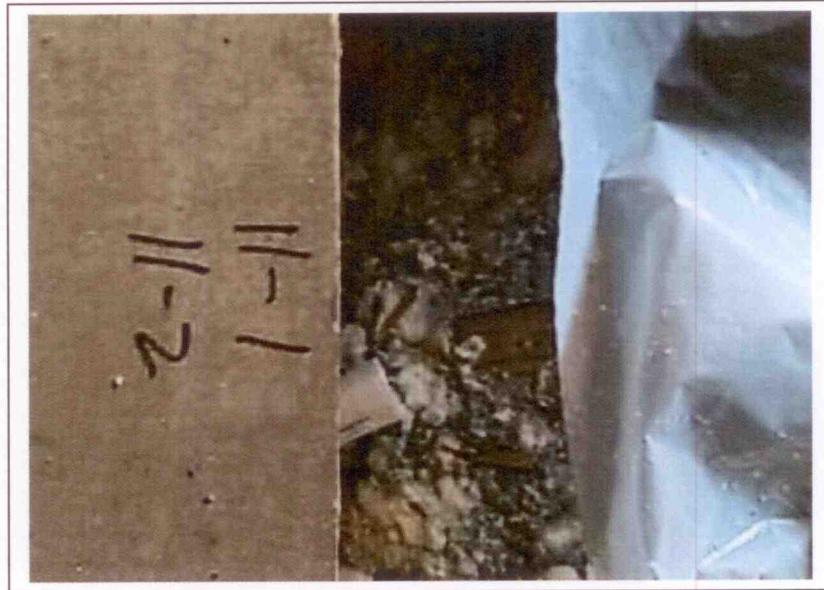
HA #11 – Blown-in insulation

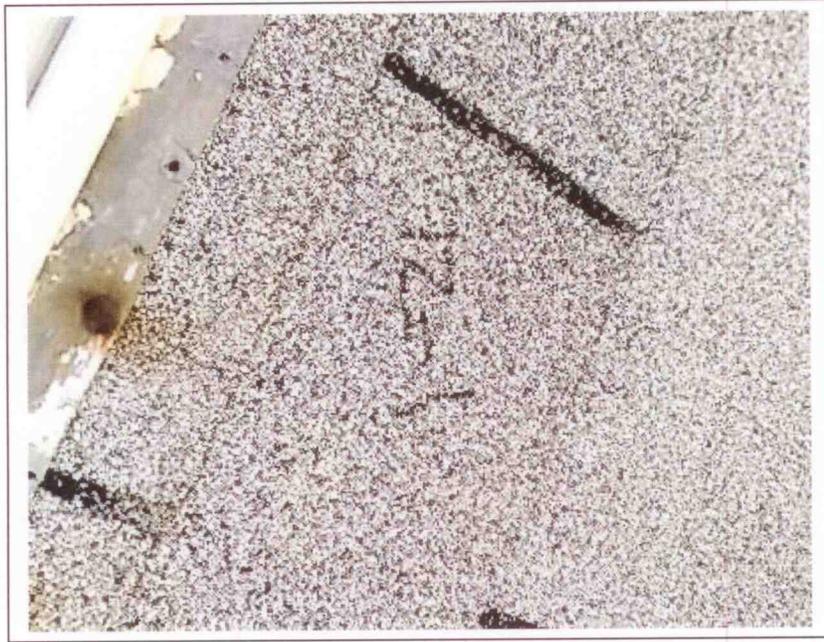
HA #12 – Black and white asphalt roof shingle

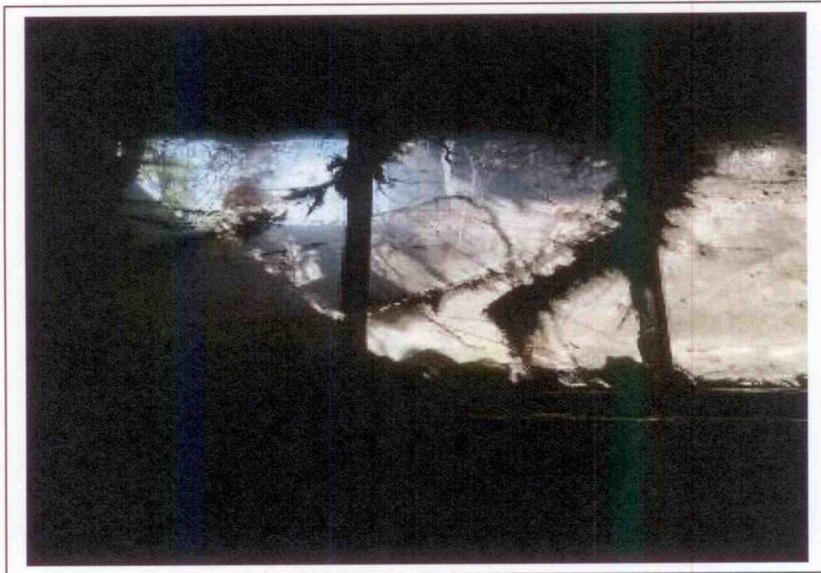
HA #13 - Window glaze, metal windows

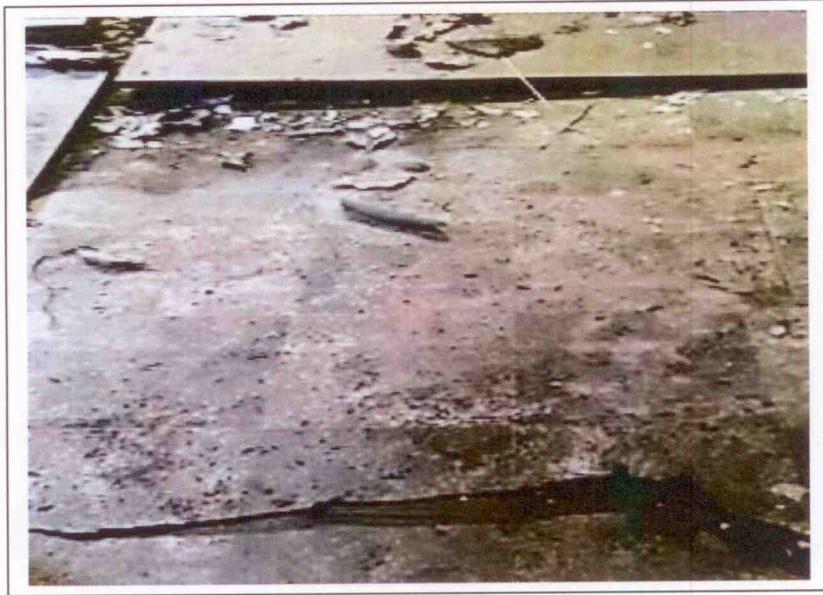
HA #14 – Brown sheet flooring
