SIERRA ENVIRONMENTAL GROUP, INC.

Re: Comprehensive Pre-Demolition Asbestos Inspection
Vacant Residences
1247-1253 Linda Vista Avenue
Dayton, Ohio 45405
Sierra Project Number: MCLB.001

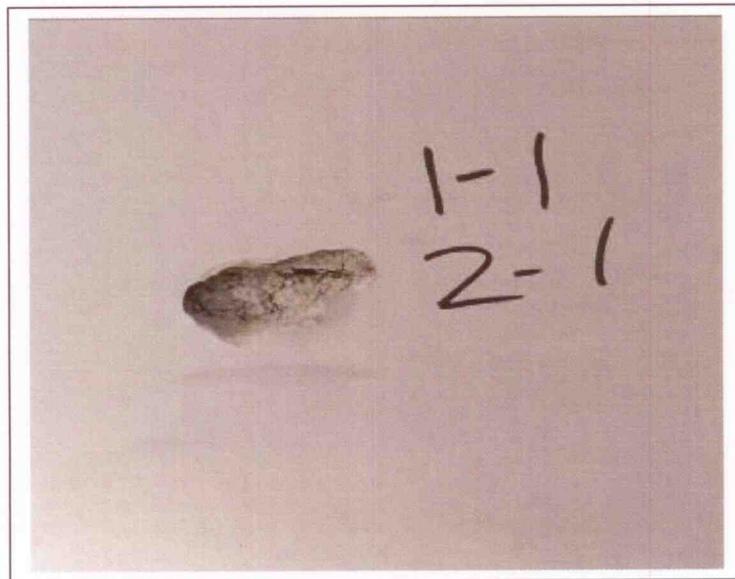
HA #1 & #2 – Hard wall and ceiling plaster

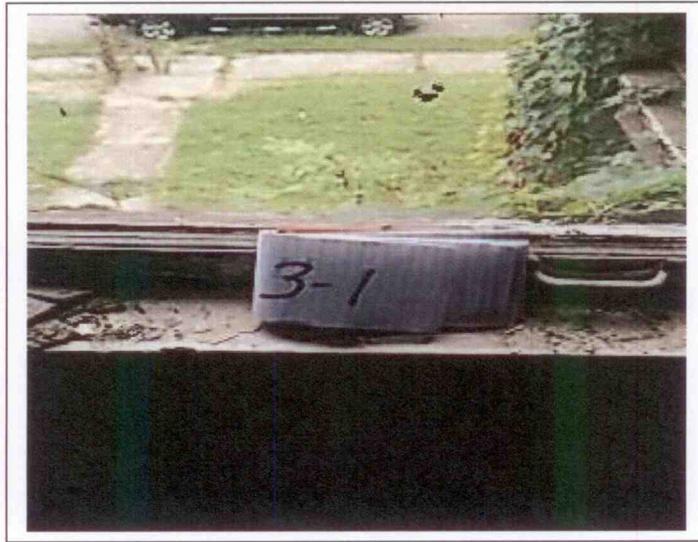
HA #3 – Window glaze

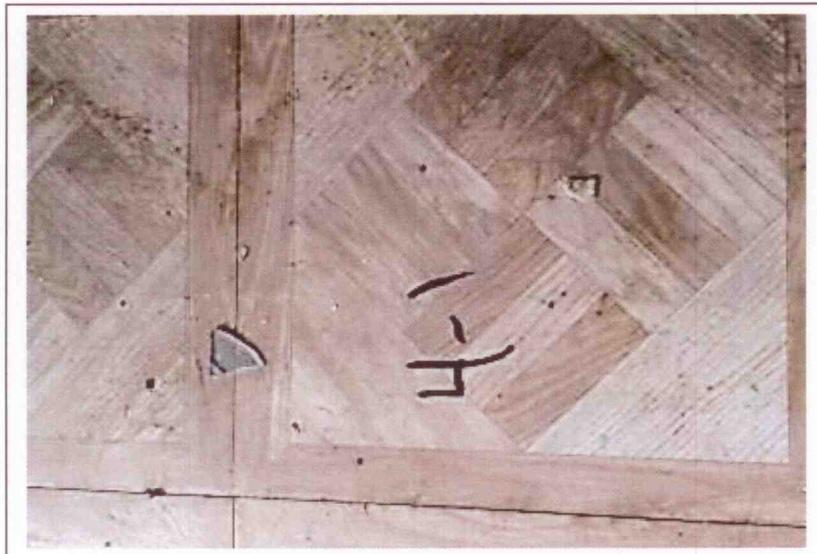
HA #4 – 12"x12" Tan sticky back floor tile

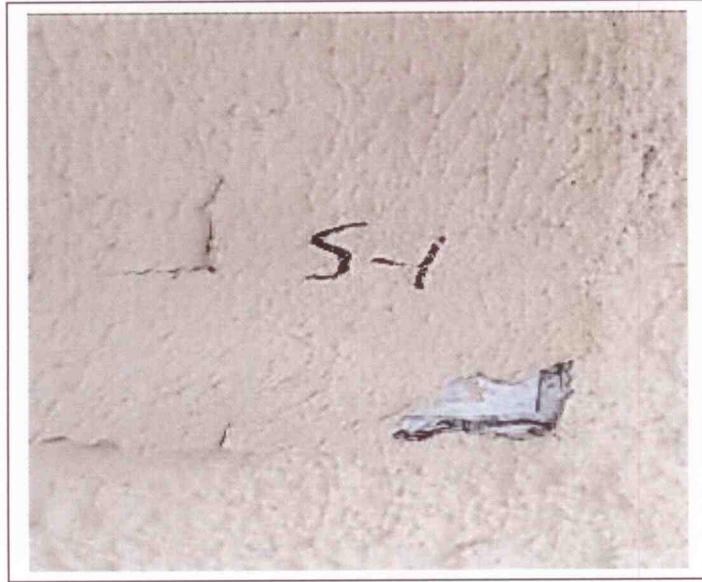
HA #5 – Exterior stucco

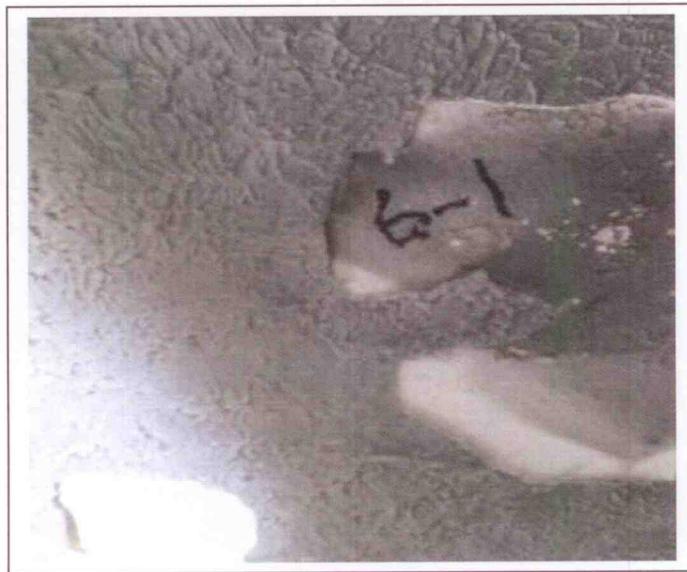
HA #6 – Textured ceiling

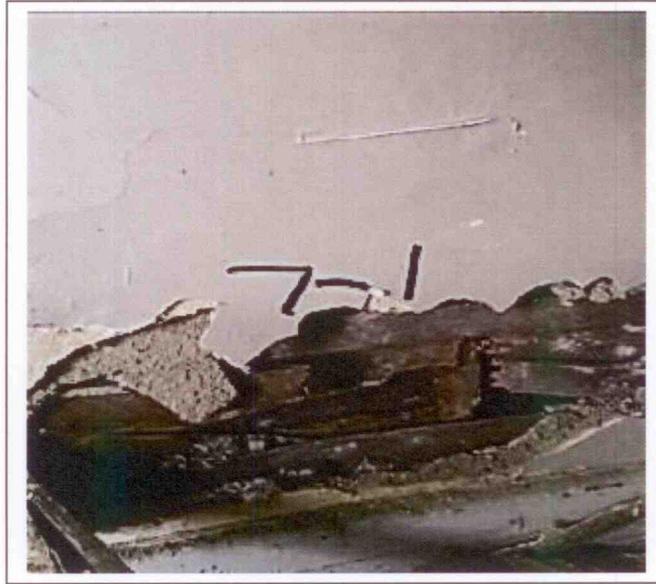
HA #7 – Duct insulation concealed behind hard wall plaster

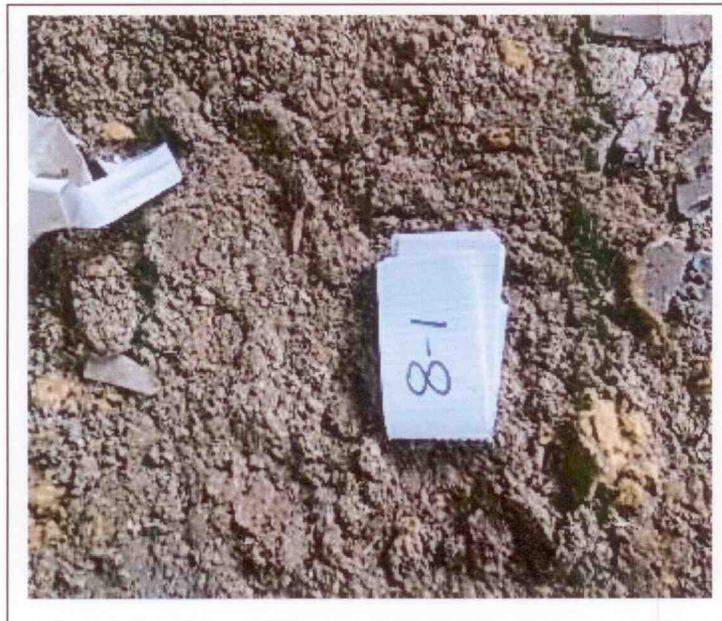
HA #8 – Blown-in insulation

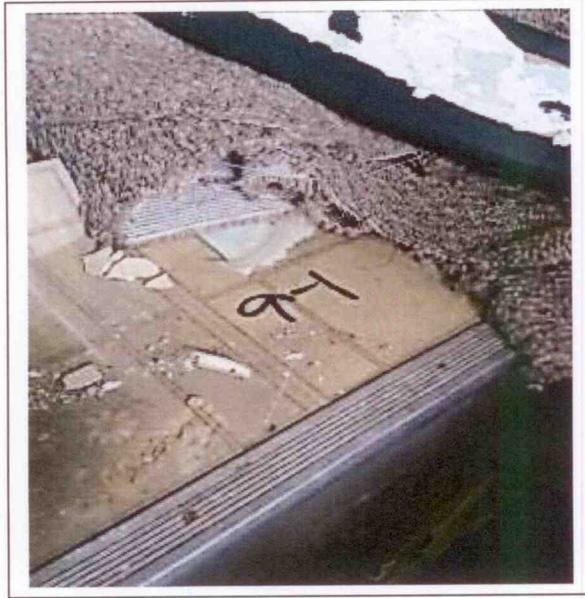
HA #9 – 12”x12” Square pattern flooring

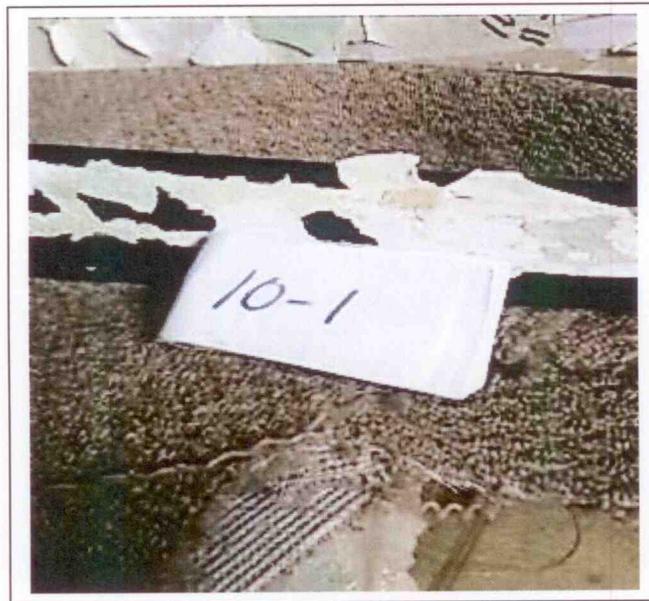
HA #10 & #11 – Black baseboard and associated mastic

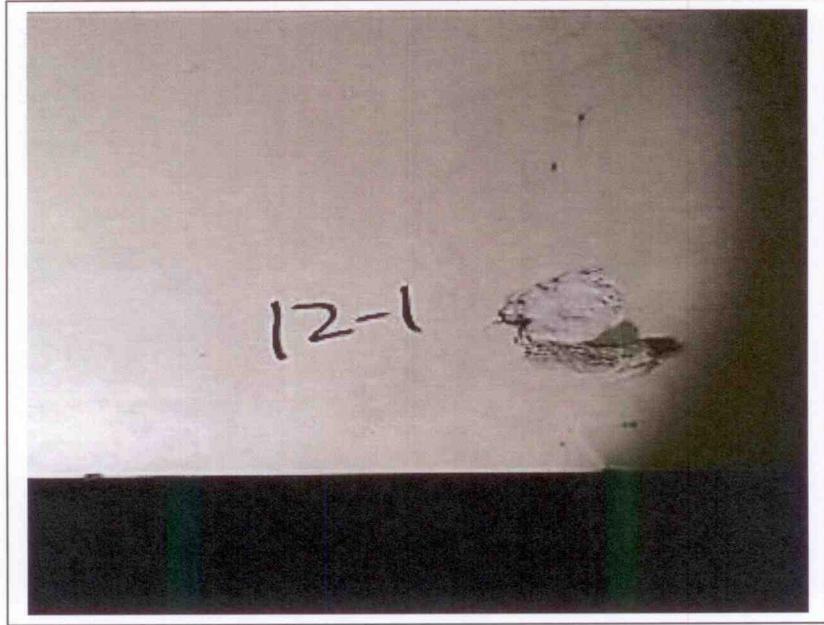
HA #12 - Drywall

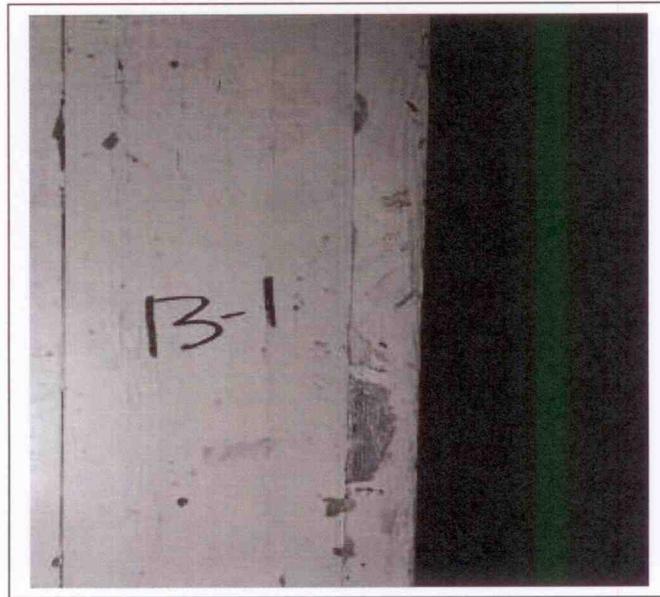
HA #13 - Joint compound

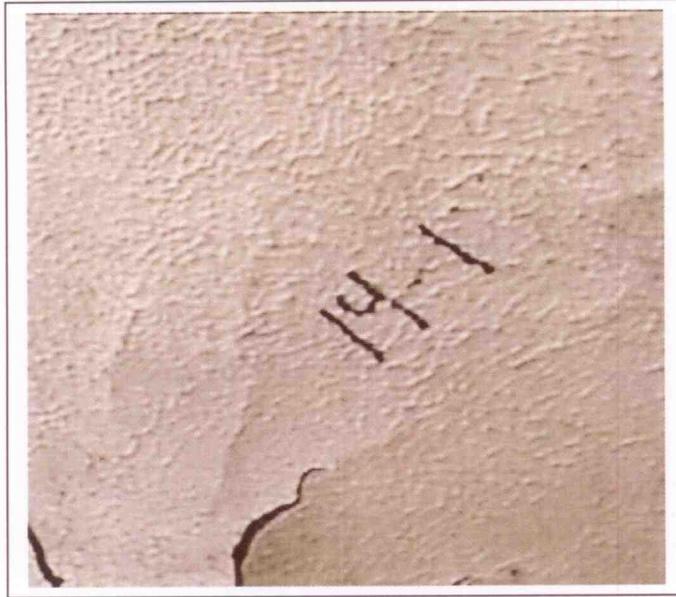
HA #14 – Textured wall

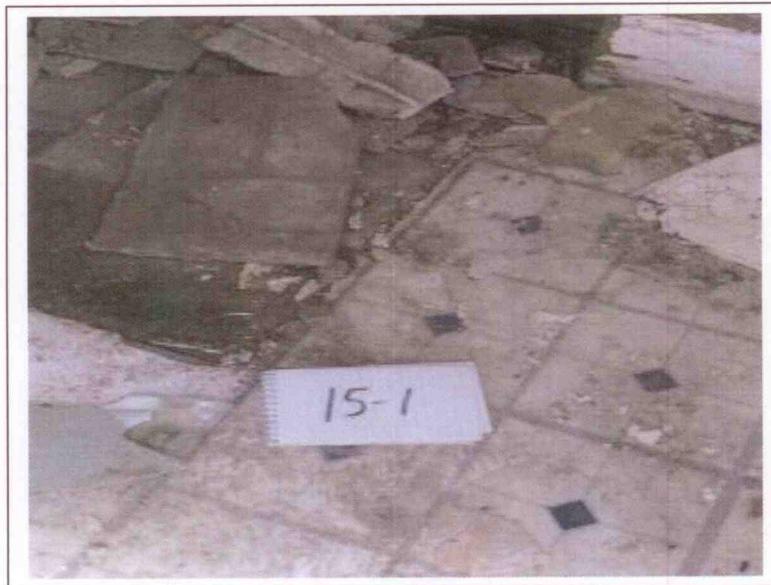
HA #15 – Black and white sheet flooring

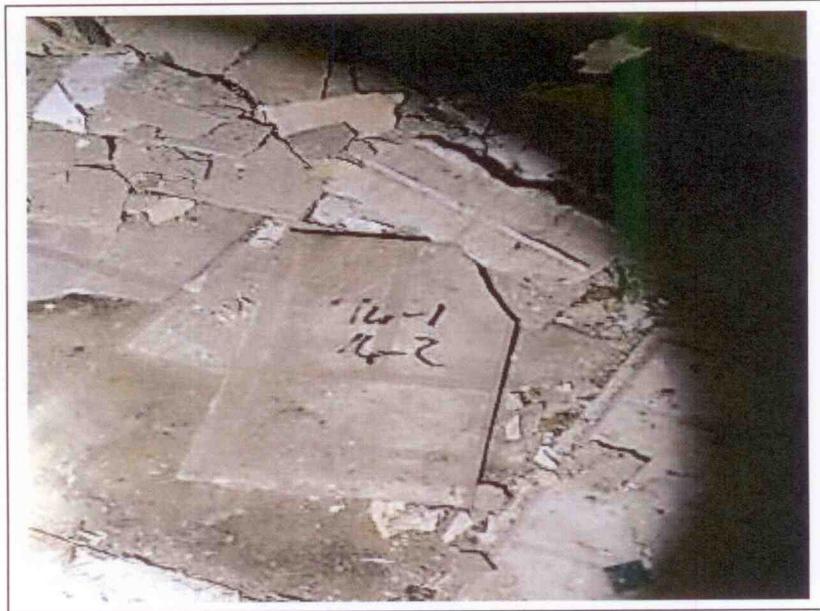
HA #16 12" Tan sticky back floor tile

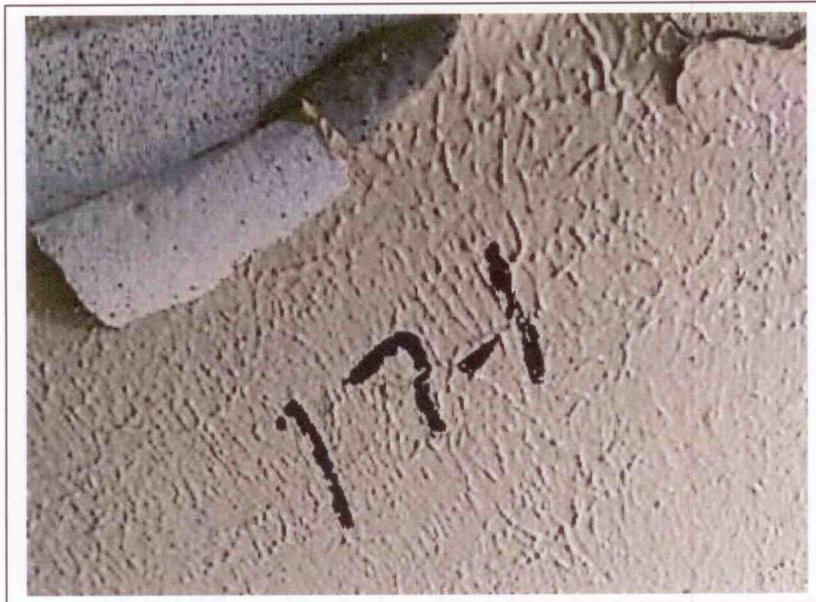
HA #17 - Textured wall

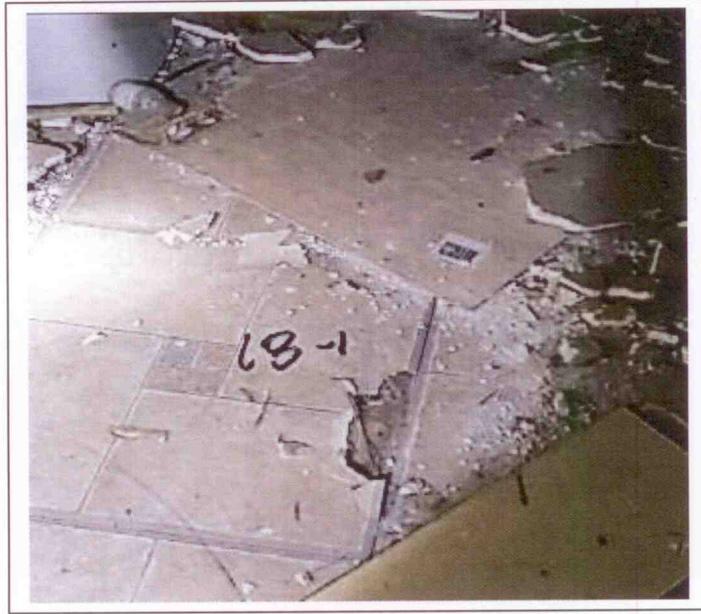
HA #18 – 12”x12” Tan sticky back floor tile

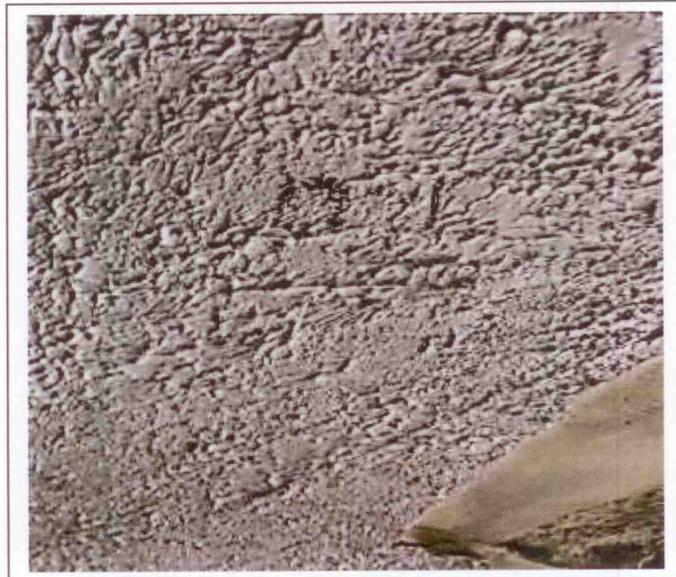
HA #19 – Textured ceiling

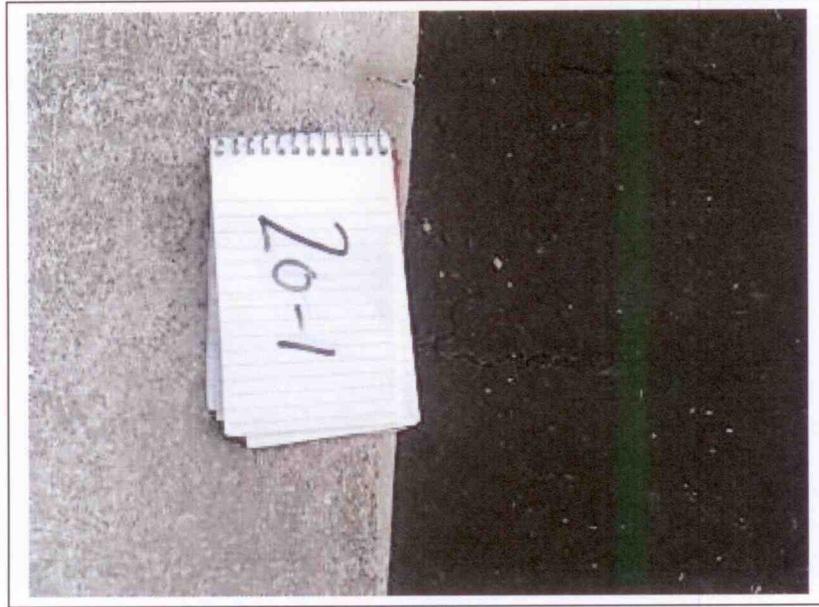
HA #20 – Tar paper

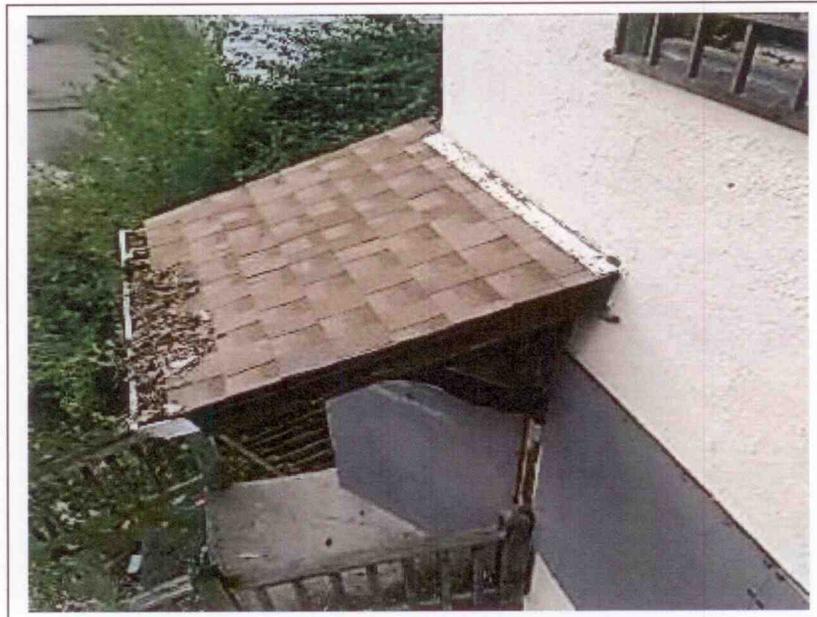
HA #21 – Brown asphalt roof shingle
