**SIERRA** ENVIRONMENTAL GROUP, INC.

September 23, 2015

**Re:** Comprehensive Pre-Demolition Asbestos Inspection  
Vacant Residence  
2035 Rugby Road  
Dayton, Ohio 45406  
Sierra Project Number: MCLB.001

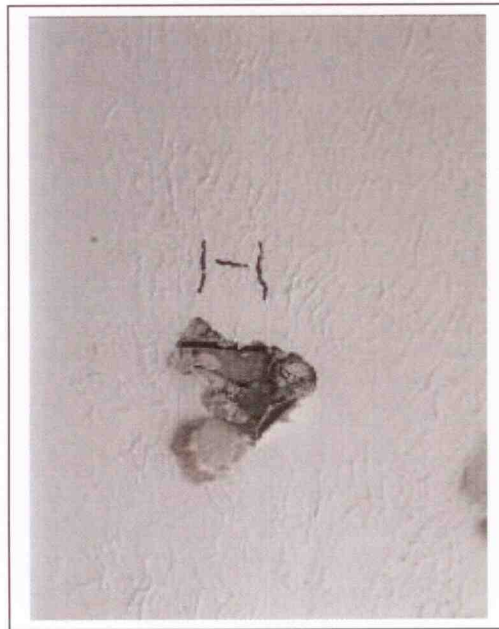
HA #1 – Textured wall

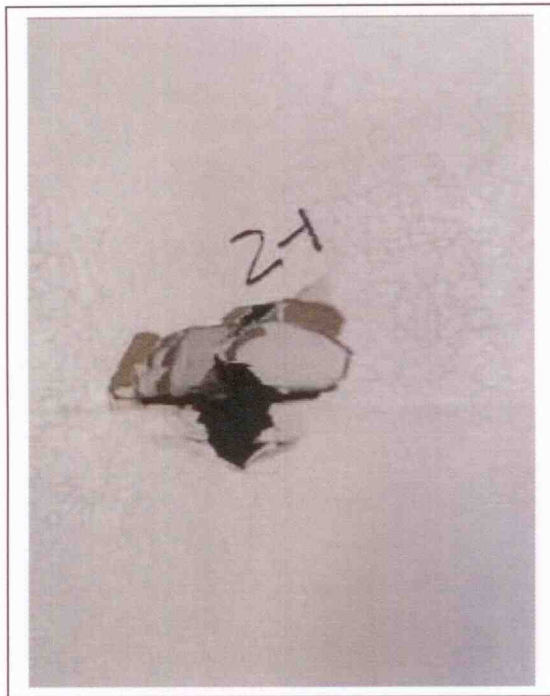
HA #2 - Drywall

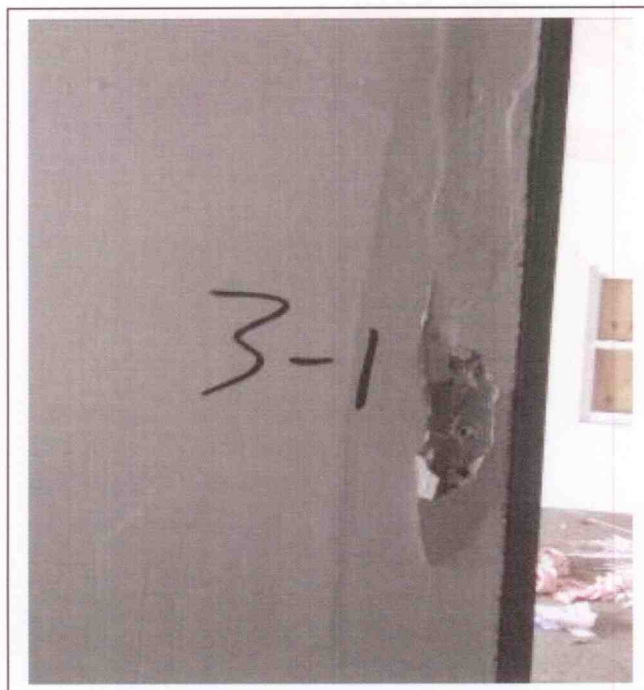
HA #3 - Joint compound

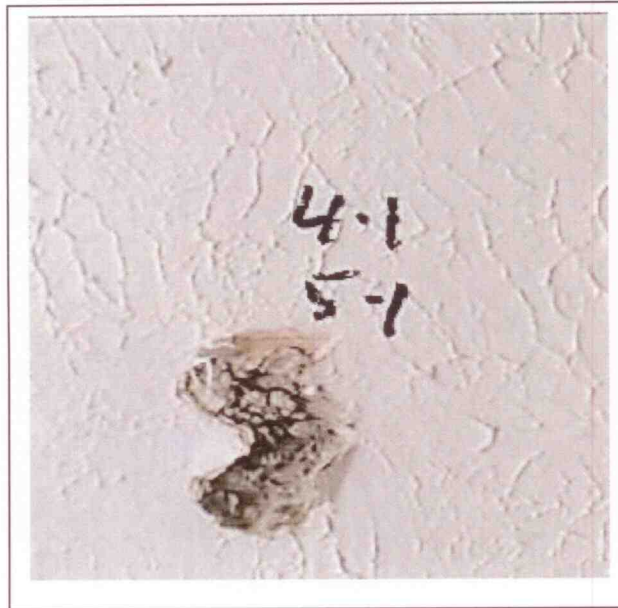
HA #4 & #5 – Hard wall and ceiling plaster

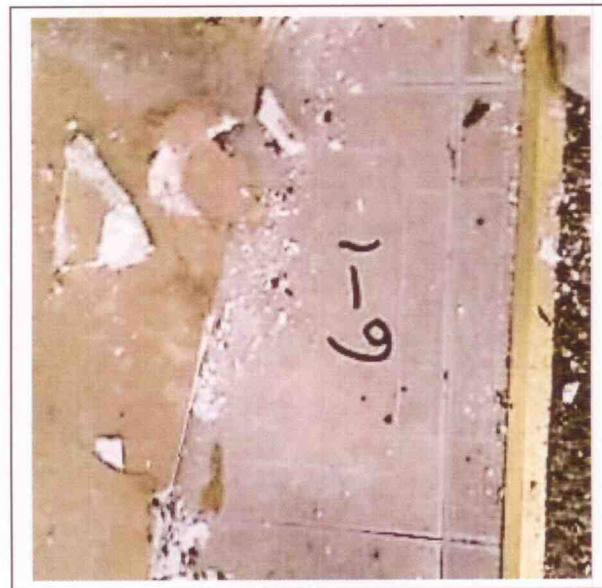
HA #6 – 12"x12" Tan sticky back floor tile

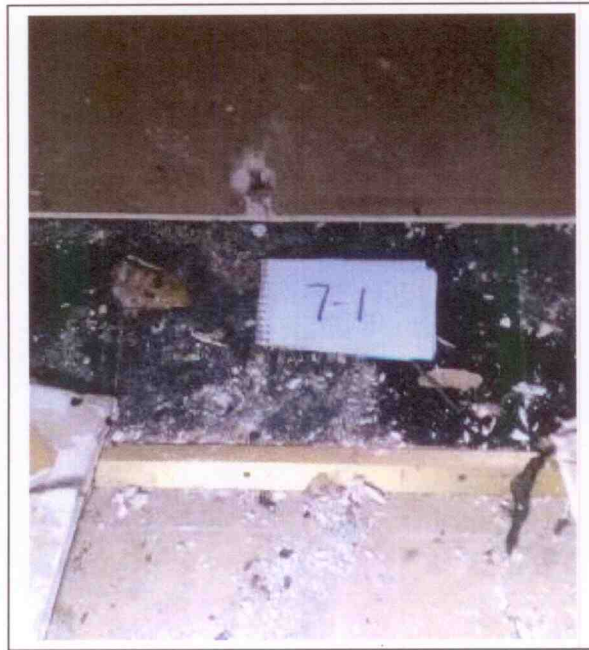
HA #7 - 12"x12" Black floor tile

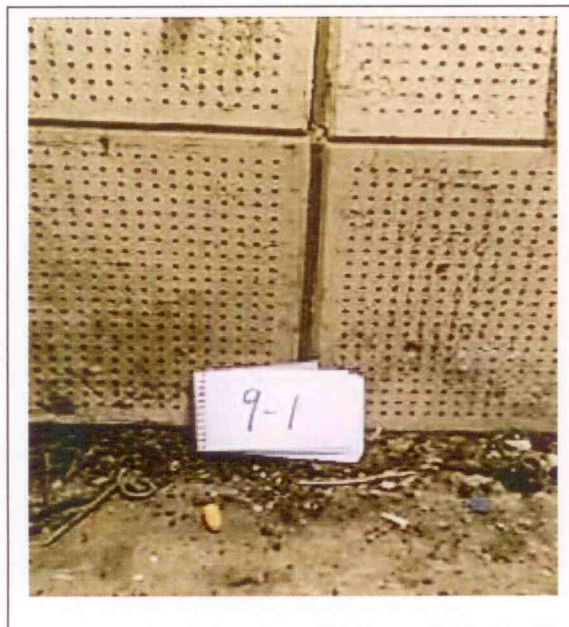
HA #9 - 12" Wall tile with hole pattern

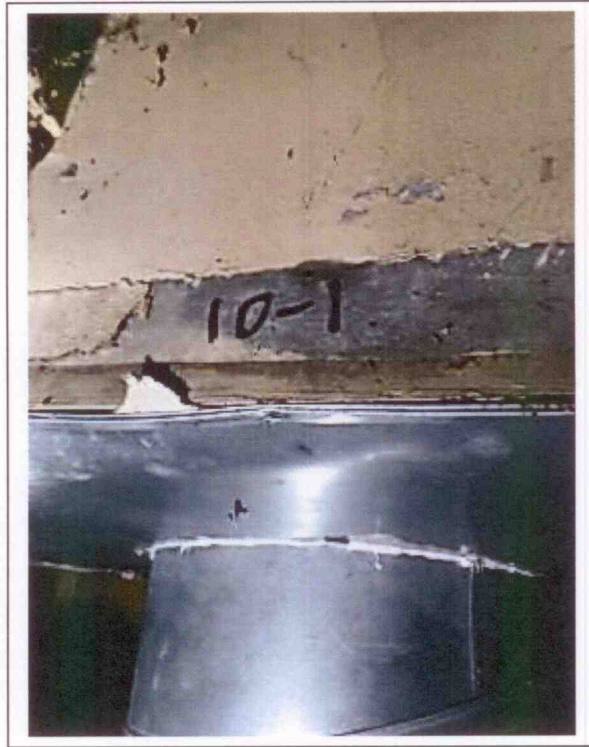
HA #10 – Duct insulation

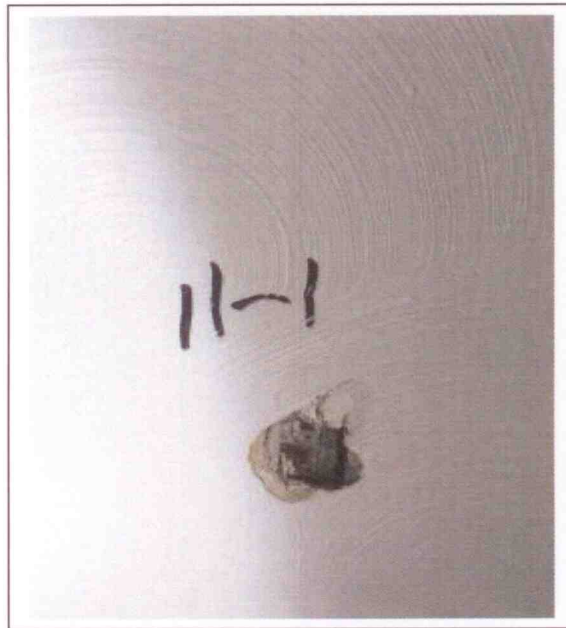
\*\*1.7% Chrysotile is present in the tan joint compound layer not in the textured ceiling material

HA #11 – Textured ceiling

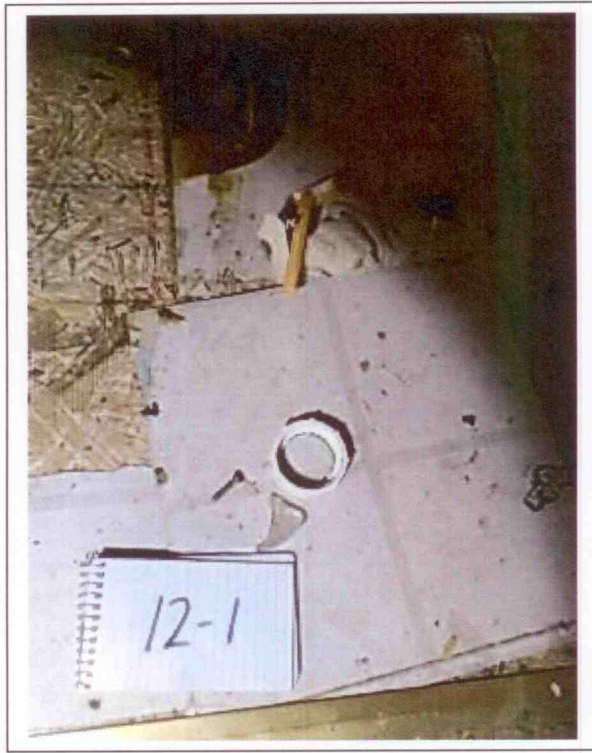
HA #12 – 12"x12" White sticky back floor tile
