SIERRA ENVIRONMENTAL GROUP, INC.

Re: Comprehensive Pre-Demolition Asbestos Inspection
Vacant Residence
1115 Tennyson Avenue
Dayton, Ohio
Sierra Project Number: MCLB.001

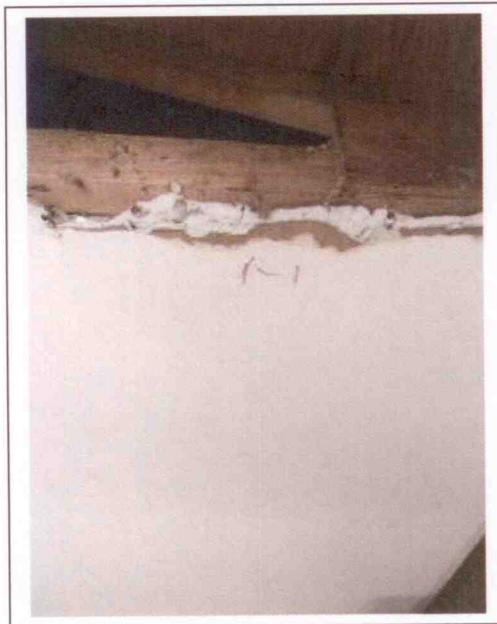
HA #1 - Drywall

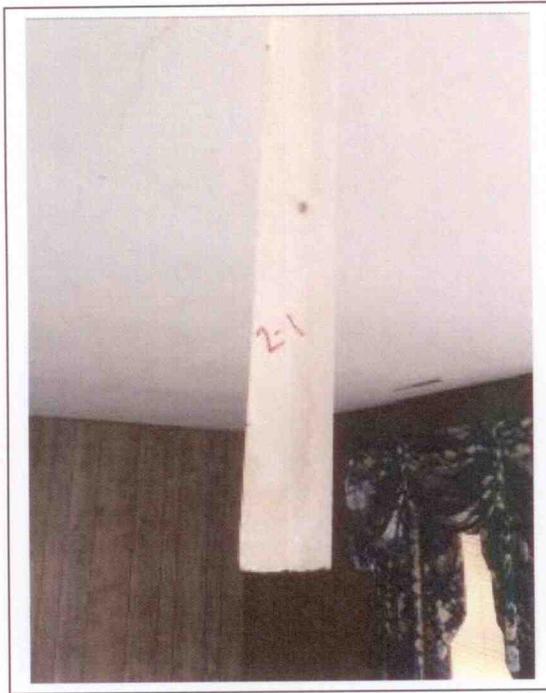
HA #2 – Joint Compound

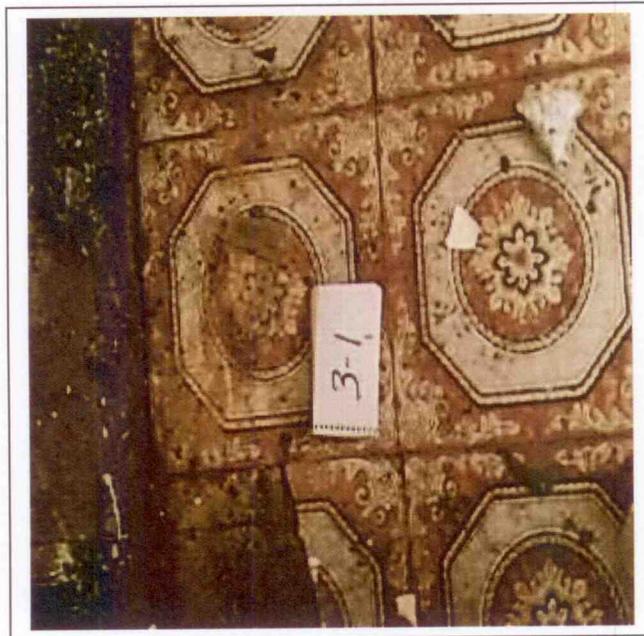
HA #3 – 12"x12" Red pattern sticky back floor tile

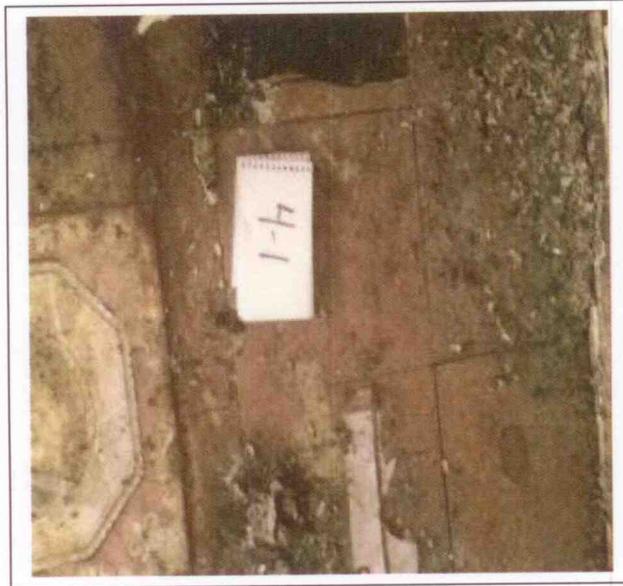
HA #4 & #5 – 9”x9” Tan floor tile and black mastic

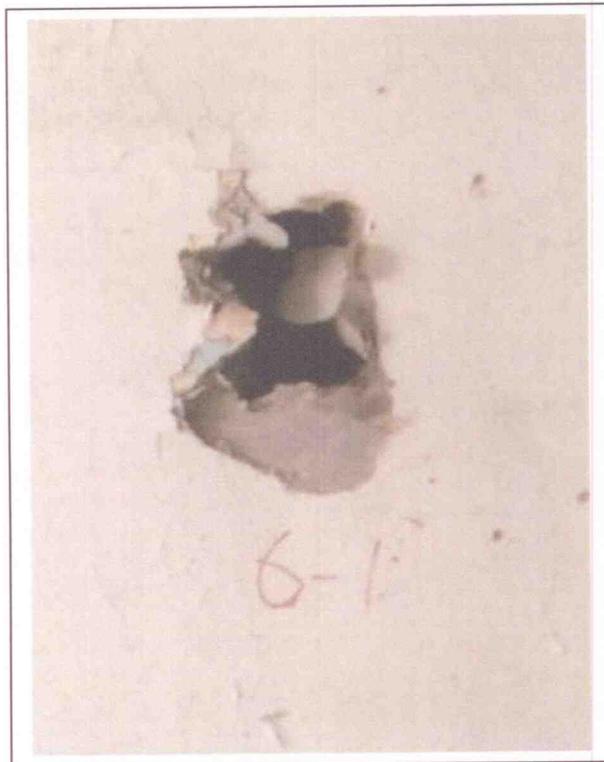
HA #6 – Fiberboard wall

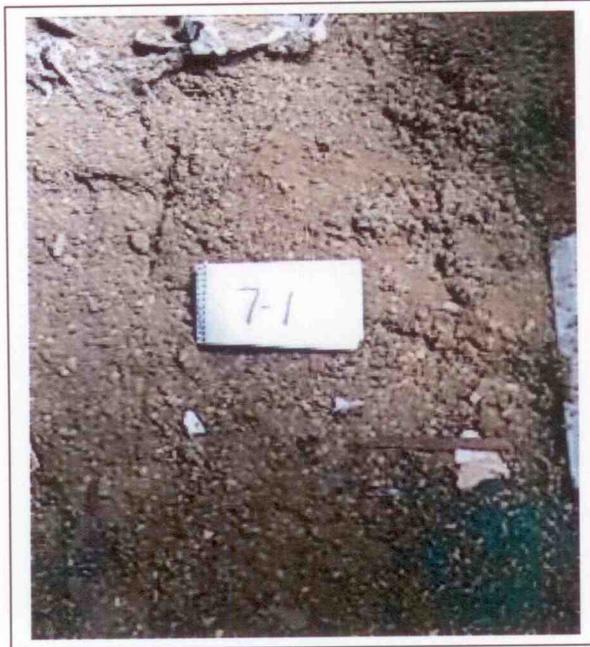
HA #7 – Blown-in insulation

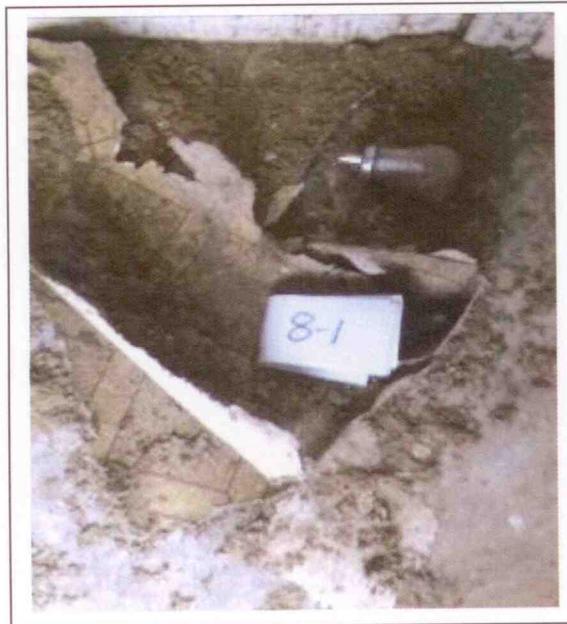
HA #8 – Cream linoleum

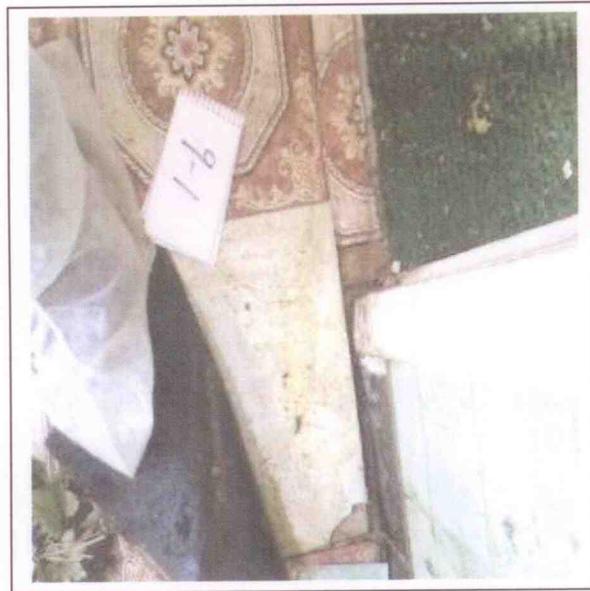
HA #9 – 12"x12" White sticky back floor tile

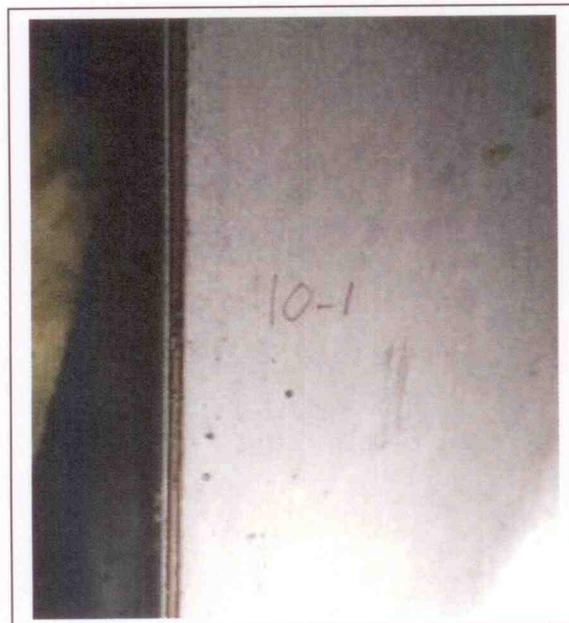
HA # 10 – Cementitious panel board

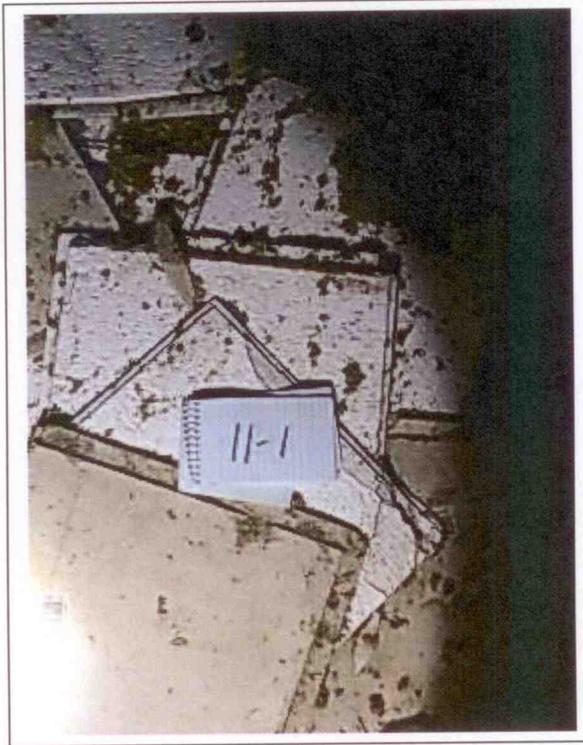
HA #11 – 12” White ceiling tile

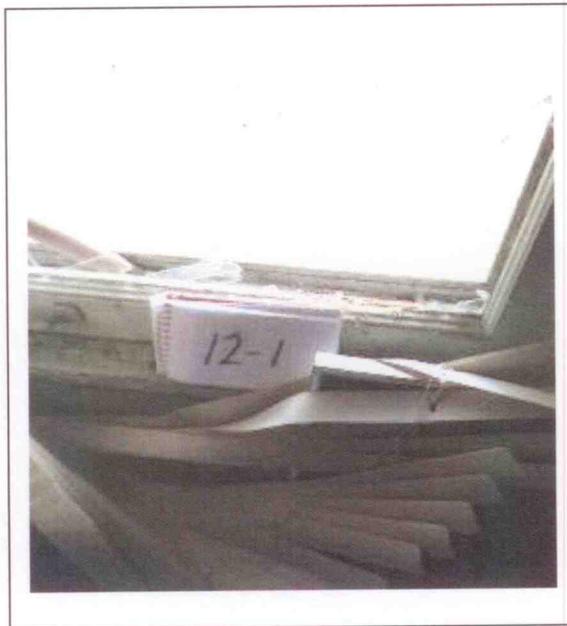
HA # 12 – Window glaze

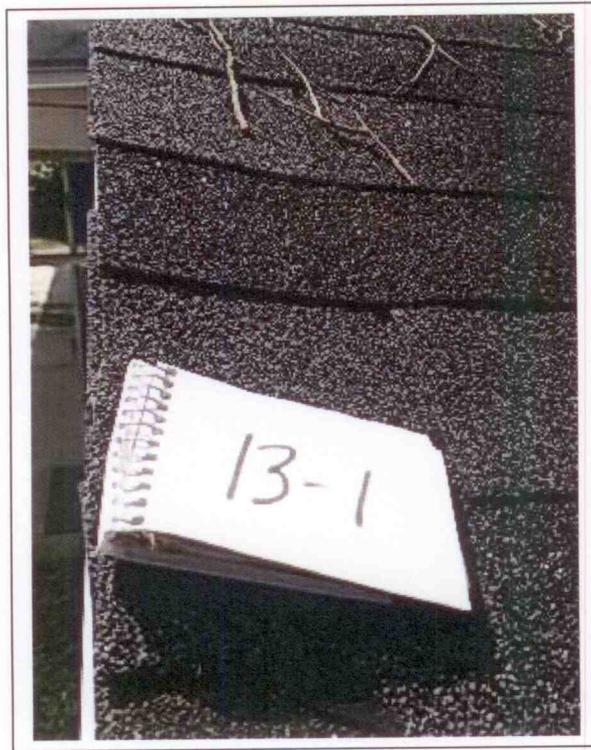
HA # 13 – Black asphalt roof shingles
