SIERRA ENVIRONMENTAL GROUP, INC.

September 23, 2015

Re: Comprehensive Pre-Demolition Asbestos Inspection
Vacant Residence
2044 Victoria Avenue
Dayton, Ohio 45406
Sierra Project Number: MCLB.001

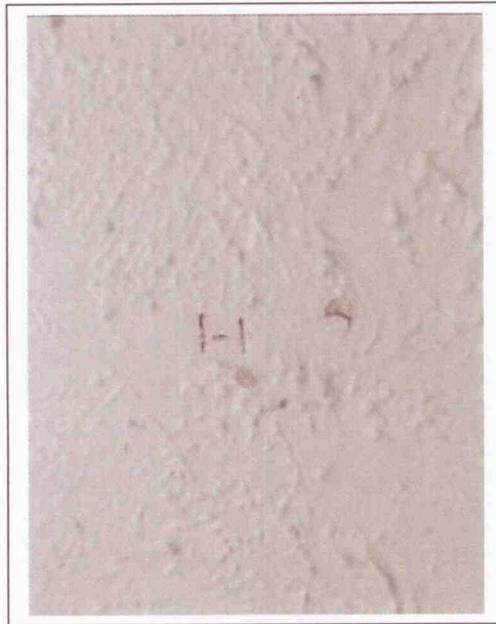
HA #1 – Textured wall and ceiling

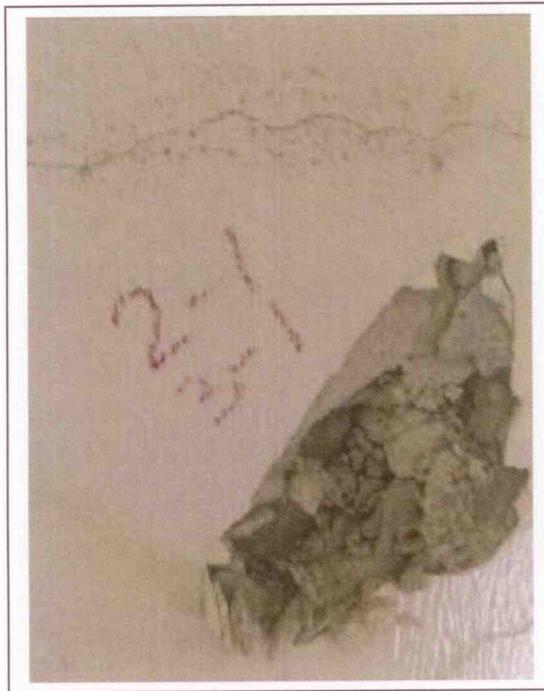
HA #2 & #3 Hard wall and ceiling plaster

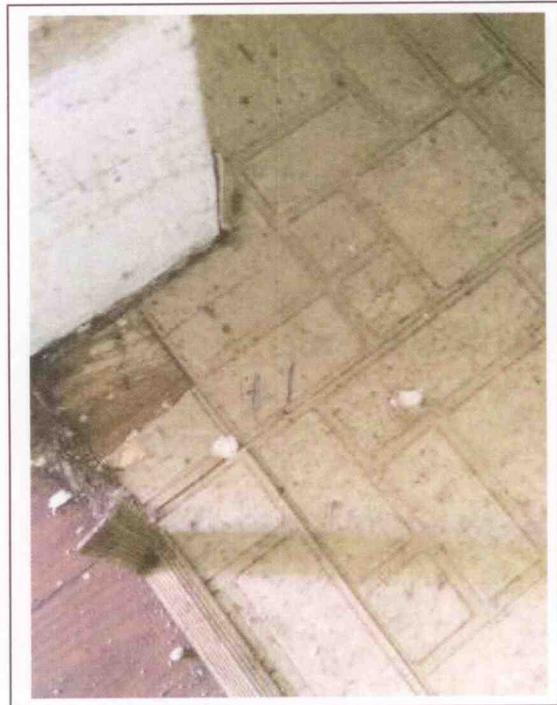
HA #4 – 12"x2" Tan sticky back floor tile

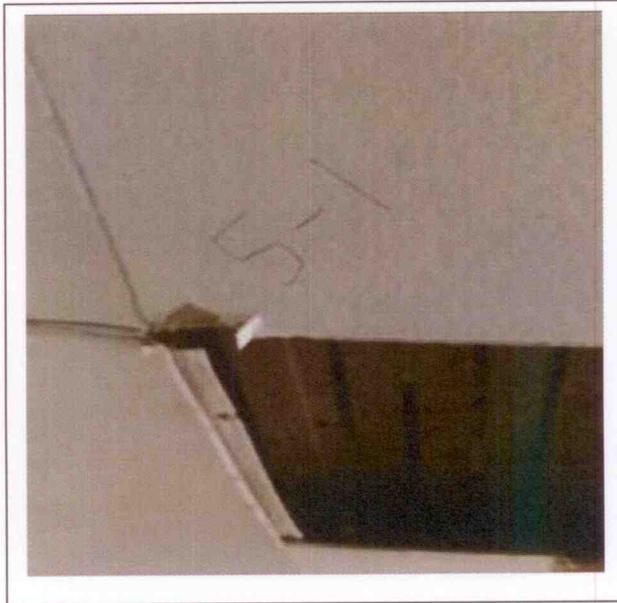
HA #5 – 12” White ceiling tile

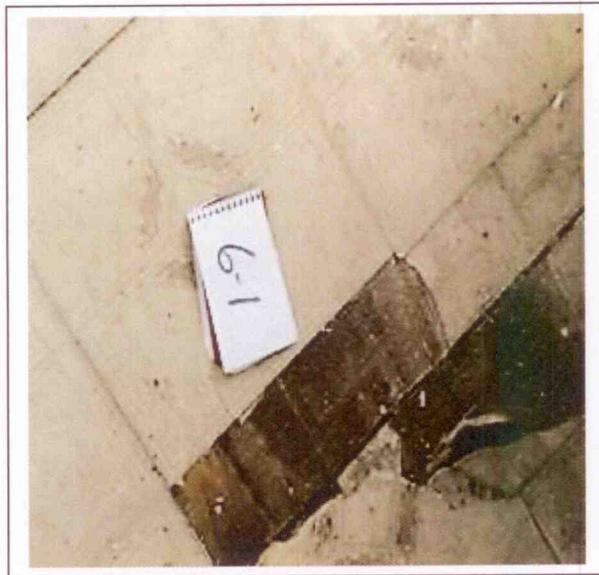
HA #6 – 12”x12” Flower pattern sticky back floor tile

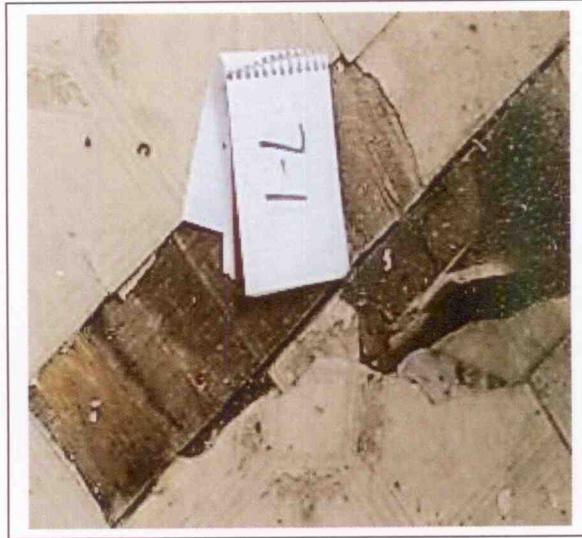
HA #7 – Tan floor tile under 12” sticky back floor tile

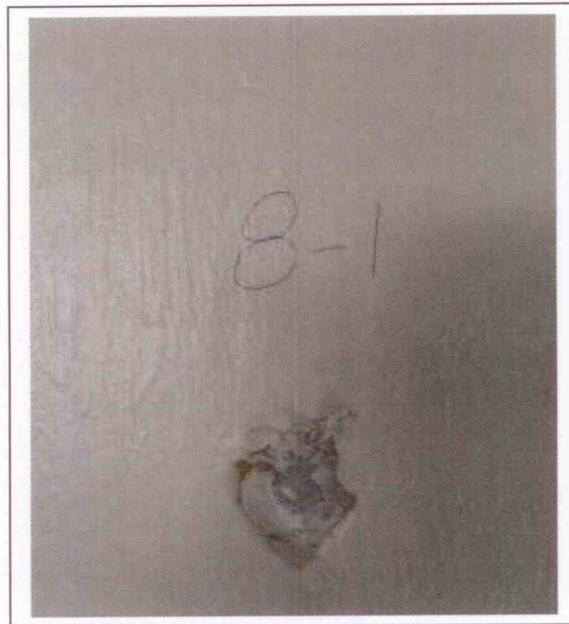
HA #8 – Textured ceiling

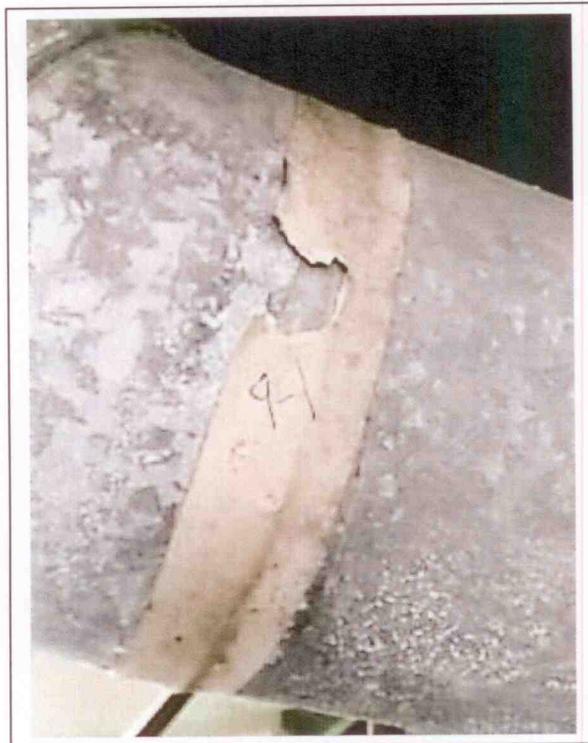
HA #9 – Duct insulation

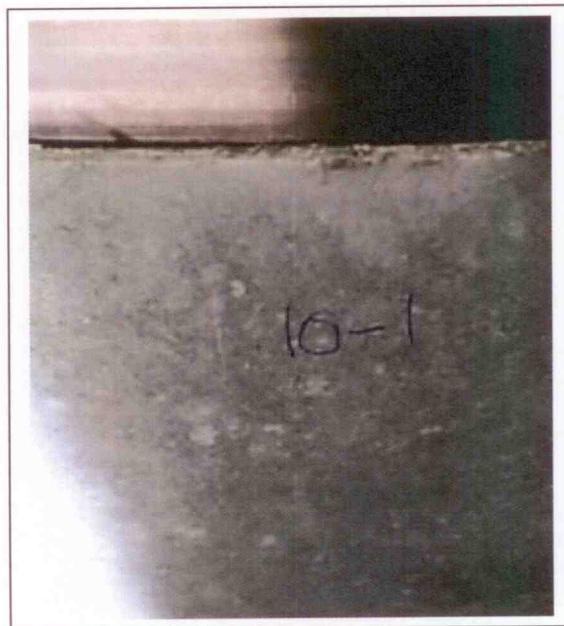
HA #10 – Heat shield

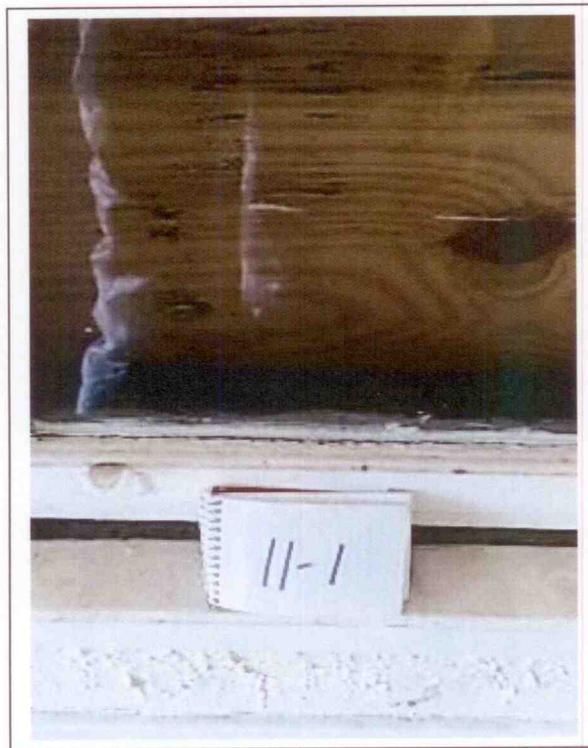
HA #11 – Window glaze

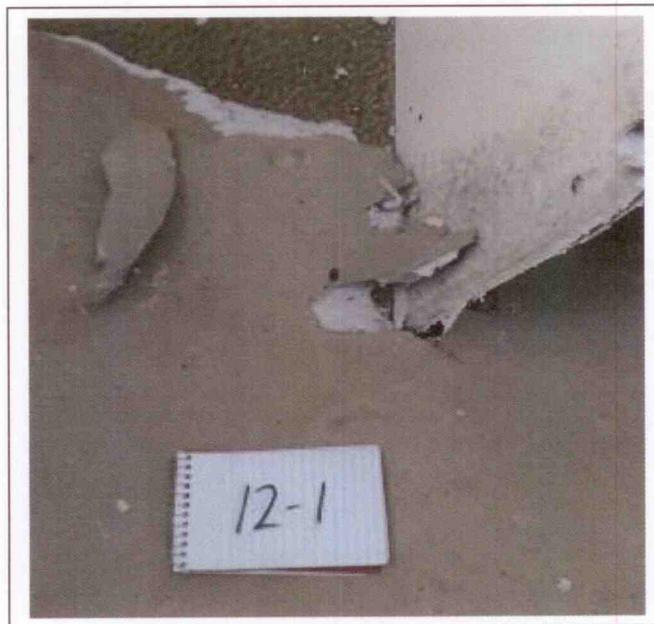
Ha #12 – Drywall, patch

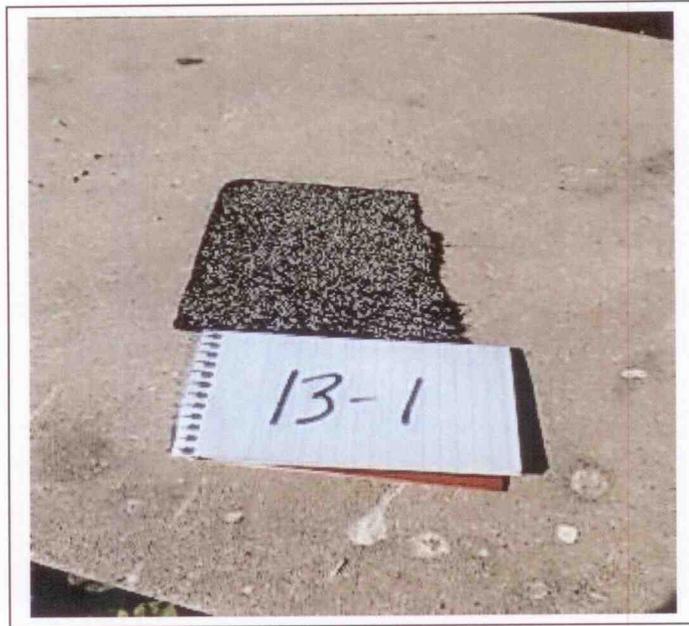
HA #13 – Black and white asphalt shingles
