Re: Comprehensive Pre-Demolition Asbestos Inspection
Vacant Residence
2106 Victoria Avenue
Dayton, Ohio
Sierra Project Number: MCLB.001

TABLE 1: BULK SAMPLE DATA SUMMARY

TABLE 2 - ASBESTOS INVENTORY

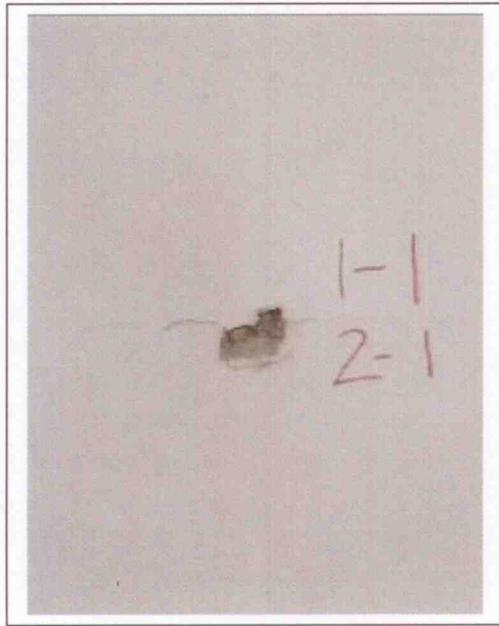
| SAMPLE DESCRIPTION (Material Type) | SAMPLE LOCATION | HOMO AREA # | SAMPLE I.D. NO. | ASBESTOS CONTENT | FRIABLE/ NONFRIABLE |
|--|---|---|---|---|---|
| Skim coat of hard wall plaster (Surfacing, >5,000 sf) | Living room | 1 | 1-1 | None Detected | Nonfriable |
| Brown coat of hard wall plaster (Surfacing, >5,000 sf) | Living room | 2 | 2-1 | None Detected | Nonfriable |

HA #1 & #2 Hard wall and ceiling plaster

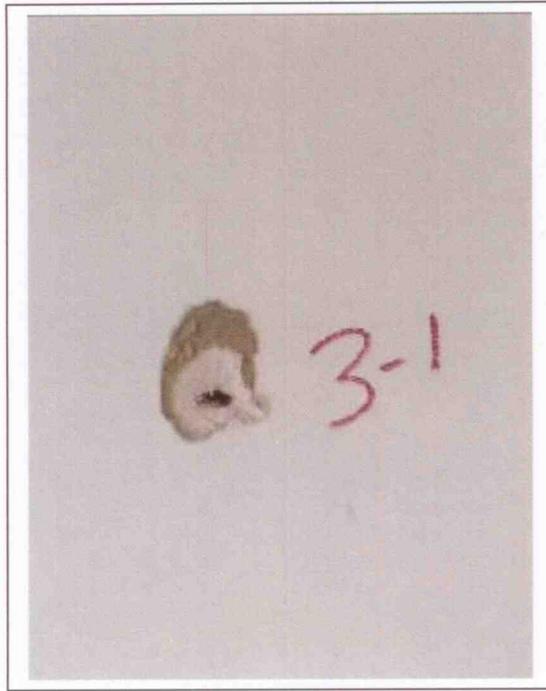
| SAMPLE DESCRIPTION (Material Type) | SAMPLE LOCATION | HOMO AREA # | SAMPLE I.D. NO. | ASBESTOS CONTENT | FRIABLE/ NONFRIABLE |
|--|---|---|---|---|---|
| Drywall, pink (Miscellaneous) | Bathroom, 2nd floor | 3 | 3-1 | None Detected | Nonfriable |

HA #3 - Drywall

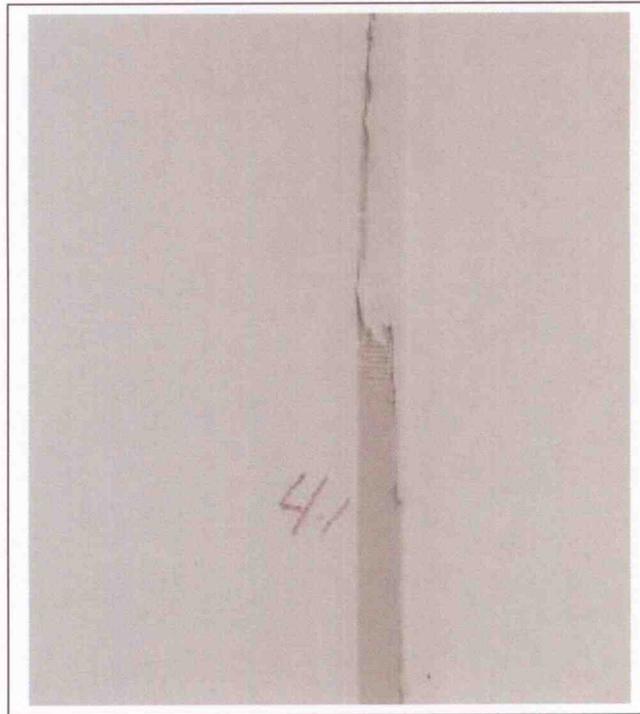
| SAMPLE DESCRIPTION (Material Type) | SAMPLE LOCATION | HOMO AREA # | SAMPLE I.D. NO. | ASBESTOS CONTENT | FRIABLE/ NONFRIABLE |
|--|---|---|---|---|---|
| Joint compound (Miscellaneous) | Bathroom, 2nd floor | 4 | 4-1 | None Detected | Nonfriable |

HA #4 - Joint compound

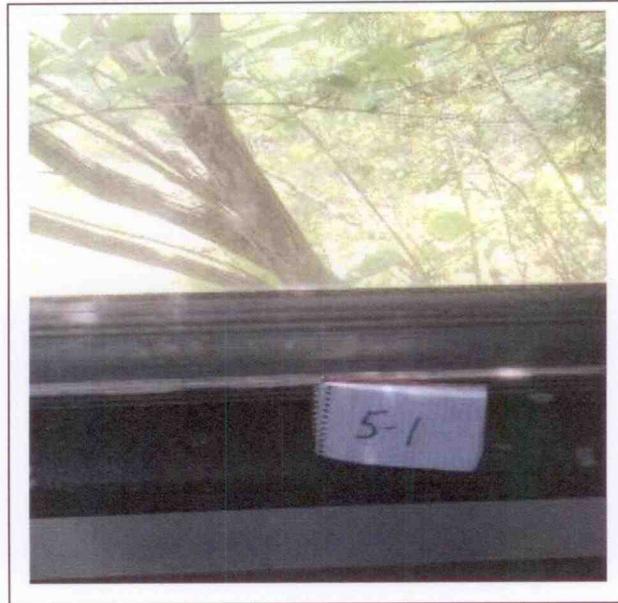
| SAMPLE DESCRIPTION (Material Type) | SAMPLE LOCATION | HOMO AREA # | SAMPLE I.D. NO. | ASBESTOS CONTENT | FRIABLE/ NONFRIABLE |
|--|---|---|---|---|---|
| Window glaze (Miscellaneous) | Exterior 1st floor | 5 | 5-1 | *3.1% Chrysotile | Friable |

| Location | Type ACM | Material Description | Amt. of Material (approx.) |
|---|---|--|---|
| Exterior residence & garage | II | Window glaze | 15 windows |

HA #5 – Window glaze

| Location | Type ACM | Material Description | Cost for abatement (approx.) |
|---|---|---|---|
| Exterior residence & garage | II | Window glaze | \$2,250.00 |

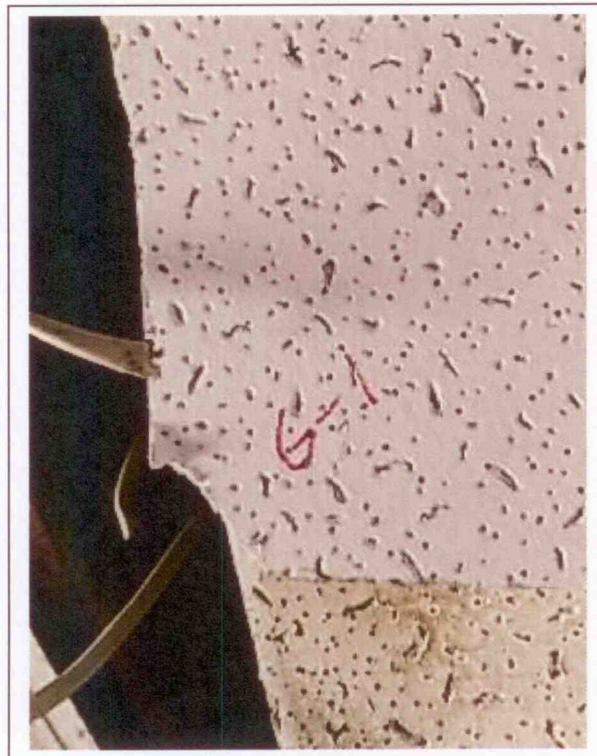
| SAMPLE DESCRIPTION (Material Type) | SAMPLE LOCATION | HOMO AREA # | SAMPLE I.D. NO. | ASBESTOS CONTENT | FRIABLE/ NONFRIABLE |
|--|---|---|---|---|---|
| 2'x2' Suspended ceiling tile with holes and fissures (Miscellaneous) | Kitchen | 6 | 6-1 | None Detected | Friable |

HA #6 – 2'x2' Suspended ceiling tile with holes and fissures

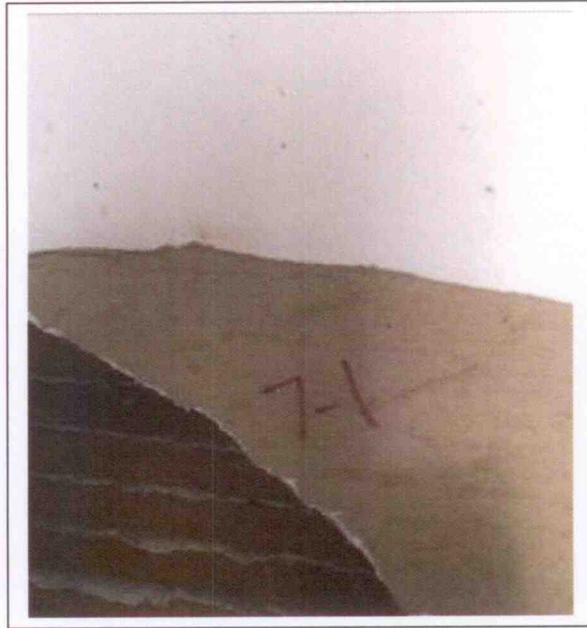
| SAMPLE DESCRIPTION (Material Type) | SAMPLE LOCATION | HOMO AREA # | SAMPLE I.D. NO. | ASBESTOS CONTENT | FRIABLE/ NONFRIABLE |
|--|---|---|---|---|---|
| Drywall, white (Miscellaneous) | Kitchen | 7 | 7-1 | None Detected | Nonfriable |

HA #7 – Drywall, white

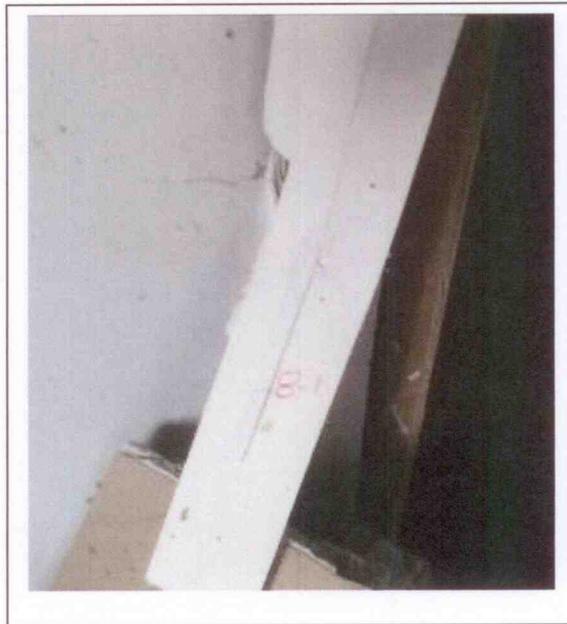
| SAMPLE DESCRIPTION (Material Type) | SAMPLE LOCATION | HOMO AREA # | SAMPLE I.D. NO. | ASBESTOS CONTENT | FRIABLE/ NONFRIABLE |
|--|---|---|---|---|---|
| Joint compound (Miscellaneous) | Kitchen | 8 | 8-1 | None Detected | Nonfriable |

HA #8 – Joint compound

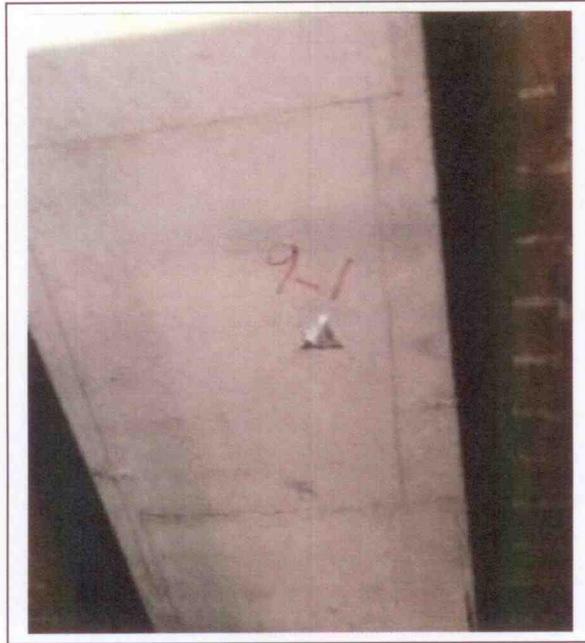
| SAMPLE DESCRIPTION (Material Type) | SAMPLE LOCATION | HOMO AREA # | SAMPLE I.D. NO. | ASBESTOS CONTENT | FRIABLE/ NONFRIABLE |
|--|---|---|---|---|---|
| Duct insulation (Thermal System Insulation) | Kitchen | 9 | 9-1 | 70% Chrysotile | Friable |

| Location | Type ACM | Material Description | Amt. of Material (approx.) |
|---|---|--|---|
| Basement | RACM | Duct insulation | 15 sf |
| Basement to the 2nd floor | RACM | Duct insulation (concealed behind hard wall and ceiling plaster) | 50 sf |

HA #9 – Duct insulation

| Location | Type ACM | Material Description | Cost for abatement (approx.) |
|---|---|---|---|
| Basement | RACM | Duct insulation | \$300.00 |
| Basement to the 2nd floor | RACM | Duct insulation (concealed behind hard wall and ceiling plaster) | \$1,250.00 |

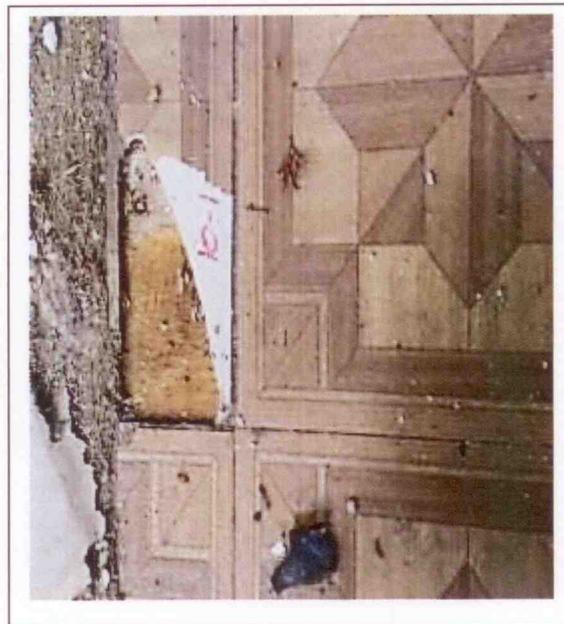
| SAMPLE DESCRIPTION (Material Type) | SAMPLE LOCATION | HOMO AREA # | SAMPLE I.D. NO. | ASBESTOS CONTENT | FRIABLE/ NONFRIABLE |
|--|---|---|---|---|---|
| 12"x12" Tan sticky back floor tile (Miscellaneous) | Kitchen | 10 | 10-1 | None Detected | Nonfriable |

HA #10 – 12"x12" Tan sticky back floor tile

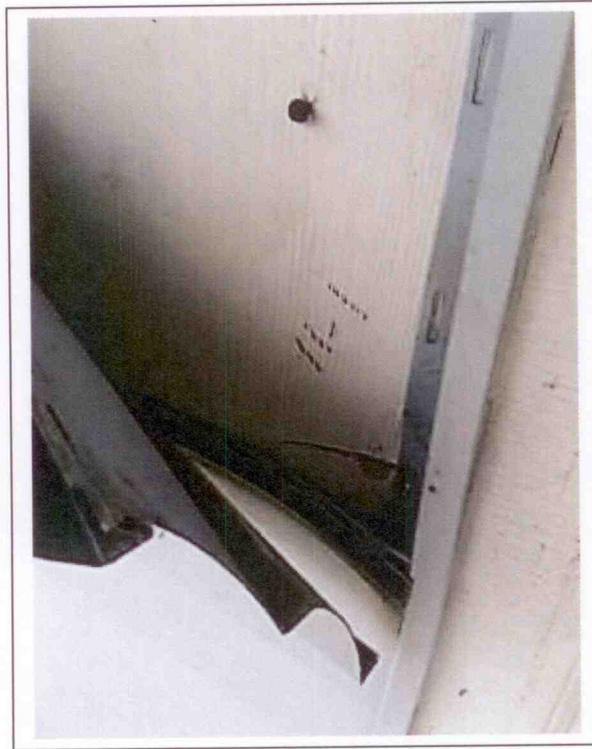
| SAMPLE DESCRIPTION (Material Type) | SAMPLE LOCATION | HOMO AREA # | SAMPLE I.D. NO. | ASBESTOS CONTENT | FRIABLE/ NONFRIABLE |
|--|---|---|---|---|---|
| Cementitious siding (Miscellaneous) | Exterior | 11 | 11-1 | 20% Chrysotile | Nonfriable |

| Location | Type ACM | Material Description | Amt. of Material (approx.) |
|---|---|--|---|
| Exterior residence | II | Cementitious siding (under vinyl siding) | 1,950 sf |

HA #11 – Cementitious siding under vinyl siding

| Location | Type ACM | Material Description | Cost for abatement (approx.) |
|---|---|---|---|
| Exterior residence | II | Cementitious siding (under vinyl siding) | \$5,850.00 |

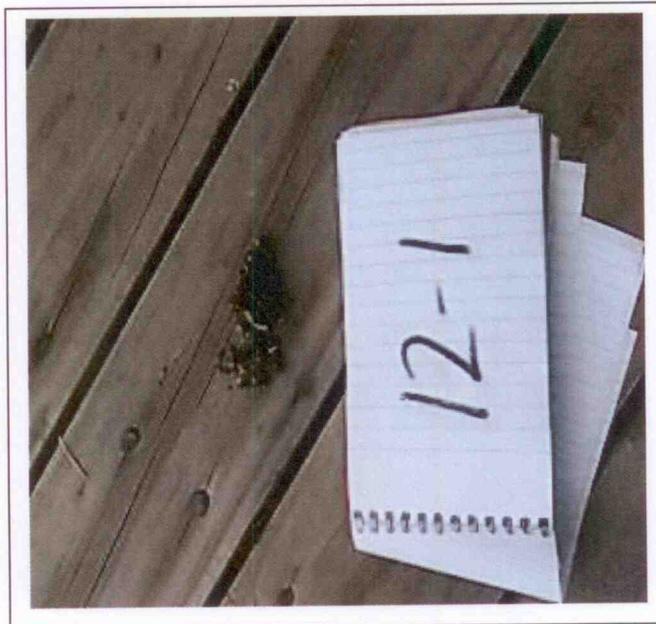
| SAMPLE DESCRIPTION (Material Type) | SAMPLE LOCATION | HOMO AREA # | SAMPLE I.D. NO. | ASBESTOS CONTENT | FRIABLE/ NONFRIABLE |
|--|---|---|---|---|---|
| Blown-in insulation (Miscellaneous) | Front right bedroom, 2nd floor | 12 | 12-1 | None Detected | Friable |

HA #12 – Blown-in insulation

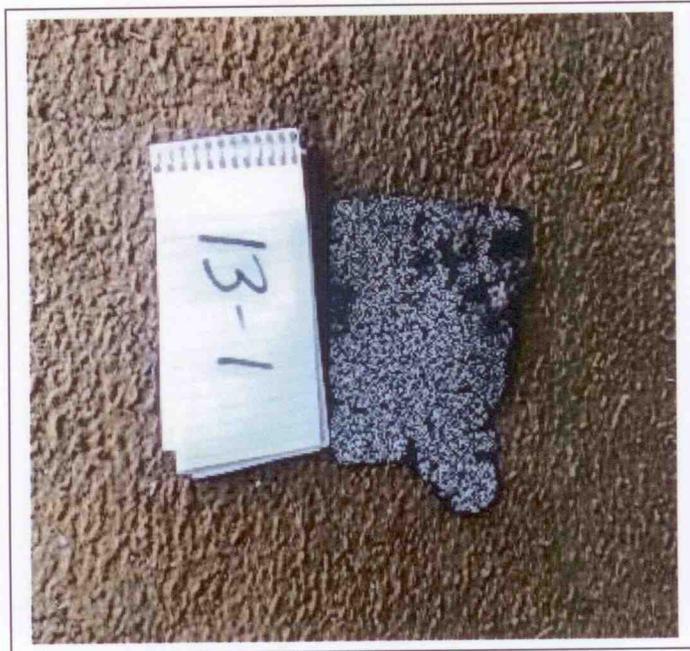
| SAMPLE DESCRIPTION (Material Type) | SAMPLE LOCATION | HOMO AREA # | SAMPLE I.D. NO. | ASBESTOS CONTENT | FRIABLE/ NONFRIABLE |
|---|---|---|---|---|---|
| Black and white asphalt roof shingle (Miscellaneous) | Exterior | 13 | 13-1 | None Detected | Nonfriable |

HA #13 – Black and white asphalt shingles
