SIERRA ENVIRONMENTAL GROUP, INC.

September 23, 2015

Re: Comprehensive Pre-Demolition Asbestos Inspection
Vacant Residence
132 Fernwood Avenue
Dayton, Ohio 45405
Sierra Project Number: MCLB.001

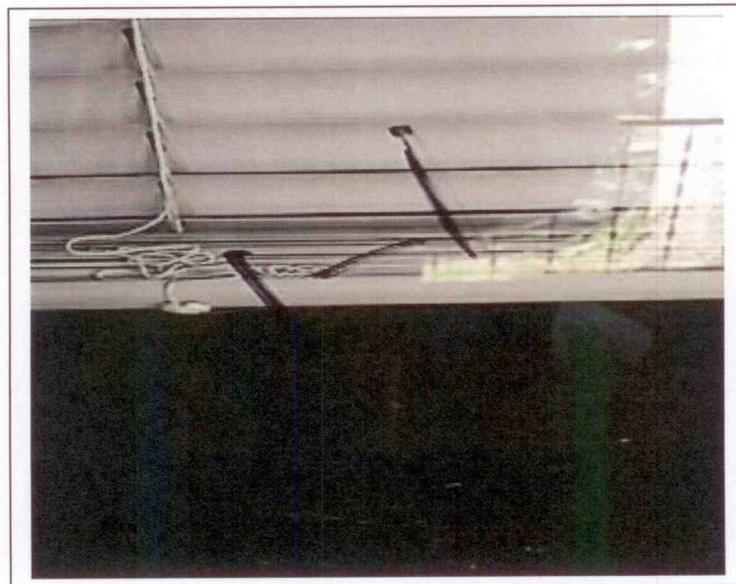
HA #1 - Window glaze

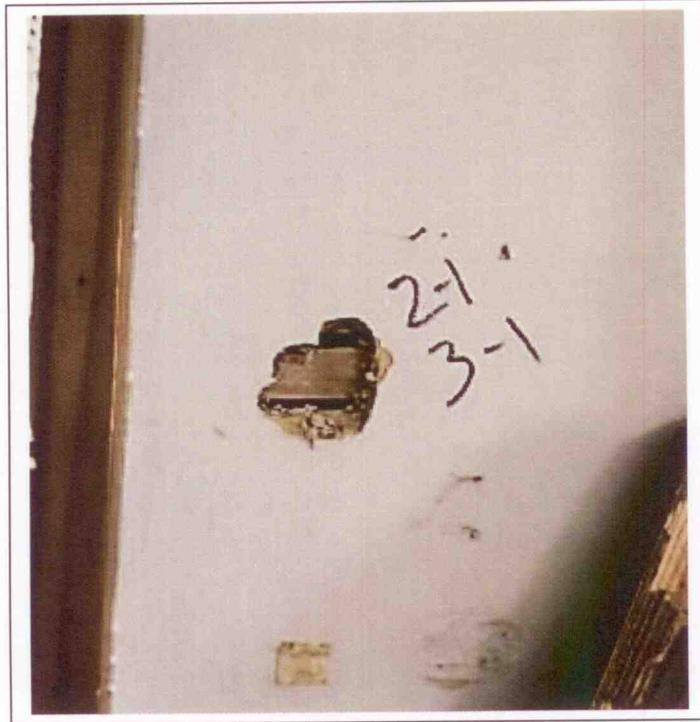
Skim coat of hard wall plaster (Surfacing, >5,000 sf)	Bedroom #1	2	2-7	None Detected	Nonfriable
Brown coat of hard wall plaster (Surfacing, >5,000 sf)	Living room	3	3-1	*0.3% Chrysotile	Nonfriable
Brown coat of hard ceiling plaster (Surfacing, >5,000 sf)	Living room	3	3-2	*0.5% Chrysotile	Nonfriable
Brown coat of hard wall plaster (Surfacing, >5,000 sf)	Dining room	3	3-3	*0.3% Chrysotile	Nonfriable
Brown coat of hard ceiling plaster (Surfacing, >5,000 sf)	Kitchen	3	3-4	*0.5% Chrysotile	Nonfriable
Brown coat of hard wall plaster (Surfacing, >5,000 sf)	Stairwell to 2nd floor	3	3-5	*0.3% Chrysotile	Nonfriable
Brown coat of hard ceiling plaster (Surfacing, >5,000 sf)	Stairwell to 2nd floor	3	3-6	*0.3% Chrysotile	Nonfriable
Brown coat of hard wall plaster (Surfacing, >5,000 sf)	Bedroom #1	3	3-7	*0.5% Chrysotile	Nonfriable
Textured ceiling (Surfacing, <5,000 sf)	Living room	4	4-1	None Detected	Nonfriable

HA #2 & #3 – Hard wall and ceiling plaster

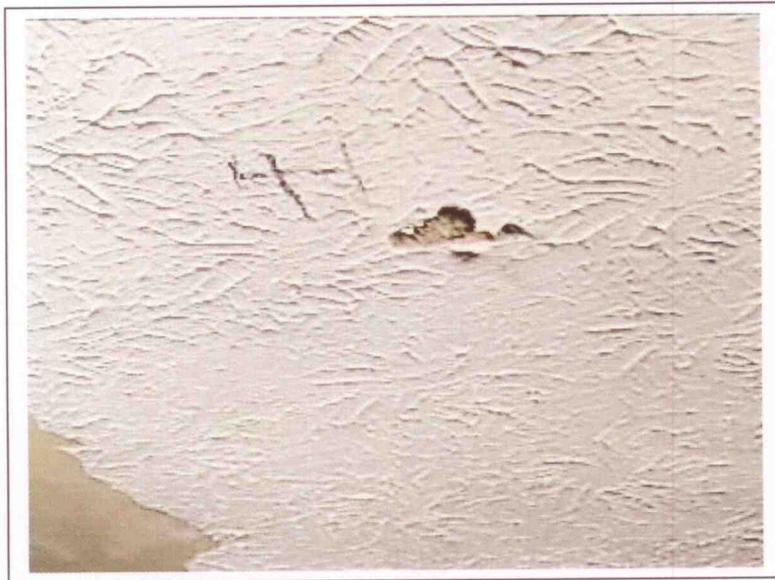
HA #4 – Textured ceiling

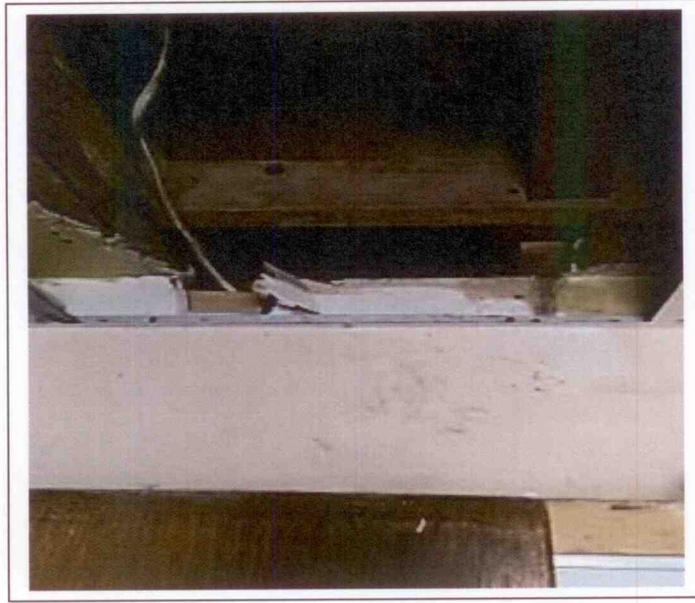
HA #5 & #9 – Drywall and associated joint compound

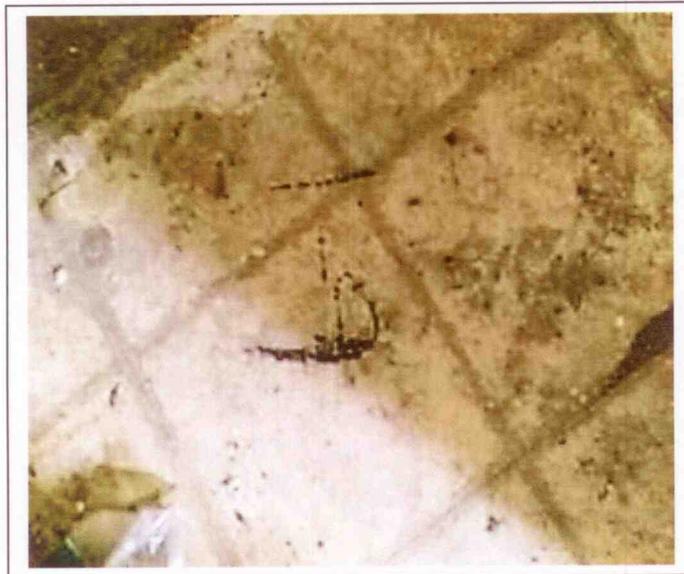
HA #6 – White sheet flooring

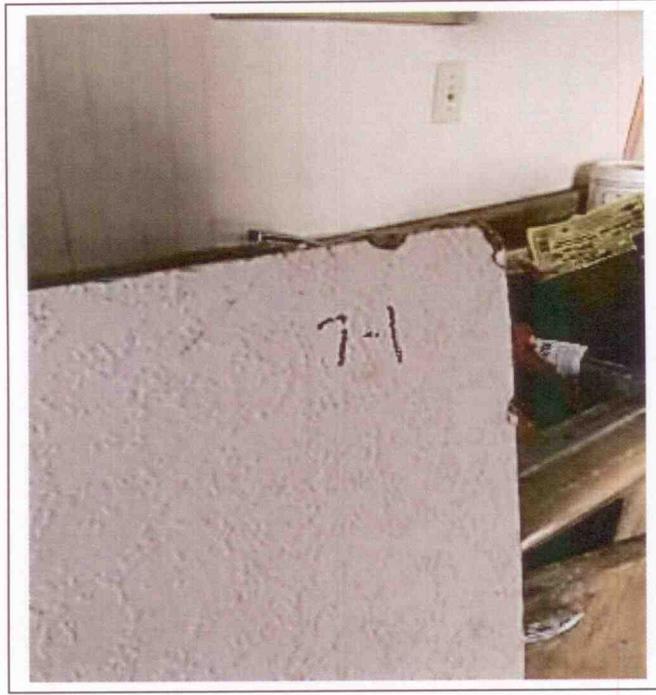
HA #7 – 2’x4’ Suspended ceiling tile, rough

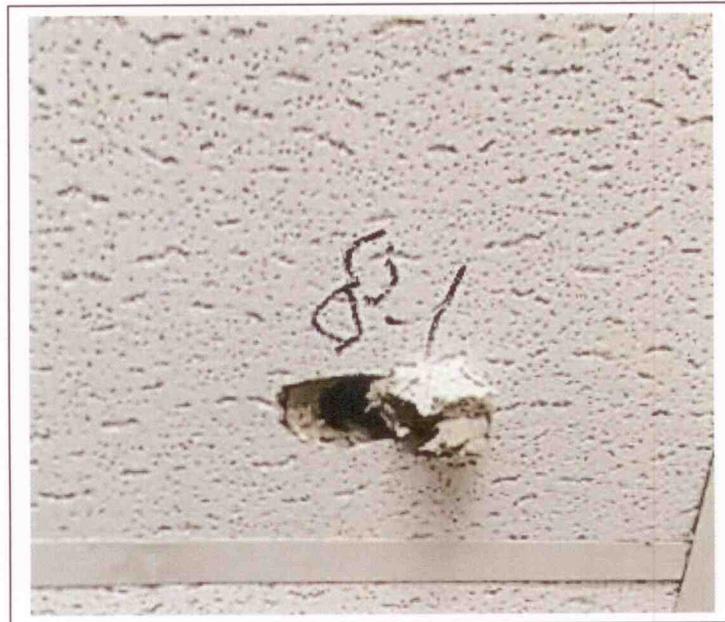
HA #8 - 2’x4’ Suspended ceiling tile with holes and fissures

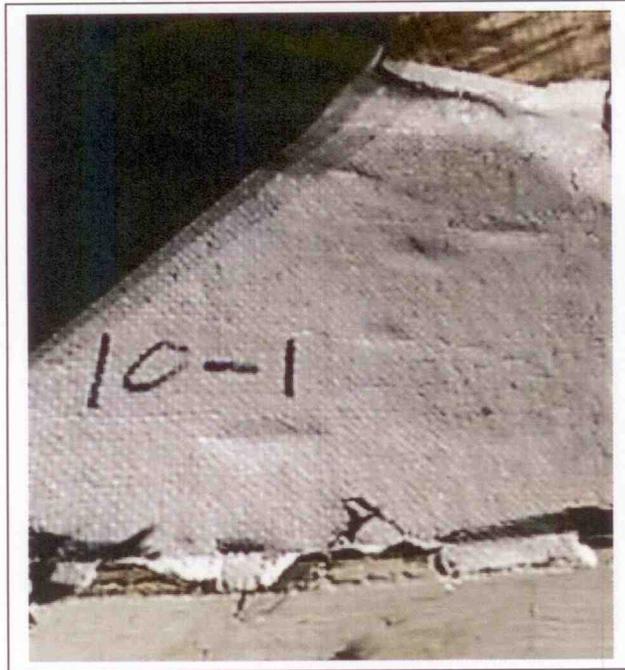
SAMPLE DESCRIPTION (Material Type)	SAMPLE LOCATION	HOMO AREA #	SAMPLE I.D. NO.	ASBESTOS CONTENT	FRIABLE/ NONFRIABLE
Duct insulation (Thermal System Insulation)	Basement	10	10-1	90% Chrysotile	Friable
12"x12" White sticky back floor tile (Miscellaneous)	Bathroom 2nd floor	11	11-1	None Detected	Nonfriable
12"x12" White sticky back floor tile (Miscellaneous)	Bathroom 2nd floor	11	11-2	None Detected	Nonfriable
Linoleum under 12" sticky back floor tile (Miscellaneous)	Bathroom 2nd floor	12	12-1	None Detected	Nonfriable
Linoleum under 12" sticky back floor tile (Miscellaneous)	Bathroom 2nd floor	12	12-2	None Detected	Nonfriable
Black and white asphalt roof shingle (Miscellaneous)	Exterior	13	13-1	None Detected	Nonfriable
Black and white asphalt roof shingle (Miscellaneous)	Exterior	13	13-2	None Detected	Nonfriable

Location	Type ACM	Material Description	Amt. of Material (approx.)
The following asbestos-containing materials are located in the vacant residence located at 132 Fernwood Avenue, Dayton.			
Basement	RACM	Duct insulation	25 sf
Basement	RACM	Duct insulation debris	20 sf
Basement to 2nd floor	RACM	Duct insulation (concealed behind hard wall and ceiling plaster)	75 sf

HA #10 – Duct insulation

Location	Type ACM	Material Description	Cost for abatement (approx.)
The following asbestos-containing materials are located in the vacant residence located at 132 Fernwood Avenue, Dayton, Ohio.			
Basement	RACM	Duct insulation	\$500.00
Basement	RACM	Duct insulation debris	\$450.00
Basement to 2nd floor	RACM	Duct insulation (concealed behind hard wall and ceiling plaster)	\$1,875.00

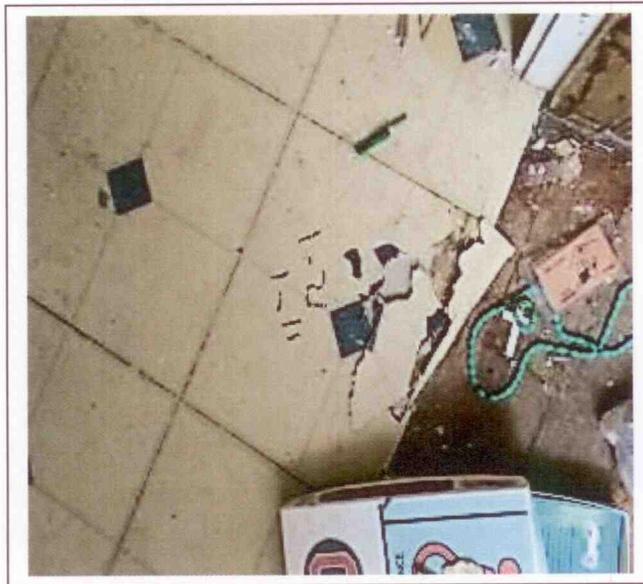
HA #11 & #12 – 12” White sticky back floor tile and linoleum

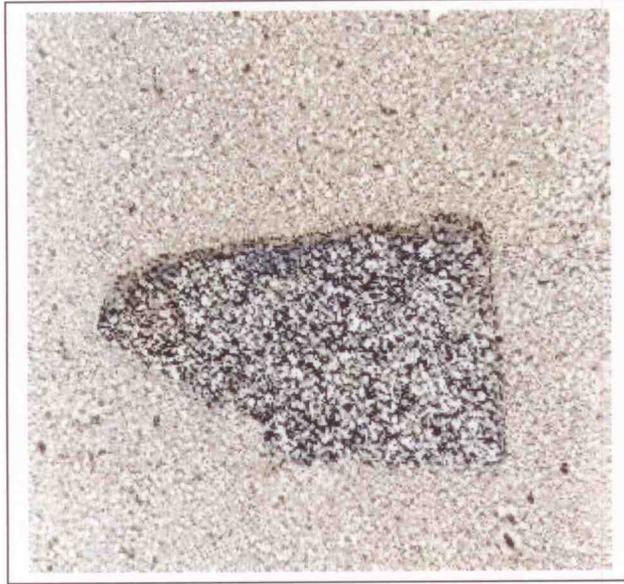
HA #13 – Black and white asphalt roof shingle
