SIERRA ENVIRONMENTAL GROUP, INC.

September 22, 2015

Re: Comprehensive Pre-Demolition Asbestos Inspection
Vacant Residence
140 Fernwood Avenue
Dayton, Ohio 45405
Sierra Project Number: MCLB.001

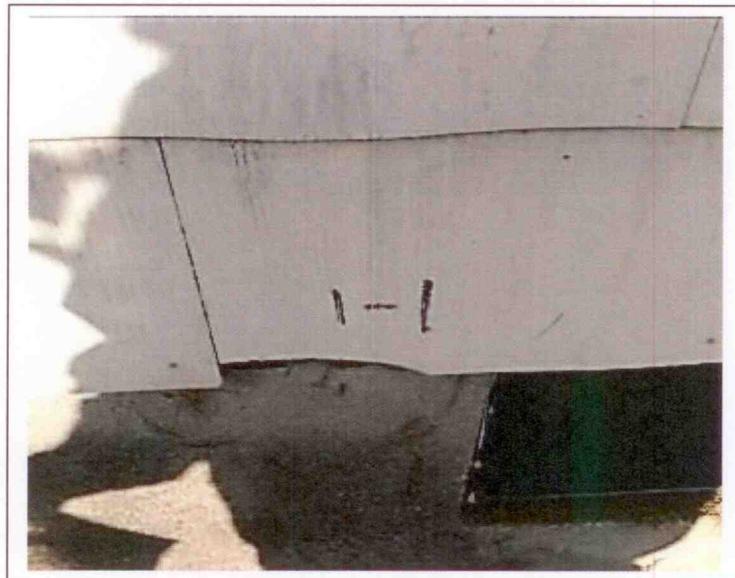
HA #1 – Cementitious siding

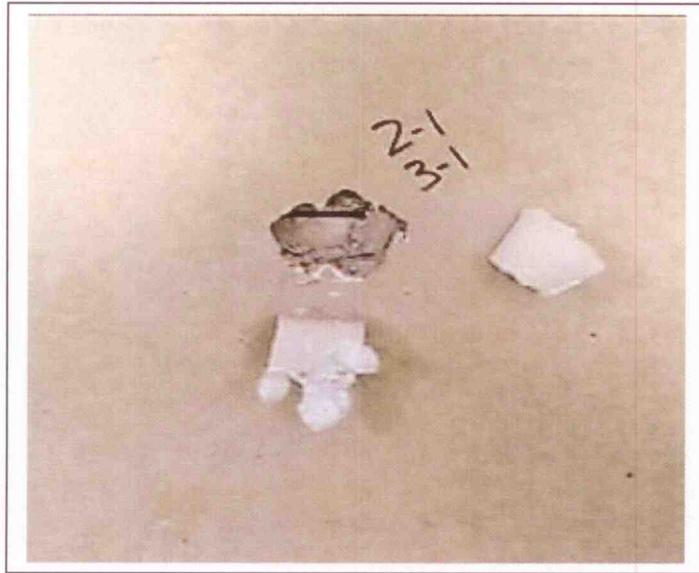
HA #2 & #3 – Hard wall and ceiling plaster

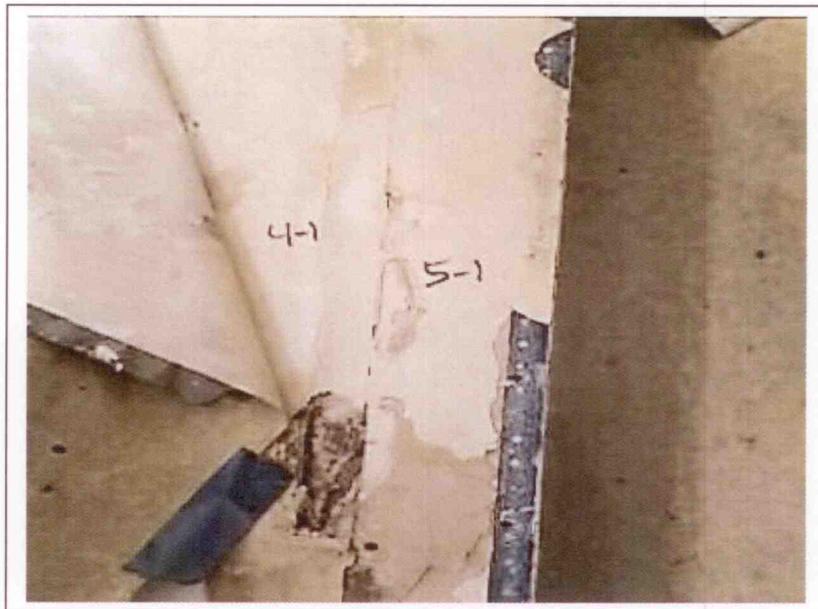
HA #4 & #5 – Drywall and associated joint compound

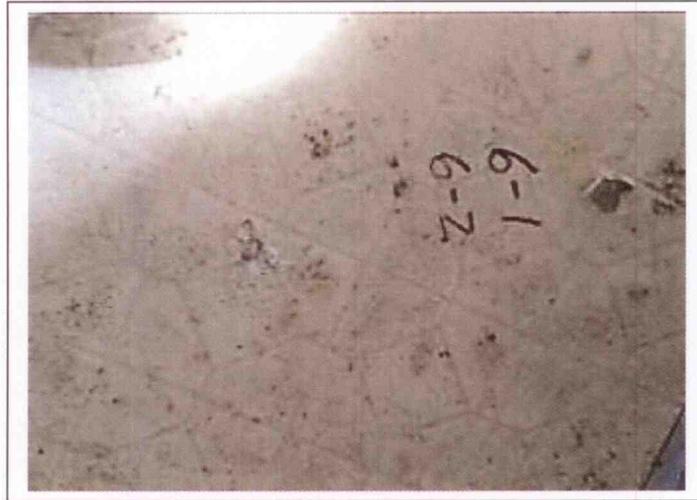
HA #6 – White sheet flooring

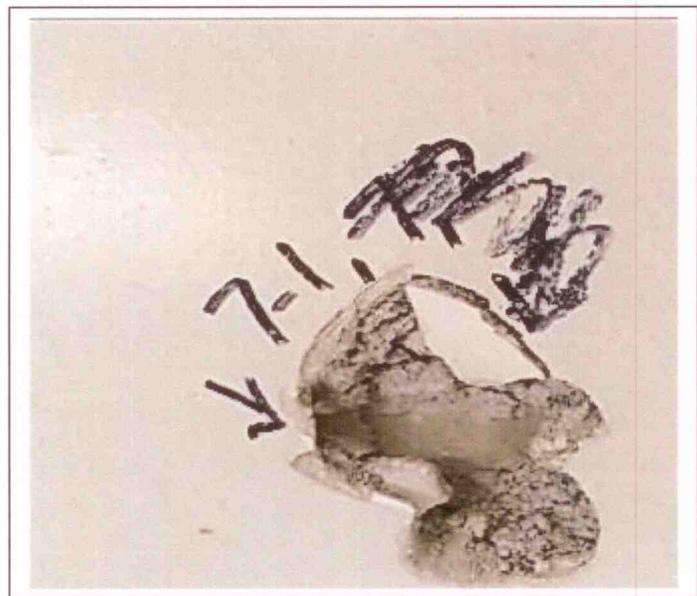
HA #7 – Drywall behind hard wall plaster

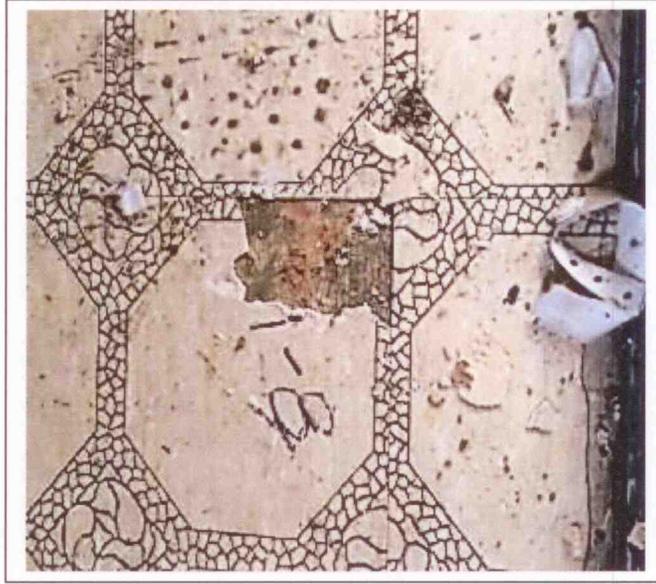
HA #8 & #12 – 12” Tan floor tile associated with yellow mastic

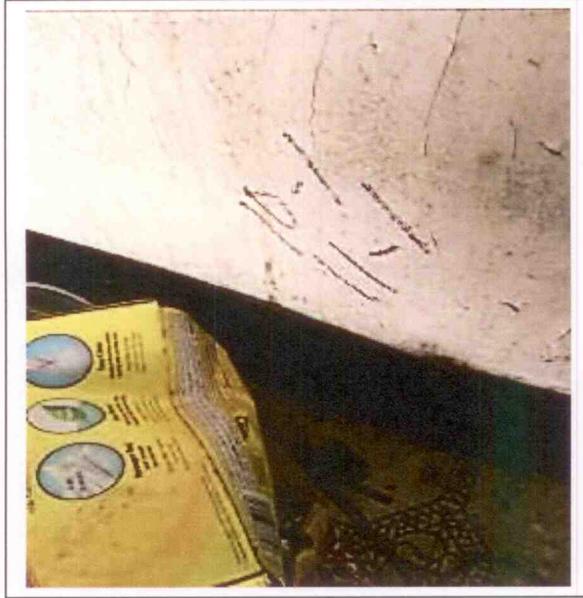
HA #10 & #11 – Black baseboard and associated yellow mastic

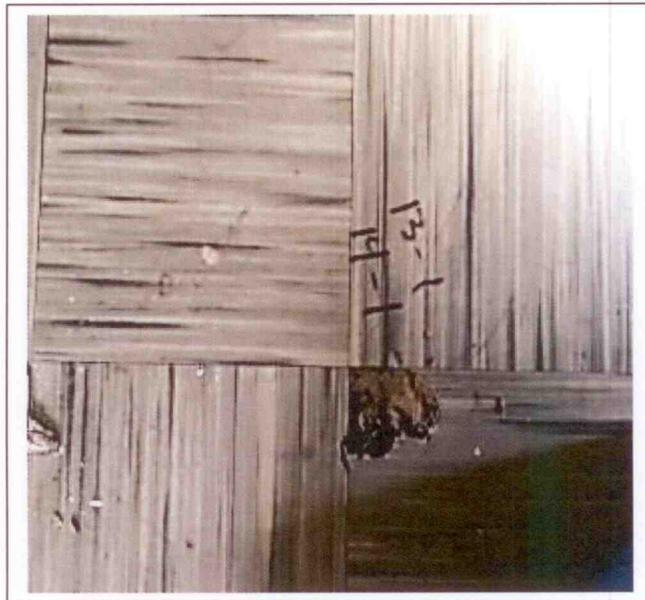
HA #13 – Grey flooring and associated black mastic

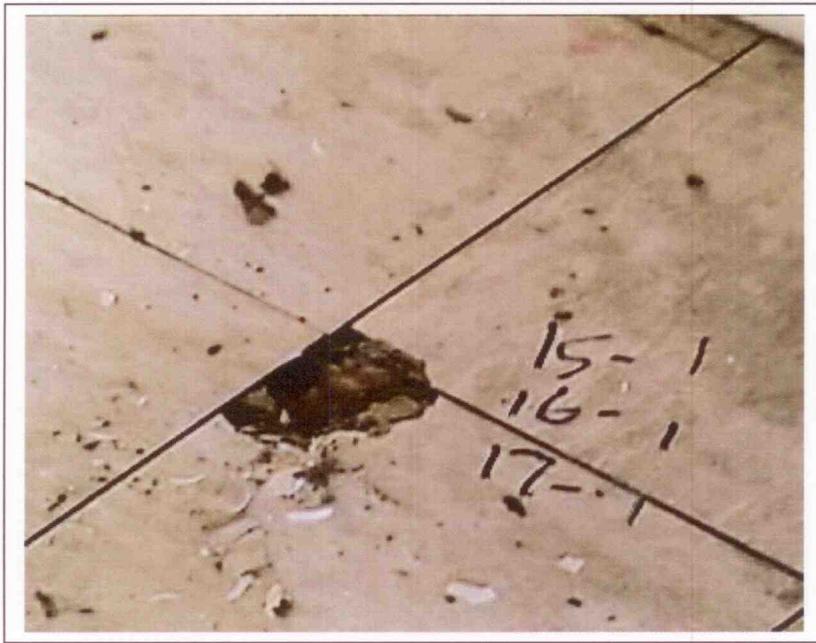
HA #15, #16 & #17 – 9” Tan floor tile, mastic and paper material

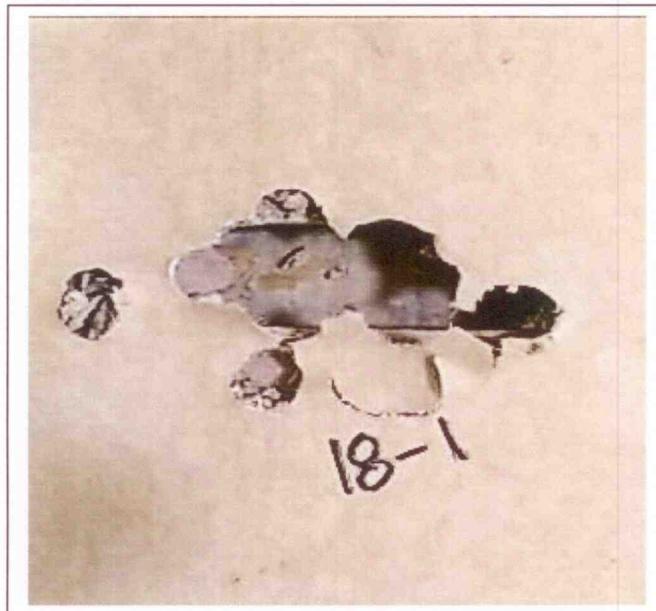
HA #18 – Duct insulation concealed behind hard wall plaster

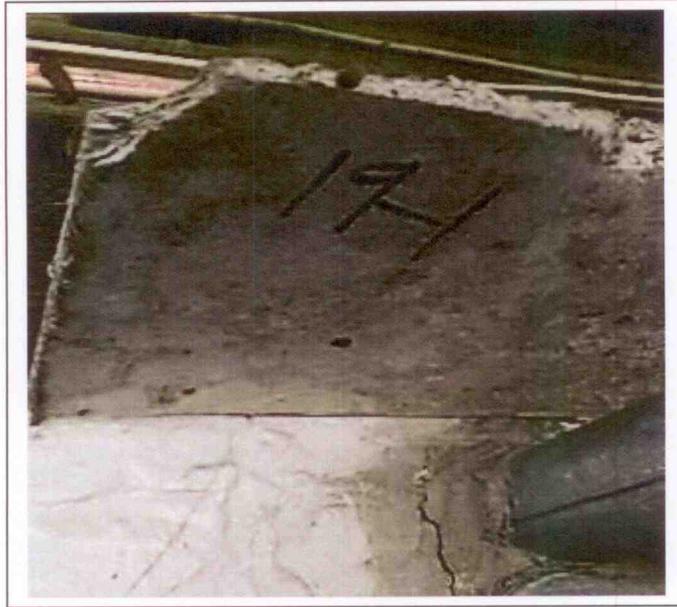
HA #19 – Heat shield

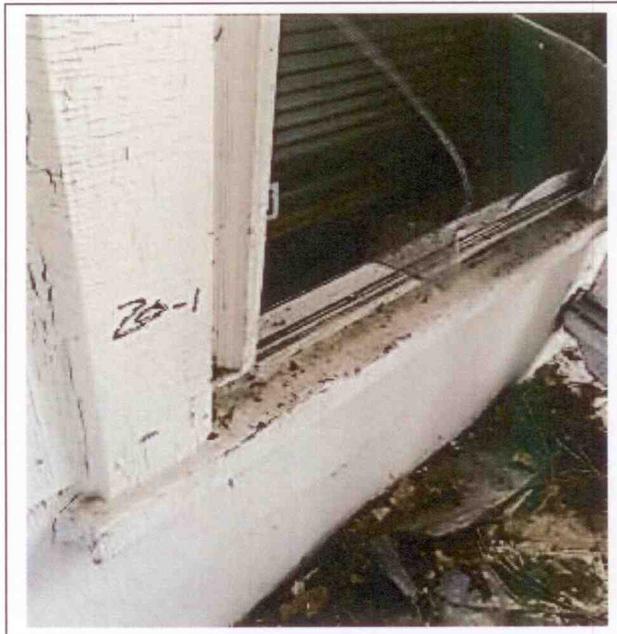
HA #20 – Window glaze
