SIERRA ENVIRONMENTAL GROUP, INC.

September 22, 2015

Re: Comprehensive Pre-Demolition Asbestos Inspection
Vacant Residence
201 Fernwood Avenue
Dayton, Ohio 45405
Sierra Project Number: MCLB.001

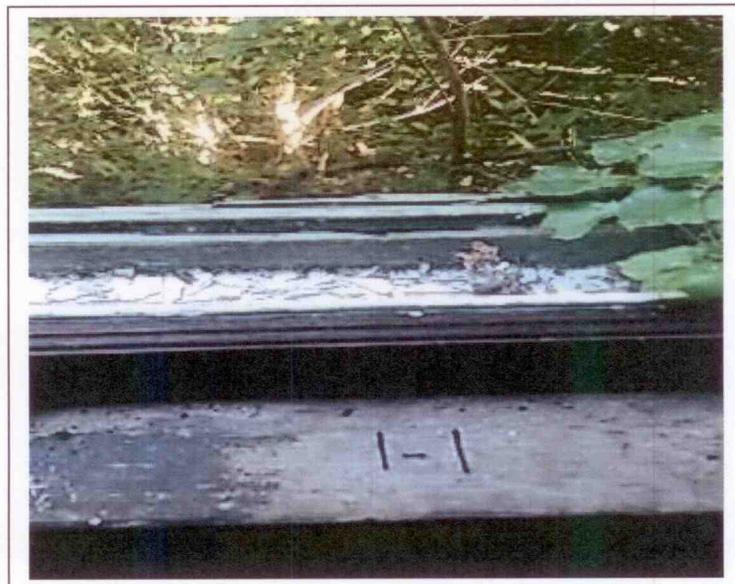
HA #1 – Window glaze

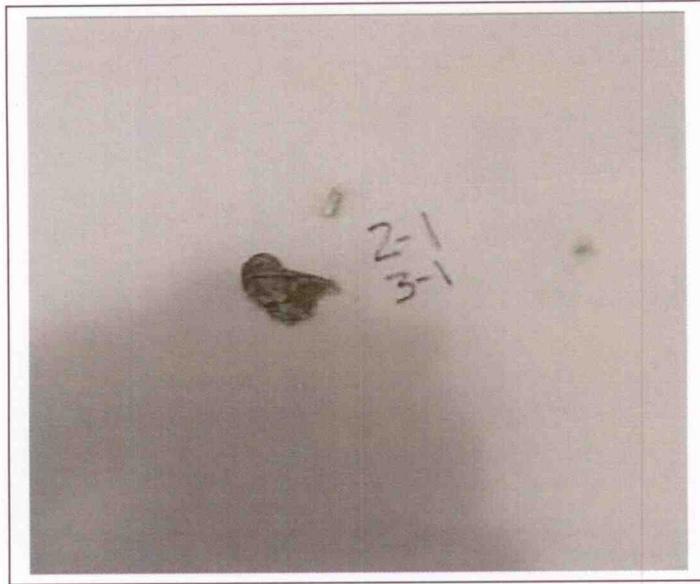
Skim coat of hard wall plaster (Surfacing, >5,000 sf)	Bedroom #2	2	2-7	None Detected	Nonfriable
Brown coat of hard wall plaster (Surfacing, >5,000 sf)	Living room	3	3-1	*2.1% Chrysotile	Nonfriable
Brown coat of hard ceiling plaster (Surfacing, >5,000 sf)	Living room	3	3-2	Stopped Analysis	Nonfriable
Brown coat of hard wall plaster (Surfacing, >5,000 sf)	Dining room	3	3-3	Stopped Analysis	Nonfriable
Brown coat of hard ceiling plaster (Surfacing, >5,000 sf)	Dining room	3	3-4	Stopped Analysis	Nonfriable
Brown coat of hard wall plaster (Surfacing, >5,000 sf)	Bathroom 2nd floor	3	3-5	Stopped Analysis	Nonfriable
Brown coat of hard ceiling plaster (Surfacing, >5,000 sf)	Bathroom 2nd floor	3	3-6	Stopped Analysis	Nonfriable
Brown coat of hard wall plaster (Surfacing, >5,000 sf)	Bedroom #2	3	3-7	Stopped Analysis	Nonfriable
Drywall (Miscellaneous)	Living room	4	4-1	None Detected	Nonfriable

Entire residence	RACM	Hard wall and ceiling plaster	4,575 sf
Basement	RACM	Duct insulation	45 sf
Basement stairwell	RACM	Duct insulation	10 sf
Basement to 2nd floor	RACM	Duct insulation (concealed behind hard wall and ceiling plaster)	75 sf

HA #2 & #3 – Hard wall and ceiling plaster

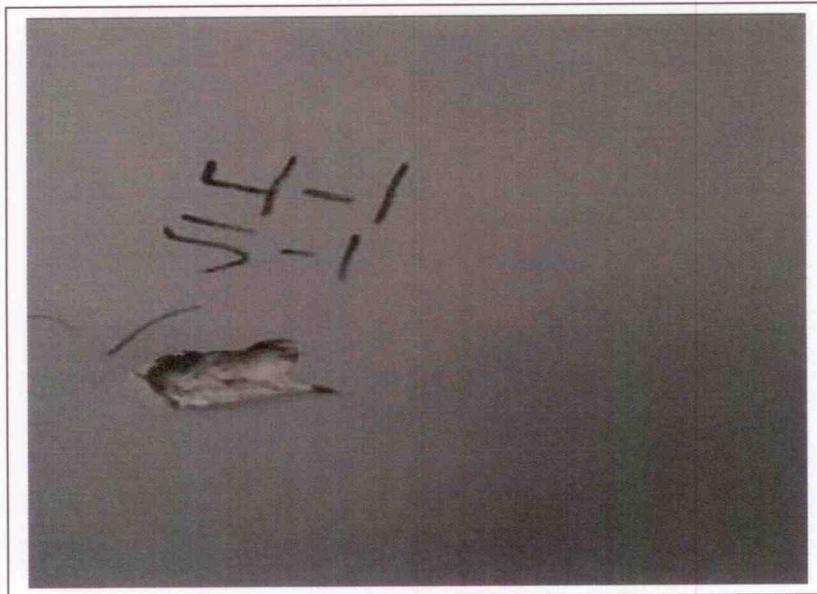
HA #4 – Drywall and associated joint compound

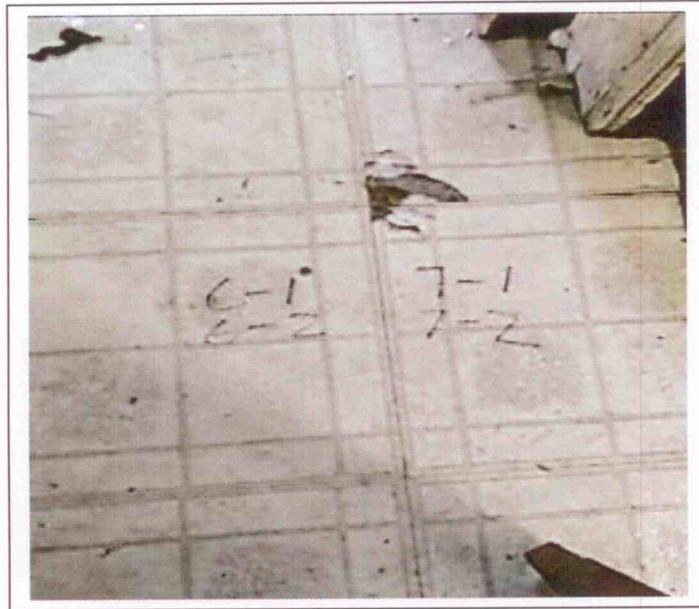
HA #6 & #7 – 12” White sticky back floor tile and grey paper

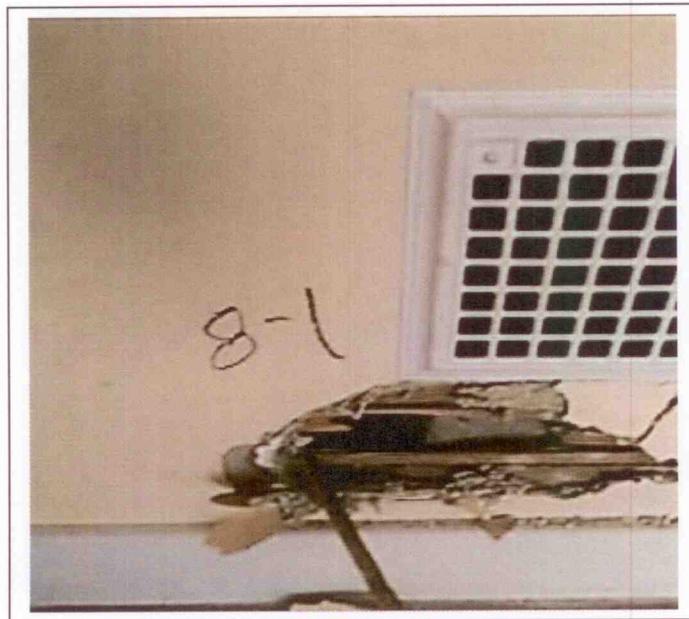
HA #8 – Duct insulation concealed behind hard wall plaster

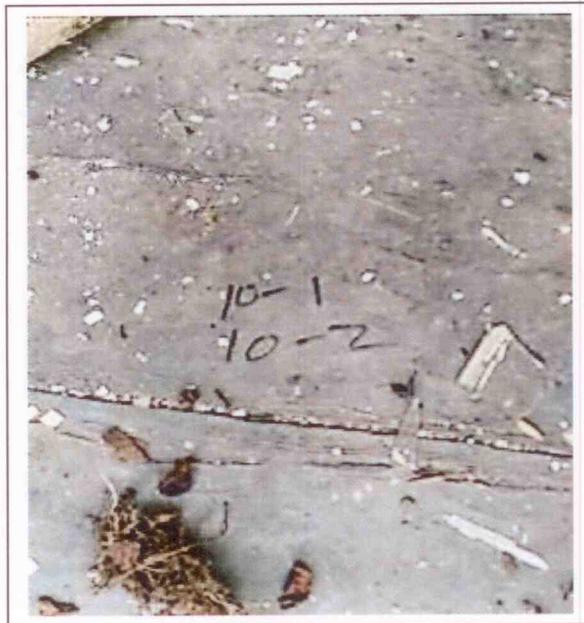
HA #10 – Grey linoleum
