ASBESTOS INSPECTION REPORT

**413-415 Hopeland St.
Dayton, OH 45417**

Re: Asbestos Inspection
413-415 Hopeland St.
Dayton, OH 45417

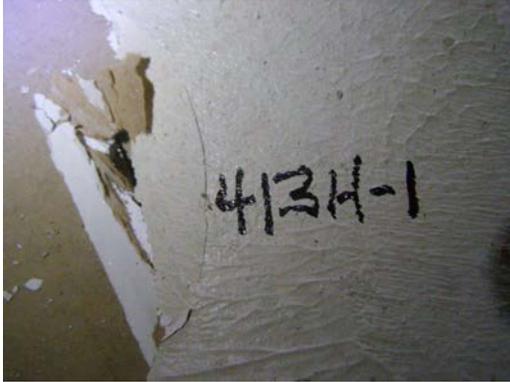
| HER Sample # Lab Sample # | Amount | Layers | Description/Sample Location | Condition | PLM Result (% Asbestos) |
|--|---|---|--|---|--|
| 413H-1 15-09-03069-001 | - | 3 | Drywall/J.C./Txt Paint, Living Room, Ceiling, Inhomogeneous | Non-friable | None Detected |

Photo 1: Drywall/J.C./Txt Paint (413H-1) Living Room, Ceiling. No Asbestos Detected.

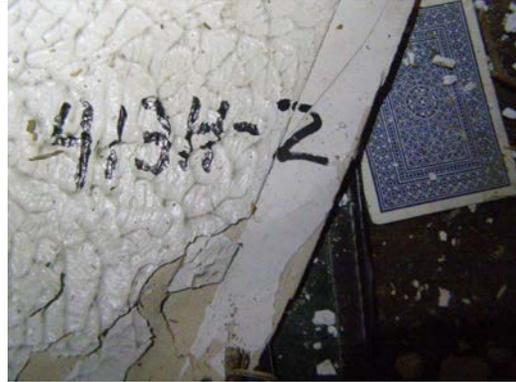
| HER Sample # Lab Sample # | Amount | Layers | Description/Sample Location | Condition | PLM Result (% Asbestos) |
|--|---|---|--|---|--|
| 413H-2 15-09-03069-002 | - | 2 | Drywall/J.C./Txt Paint, Family Room, Ceiling, Inhomogeneous | Non-friable | None Detected |

Photo 2: Drywall/J.C./Txt Paint (413H-2) Family Room, Ceiling. No Asbestos Detected.

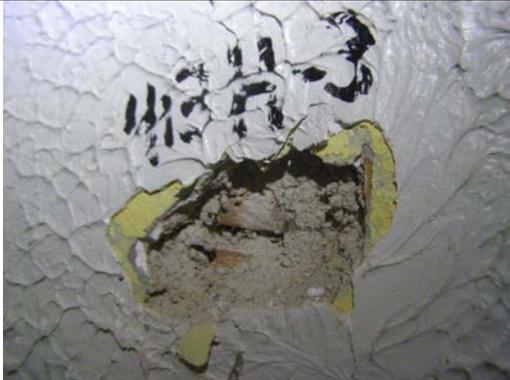
| HER Sample # Lab Sample # | Amount | Layers | Description/Sample Location | Condition | PLM Result (% Asbestos) |
|--|---|---|--|---|--|
| 413H-3 15-09-03069-003 15-09-03108-004 | - | 2 | Plaster/Txt Paint, Family Room Closet, Wall D, Inhomogeneous | Non-friable | Trace <1% Chrysotile Asbestos Present (PC=0.50%) |

Photo 3: Plaster/Txt Paint (413H-3) Family Room Closet, Wall D. Trace <1% Chrysotile Asbestos Detected (PC=0.50%).

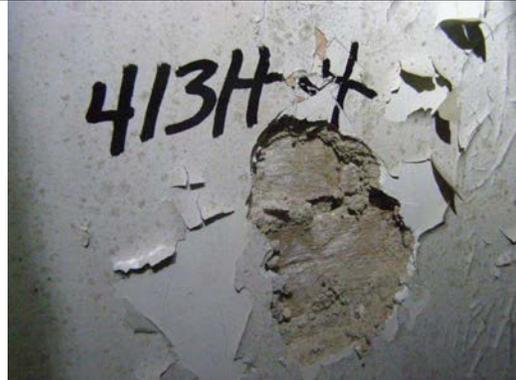
| HER Sample # Lab Sample # | Amount | Layers | Description/Sample Location | Condition | PLM Result (% Asbestos) |
|--|---|---|--|---|--|
| 413H-4 15-09-03069-004 15-09-03108-005 | - | 1 | Plaster, Basement Steps, Wall C, Inhomogeneous | Non-friable | Trace <1% Chrysotile Asbestos Present (PC=0.25%) |

Photo 4: Plaster (413H-4) Basement Steps, Wall C. Trace <1% Chrysotile Asbestos Detected (PC=0.25%).

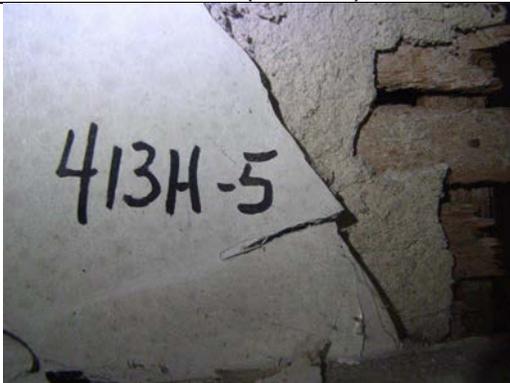
| HER Sample # Lab Sample # | Amount | Layers | Description/Sample Location | Condition | PLM Result (% Asbestos) |
|--|---|---|--|---|--|
| 413H-5 15-09-03069-005 15-09-03108-006 | - | 1 | Plaster, Kitchen, Wall B, Inhomogeneous | Non-friable | Trace <1% Chrysotile Asbestos Present (PC=0.25%) |

Photo 5: Plaster (413H-5) Kitchen, Wall B. Trace <1% Chrysotile Asbestos Detected (PC=0.25%).

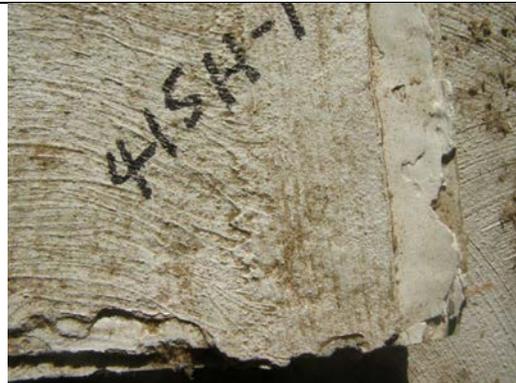
| HER Sample # Lab Sample # | Amount | Layers | Description/Sample Location | Condition | PLM Result (% Asbestos) |
|--|---|---|--|---|--|
| 415H-1 15-09-03069-007 | - | 3 | Drywall/J.C./Txt Paint, Bedroom 1, Ceiling, Inhomogeneous | Non-friable | None Detected |

Photo 6: Drywall/J.C./Txt Paint (415H-1) Bedroom 1, Ceiling. No Asbestos Detected

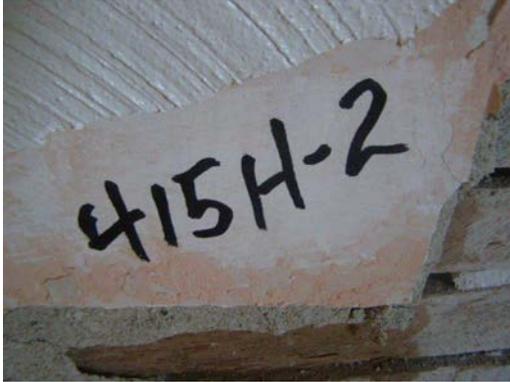
| HER Sample # Lab Sample # | Amount | Layers | Description/Sample Location | Condition | PLM Result (% Asbestos) |
|--|---|---|--|---|--|
| 415H-2 15-09-03069-008 15-09-03108-001 | - | 2 | Plaster, Living Room, Wall C, Inhomogeneous | Non-friable | Trace <1% Chrysotile Asbestos Present (PC=0.25%) |

Photo 7: Plaster (415H-2) Living Room, Ceiling.
No Asbestos Detected.

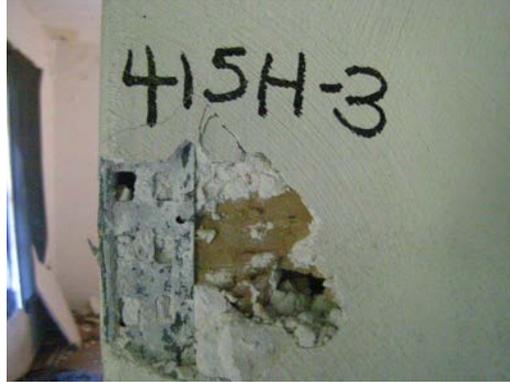
| HER Sample # Lab Sample # | Amount | Layers | Description/Sample Location | Condition | PLM Result (% Asbestos) |
|--|---|---|--|---|--|
| 415H-3 15-09-03069-009 | - | 2 | Drywall/J.C./Txt Paint, Kitchen, Wall A, Inhomogeneous | Non-friable | None Detected |

Photo 8: Drywall/J.C./Txt Paint (415H-3) Kitchen, Wall A.
No Asbestos Detected.

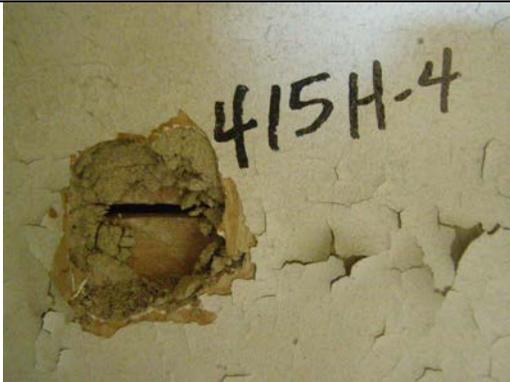
| HER Sample # Lab Sample # | Amount | Layers | Description/Sample Location | Condition | PLM Result (% Asbestos) |
|--|---|---|--|---|--|
| 415H-4 15-09-03069-010 15-09-03108-002 | - | 1 | Plaster, Bedroom 1 Closet, Wall C, Inhomogeneous | Non-friable | Trace <1% Chrysotile Asbestos Present (PC=0.25%) |

Photo 9: Plaster (415H-4) Bedroom 1 Closet, Wall C.
Trace <1% Chrysotile Asbestos Detected (PC=<0.25%).

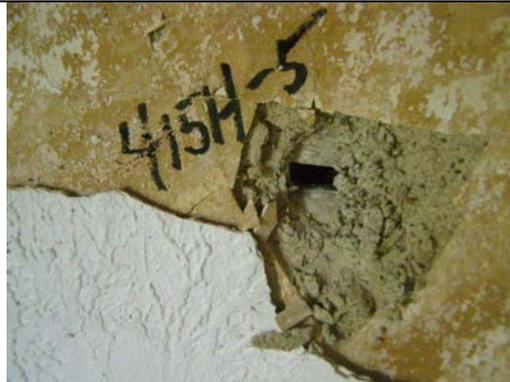
| HER Sample # Lab Sample # | Amount | Layers | Description/Sample Location | Condition | PLM Result (% Asbestos) |
|--|---|---|--|---|--|
| 415H-5 15-09-03069-011 15-09-03108-003 | - | 2 | Plaster/Txt Paint, Living Room 2, Wall C, Inhomogeneous | Non-friable | Trace <1% Chrysotile Asbestos Present (PC=0.25%) |

Photo 10: Drywall/J.C./Txt Paint (415H-5) Living Room 2,
Wall C. Trace <1% Chrysotile Asbestos Detected
(PC=0.25%).

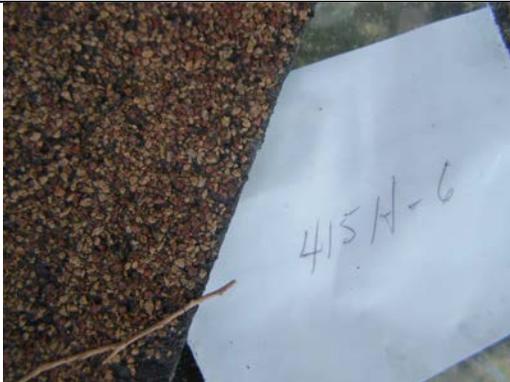
| HER Sample # Lab Sample # | Amount | Layers | Description/Sample Location | Condition | PLM Result (% Asbestos) |
|--|---|---|--|---|--|
| 415H-6 15-09-03069-012 | - | 2 | Roof Shingle, Exterior, Inhomogeneous | Non-friable | None Detected |

Photo 11: Roof Shingle (415H-6) Exterior.
No Asbestos Detected.

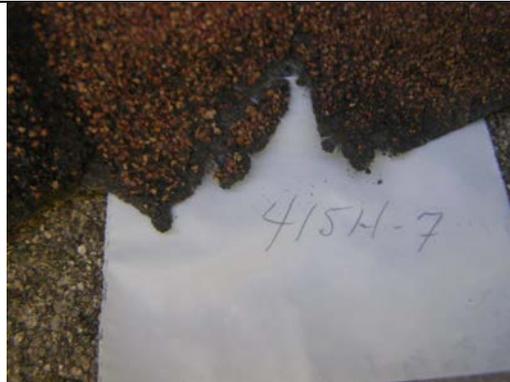
| HER Sample # Lab Sample # | Amount | Layers | Description/Sample Location | Condition | PLM Result (% Asbestos) |
|--|---|---|--|---|--|
| 415H-7 15-09-03069-013 | - | 2 | Roof Shingle, Exterior, Inhomogeneous | Non-friable | None Detected |

Photo 12: Roof Shingle (415H-7) Exterior.
No Asbestos Detected.

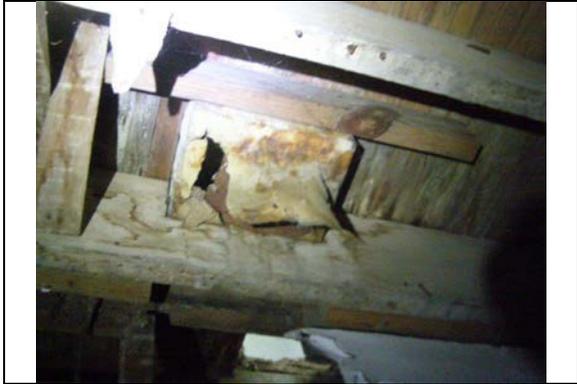
Photo 13: House Interior Ceiling.
