ASBESTOS INSPECTION REPORT

**1426 Kipling Dr.
Dayton, OH 45406**

**Lynda M. Hart
Asbestos Hazards Evaluation Specialist
Ohio #ES-32558
September 24, 2015**

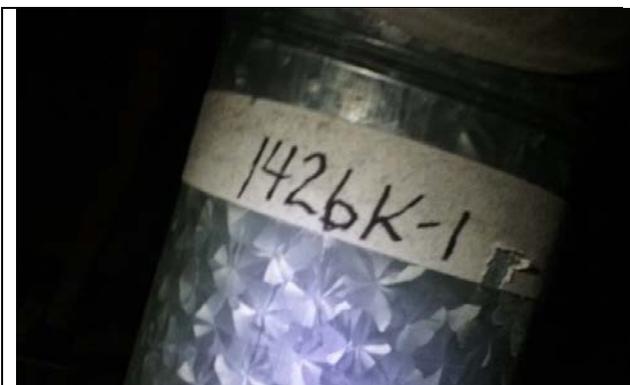
- Seam Tape, Basement

Photo 1: Seam Tape (1426K-1) Basement, Ceiling.
65% Chrysotile Asbestos Detected.

Confirmed or assumed asbestos-containing materials, which will be disturbed during demolition activities, are regulated under current Federal and State regulations. Hart Environmental Resources recommends the removal of these materials by a licensed asbestos abatement contractor. It is also strongly recommended that the specifications for the removal program be developed by a licensed Asbestos Project Designer to ensure that all regulatory requirements are satisfied. The work should be properly documented in the event of future litigation.

| <u>Material</u> | <u>Est. Qty.</u> | <u>Est. Unit Cost</u> | <u>Est. Cost</u> |
|---|---|---|---|
| Seam Tape | 11 sq ft. | \$ 20/sq ft. | \$ 220 |

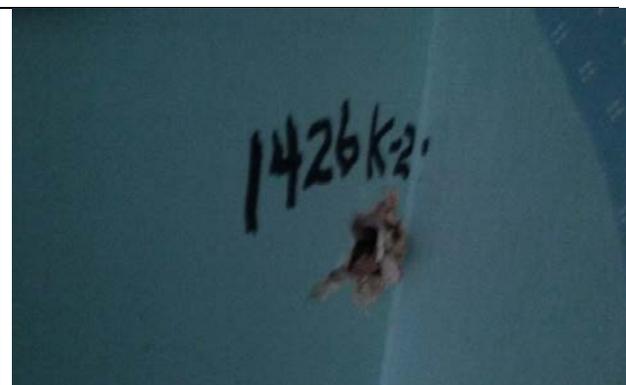
Photo 2: Drywall/J.C. (1426K-2) Dining Room, Wall A.
Trace <1% Chrysotile Asbestos Detected (PC=0.75%).

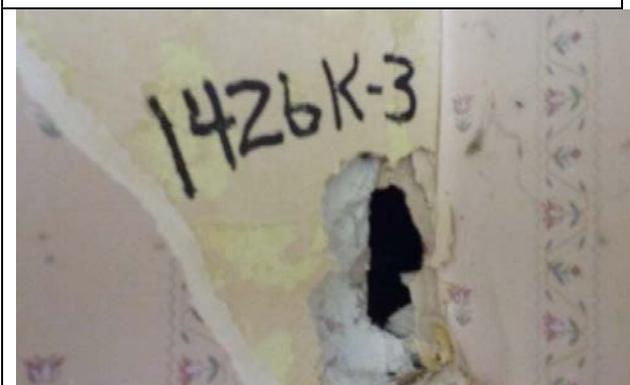
Photo 3: Drywall/J.C. (1426K-3) Living Room, Wall A.
Trace <1% Chrysotile Asbestos Detected (PC=0.50%).

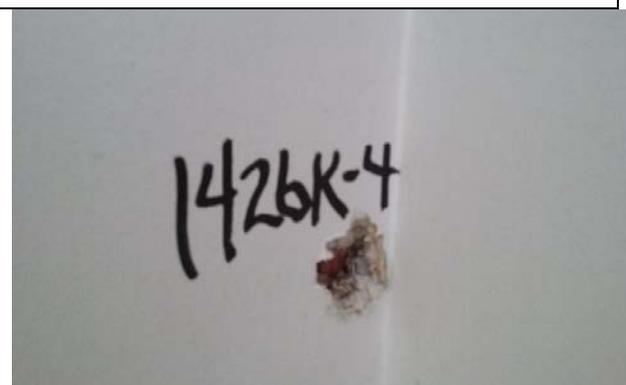
Photo 4: Drywall/J.C. (1426K-4) Bedroom 2, Wall C.
Trace <1% Chrysotile Asbestos Detected (PC=0.75%).

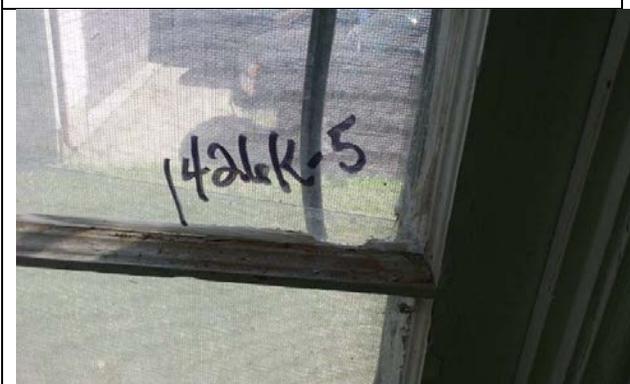
Photo 5: Window Glazing (1426K-5) Bedroom 2, Wall D.
No Asbestos Detected

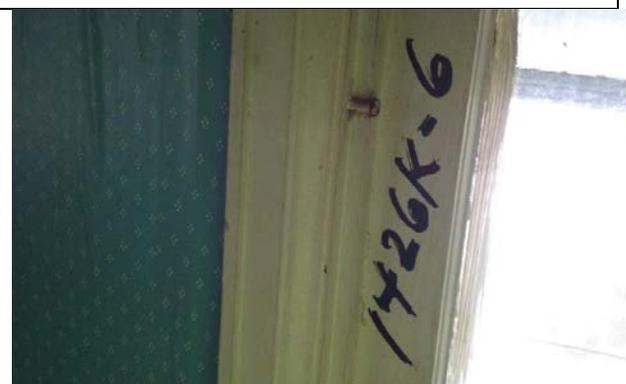
Photo 6: Window Glazing (1426K-6) Dining Room, Wall B.
No Asbestos Detected

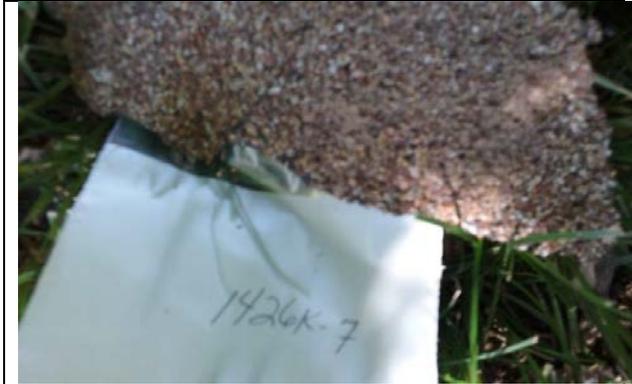
**Photo 7: Roof Shingle (1426K-7) Exterior.
No Asbestos Detected.**

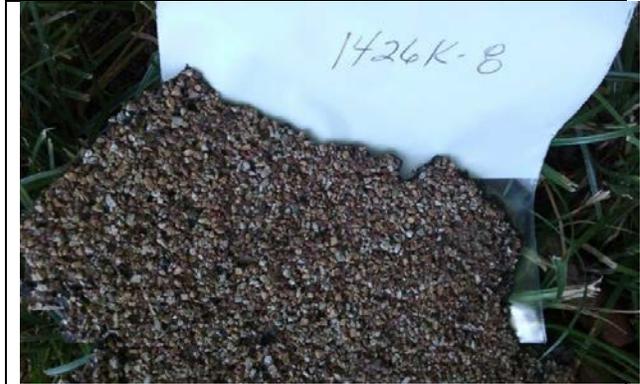
**Photo 8: Roof Shingle (1426K-8) Exterior.
No Asbestos Detected.**
