ASBESTOS INSPECTION REPORT

**2061 Kipling Dr.
Dayton, OH 45406**

Re: Asbestos Inspection
2061 Kipling Dr.
Dayton, OH 45406

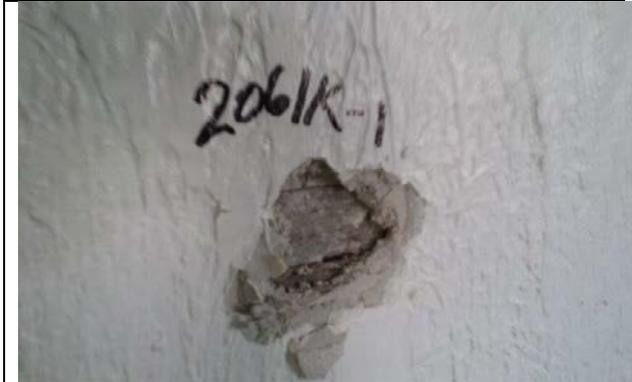
Photo 1: Plaster/Txt Paint (2061K-1) Living Room, Wall C.
<1% Chrysotile Asbestos Detected (PC=<0.25%).

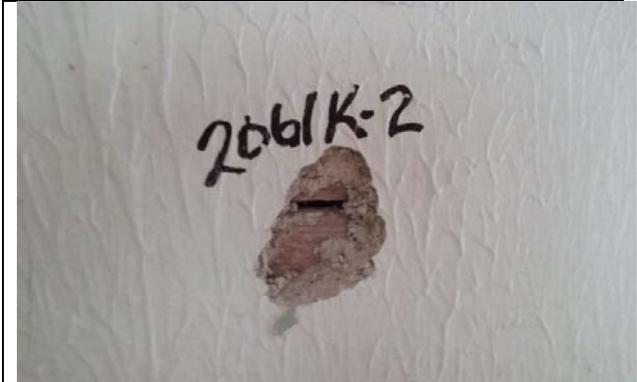
Photo 2: Plaster/Txt Paint (2061K-2) Kitchen, Wall A.
<1% Chrysotile Asbestos Detected (PC=<0.25%).

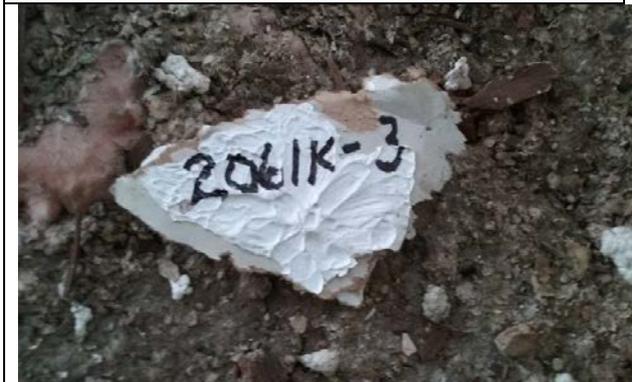
Photo 3: Drywall/Txt Paint (2061K-3) Hall, Ceiling.
No Asbestos Detected.

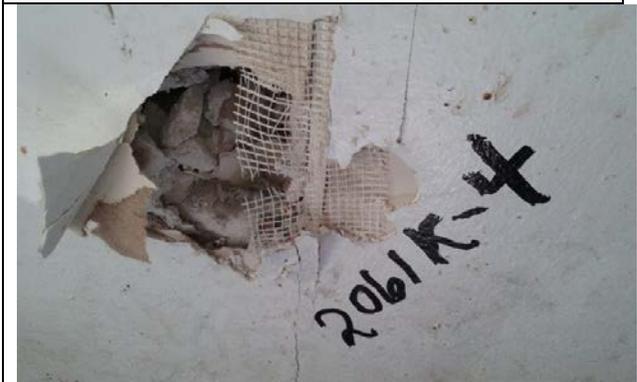
Photo 4: Drywall/J.C. (2061K-4) Bedroom 1, Wall B.
No Asbestos Detected.

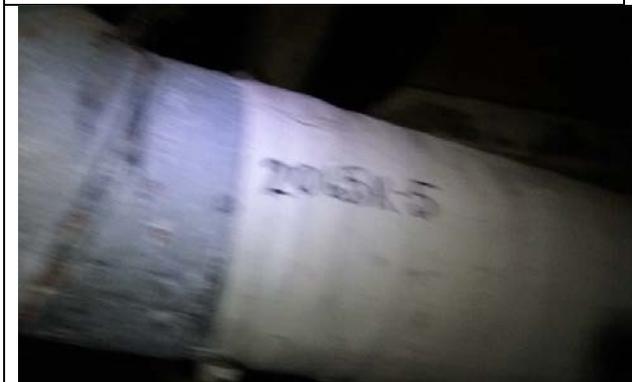
- Duct Work Wrap, Basement
- Furnace Board, Basement
- Seam Tape, Basement

Photo 5: Duct Work Wrap (2061K-5) Basement, Ceiling.
45% Chrysotile Asbestos Detected.

Confirmed or assumed asbestos-containing materials, which will be disturbed during demolition activities, are regulated under current Federal and State regulations. Hart Environmental Resources recommends the removal of these materials by a licensed asbestos abatement contractor. It is also strongly recommended that the specifications for the removal program be developed by a licensed Asbestos Project Designer to ensure that all regulatory requirements are satisfied. The work should be properly documented in the event of future litigation.

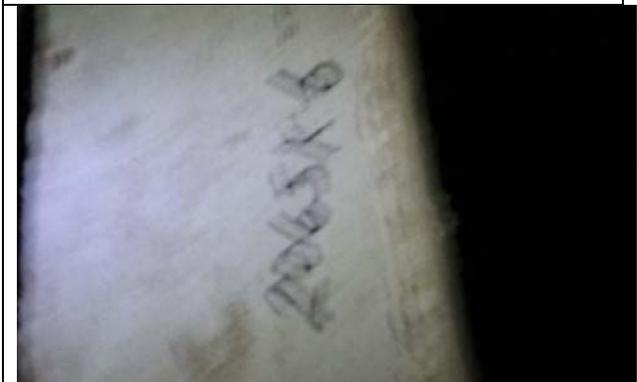
Photo 6: Furnace Board (2061K-6) Basement, Post.
75% Chrysotile Asbestos Detected.

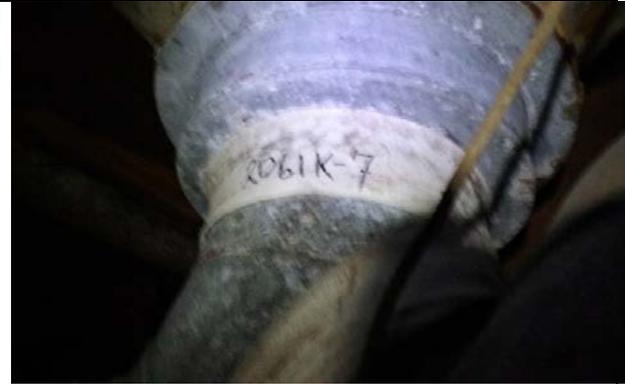
Photo 7: Seam Tape (2061K-7) Basement, Ceiling.
45% Chrysotile Asbestos Detected.

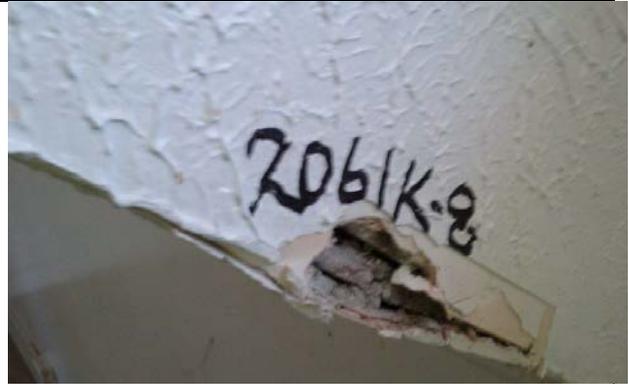
Photo 8: Plaster/Txt Paint (2061K-8) Bedroom 2, Ceiling.
No Asbestos Detected.

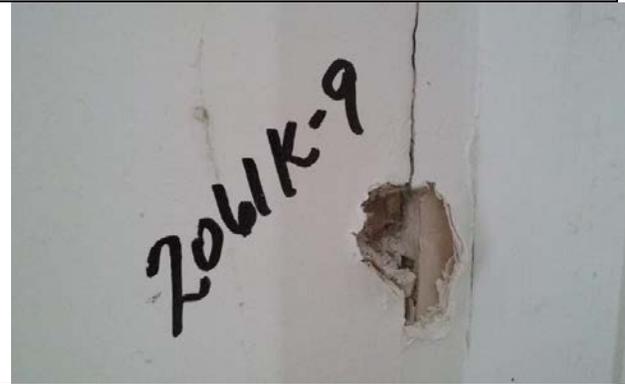
Photo 9: Drywall/J.C. (2061K-9) Bath, Wall A.
No Asbestos Detected.

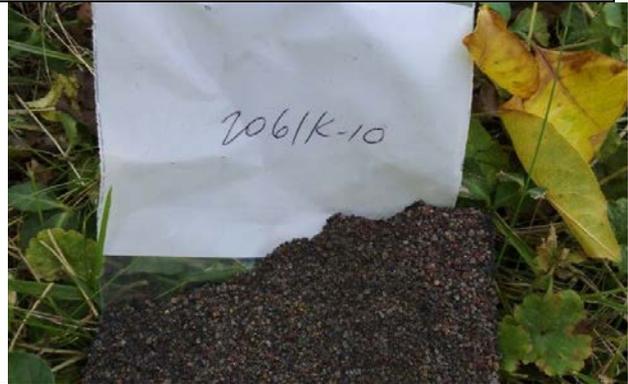
Photo 10: Roof Shingle (2061K-10) Exterior.
No Asbestos Detected.

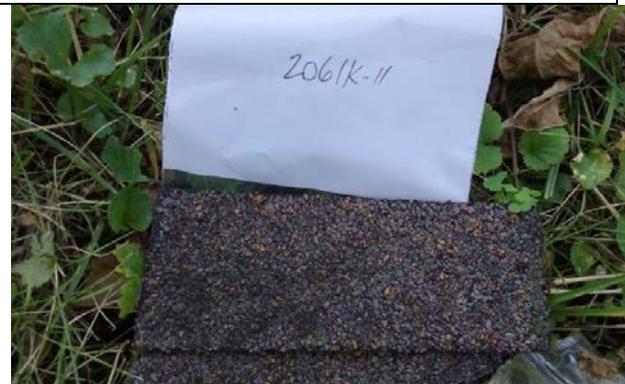
Photo 11: Roof Shingle (2061K-11) Exterior.
No Asbestos Detected.
