ASBESTOS INSPECTION REPORT

**139 N. Marion St.
Dayton, OH 45417**

Re: Asbestos Inspection
139 N. Marion St.
Dayton, OH 45417

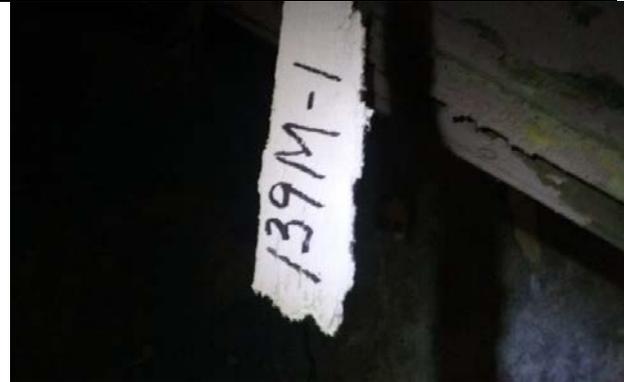
- Seam Tape, Basement
- Ground Debris, Seam Tape, Basement
- Duct Work Wrap, Dining Room & Living Room

Photo 1: Seam Tape (139M-1) Basement, Ceiling.
65% Chrysotile Asbestos Detected.

Confirmed or assumed asbestos-containing materials, which will be disturbed during demolition activities, are regulated under current Federal and State regulations. Hart Environmental Resources recommends the removal of these materials by a licensed asbestos abatement contractor. It is also strongly recommended that the specifications for the removal program be

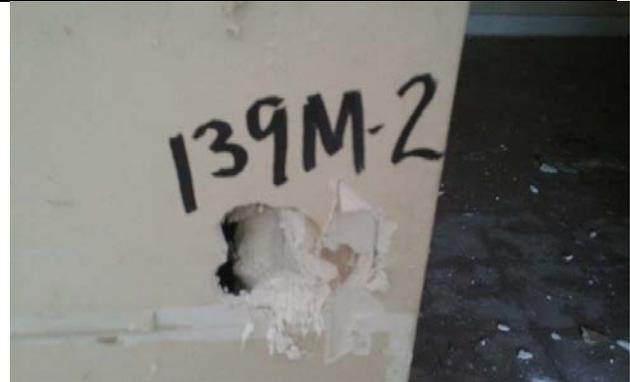
Photo 2: Drywall/J.C. (139M-2) Kitchen, Wall D.
No Asbestos Detected.

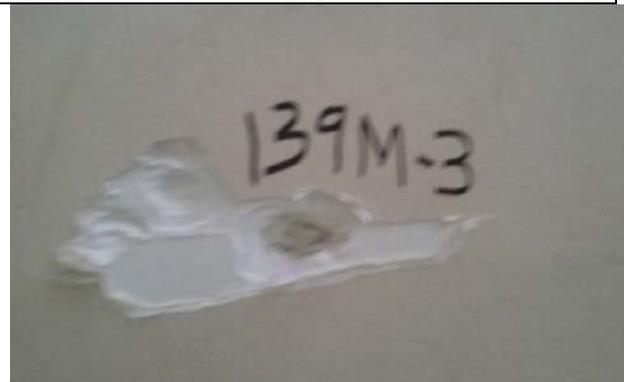
Photo 3: Drywall/J.C. (139M-3) 2nd Floor Stairs, Wall B.
No Asbestos Detected.

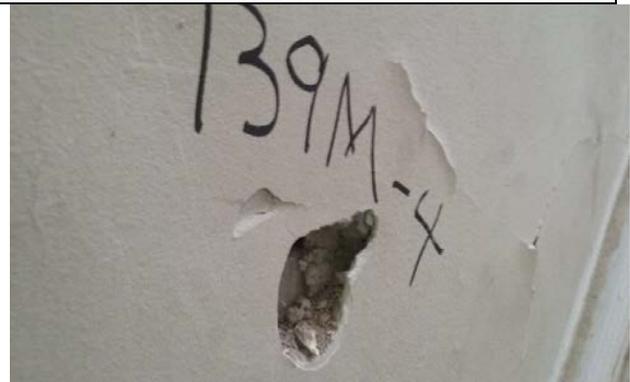
Photo 4: Plaster (139M-4) 2nd Floor Stairs, Wall B.
No Asbestos Detected.

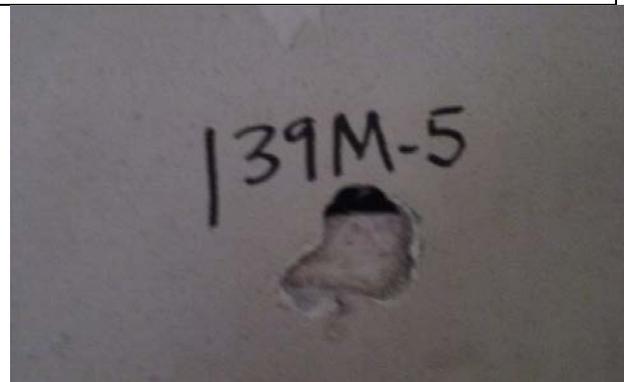
Photo 5: Plaster (139M-5) Living Room, Wall D.
No Asbestos Detected

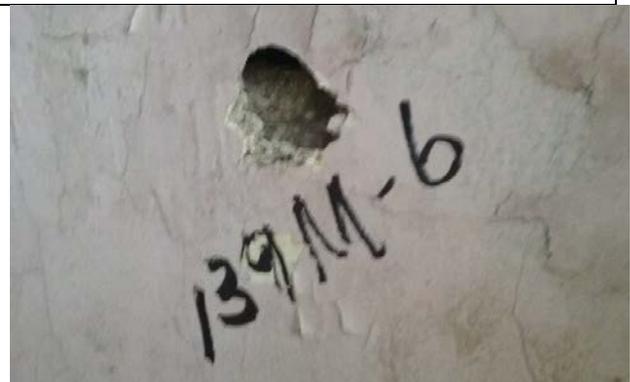
Photo 6: Plaster (139M-6) Basement Stairs, Wall B.
No Asbestos Detected

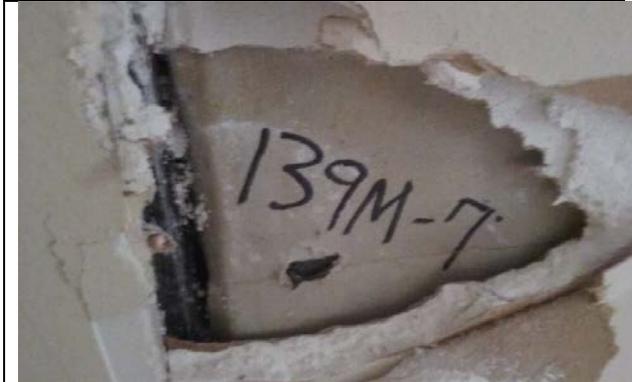
Photo 7: Duct Work Wrap (139M-7) Dining Room, Wall B.
65% Chrysotile Asbestos Detected.

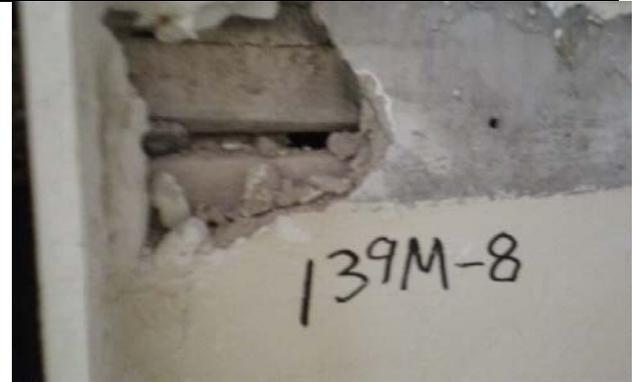
Photo 8: Plaster (139M-8) Bedroom 1 Closet, Wall B.
No Asbestos Detected.

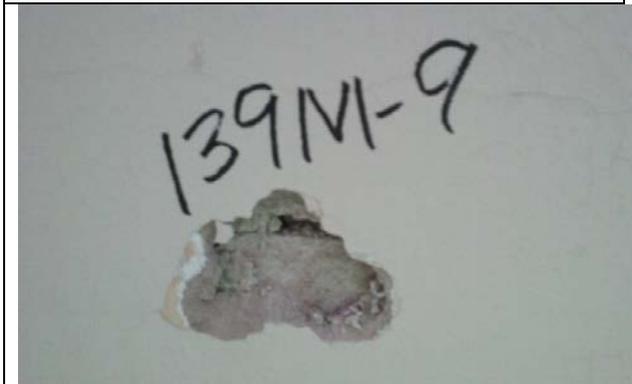
Photo 9: Plaster (139M-9) Bedroom 2.
No Asbestos Detected.

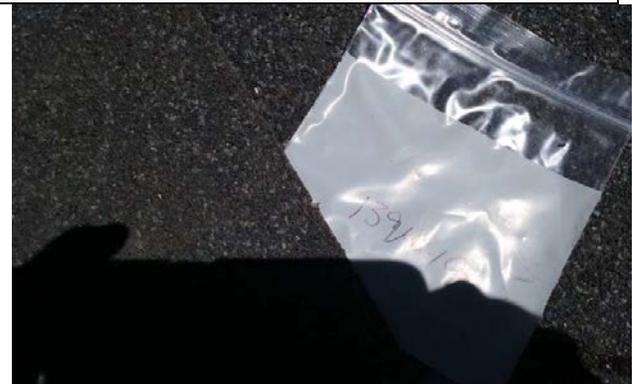
Photo 10: Roof Shingle (139M-10) Exterior.
No Asbestos Detected.

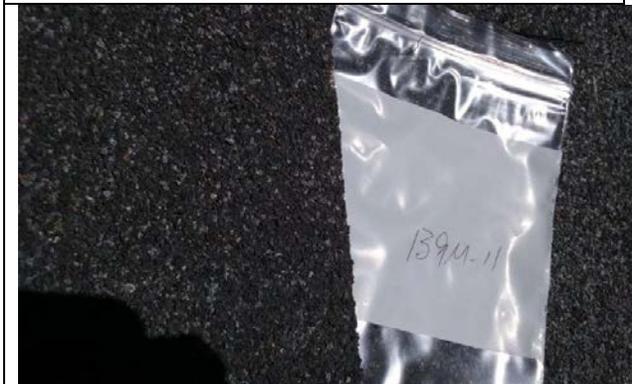
Photo 11: Roof Shingle (139M-11) Exterior.
No Asbestos Detected.

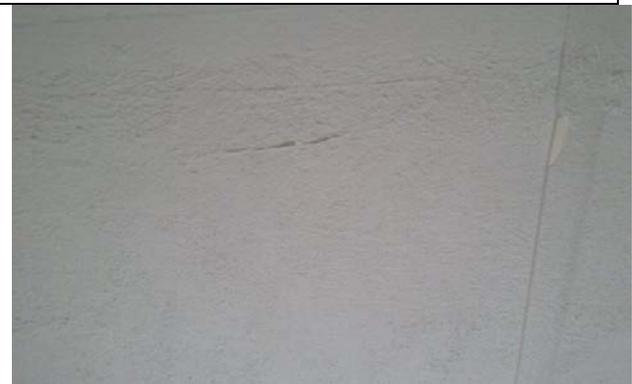
Photo 12: Txt Paint (139M-12) Bedroom 2, Ceiling.
No Asbestos Detected.

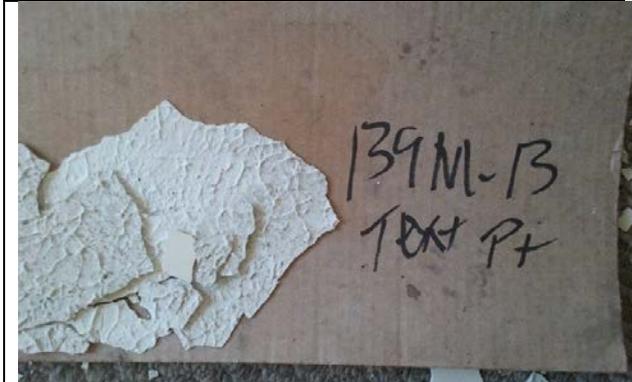
**Photo 13: Txt Paint (139M-13) Hall, Ceiling.
No Asbestos Detected.**

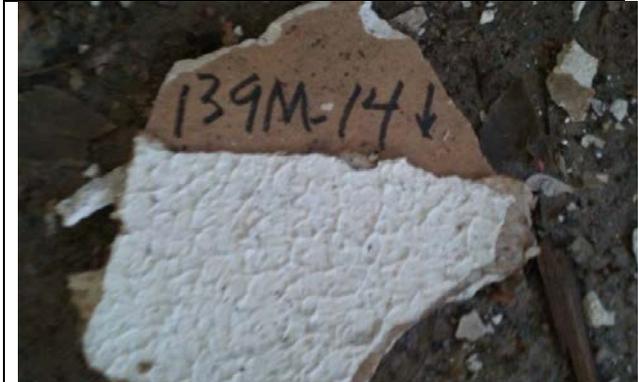
**Photo 14: Txt Paint (139M-14) Bedroom 3, Ceiling.
No Asbestos Detected.**
