ASBESTOS INSPECTION REPORT

**235 Reisinger Ave.
Dayton, OH 45417**

Re: Asbestos Inspection
235 Reisinger Ave.
Dayton, OH 45417

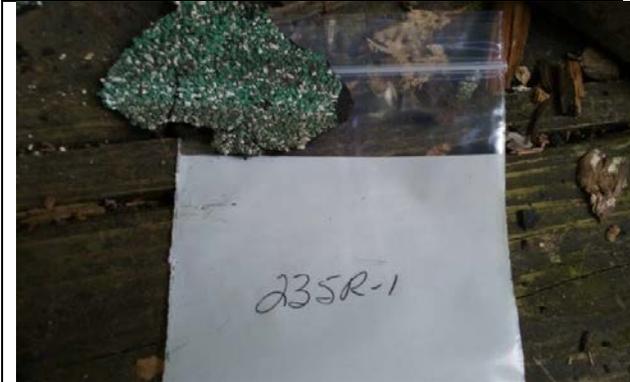
Photo 1: Roof Shingle (235R-1) Exterior.
No Asbestos Detected.

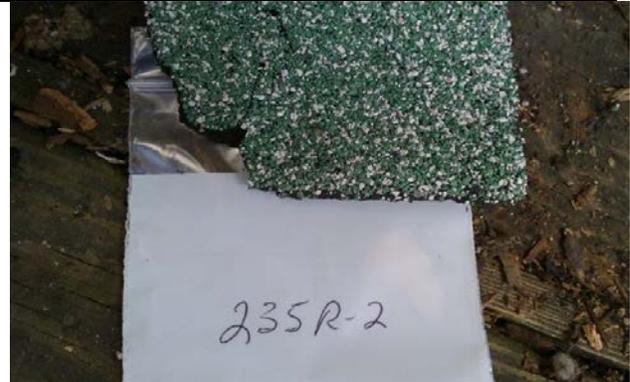
Photo 2: Roof Shingle (235R-2) Exterior.
No Asbestos Detected.

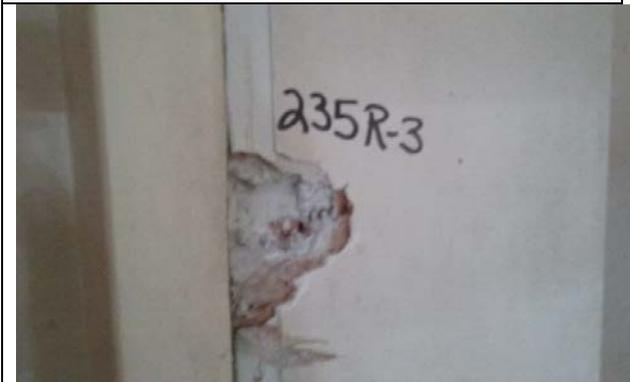
Photo 3: Drywall/J.C. (235R-3) Living Room, Wall C.
No Asbestos Detected.

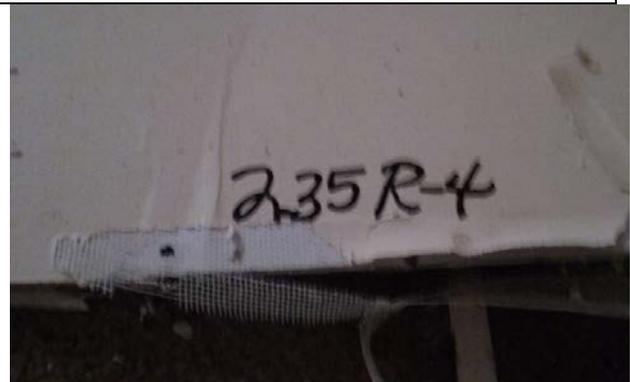
Photo 4: Drywall/J.C. (235R-4) Dining Room, Ceiling.
No Asbestos Detected.

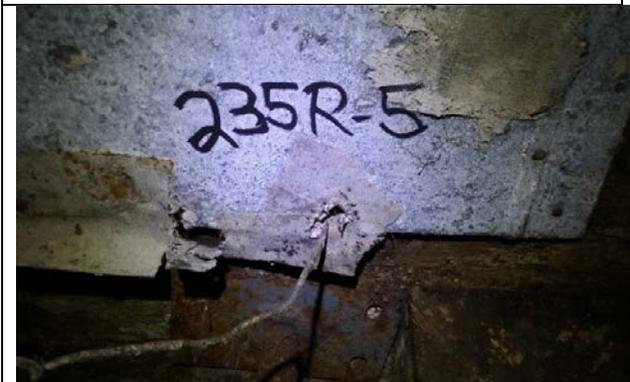
- Seam Tape, Basement

Photo 5: Seam Tape (235R-5) Basement, Ceiling.
55% Chrysotile Asbestos Detected.

Confirmed or assumed asbestos-containing materials, which will be disturbed during demolition activities, are regulated under current Federal and State regulations. Hart Environmental Resources recommends the removal of these materials by a licensed asbestos abatement contractor. It is also strongly recommended that the specifications for the removal program be developed by a licensed Asbestos Project Designer to ensure that all regulatory requirements are satisfied. The work should be properly documented in the event of future litigation.

<u>Material</u>	<u>Est. Qty.</u>	<u>Est. Unit Cost</u>	<u>Est. Cost</u>
Seam Tape	3 sq ft	\$ 20/sq ft.	\$ 60

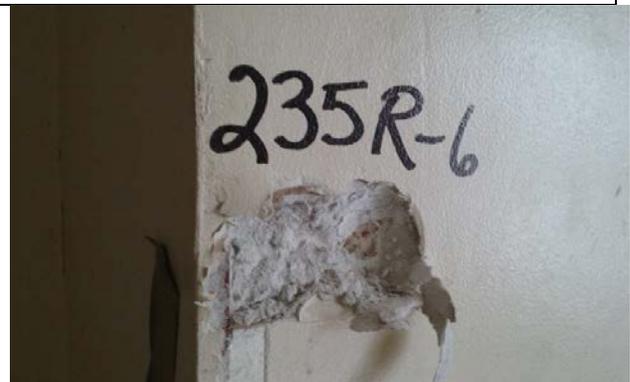
Photo 6: Drywall/J.C. (235R-6) Bedroom 1, Wall D.
No Asbestos Detected.
