## **ASBESTOS INSPECTION REPORT**

**122-124 Watterson St.  
Dayton, OH 45417**

**Lynda M. Hart  
Asbestos Hazards Evaluation Specialist  
Ohio #ES-32558  
September 24, 2015**

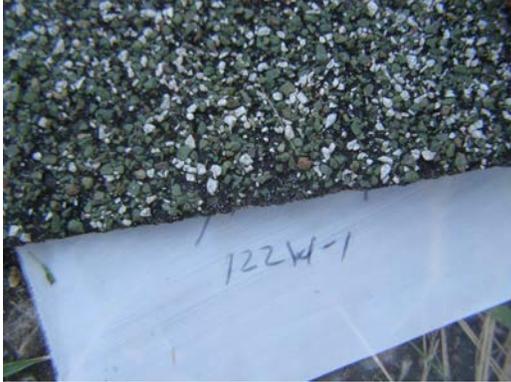
Photo 1: Shingle (122W-1) Roof, Exterior.  
No Asbestos Detected.

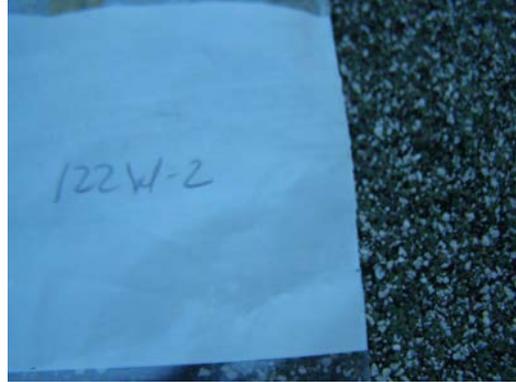
Photo 2: Shingle (122W-2) Roof, Exterior.  
No Asbestos Detected.

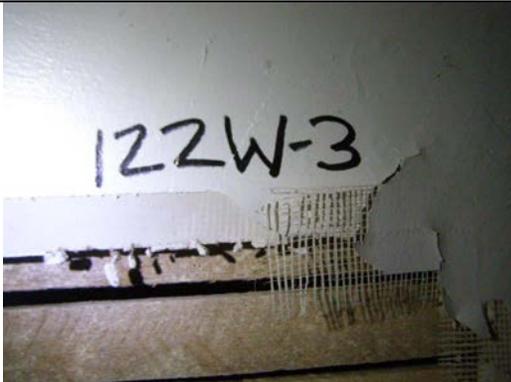
Photo 3: Drywall/J.C. (122W-3) 2<sup>nd</sup> Floor Stairs, Wall D.  
No Asbestos Detected.

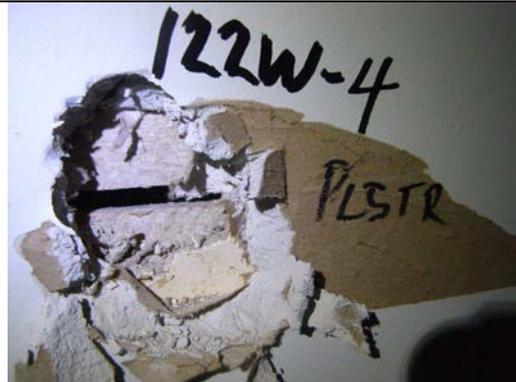
Photo 4: Plaster (122W-4) Living Room, Wall B.  
No Asbestos Detected.

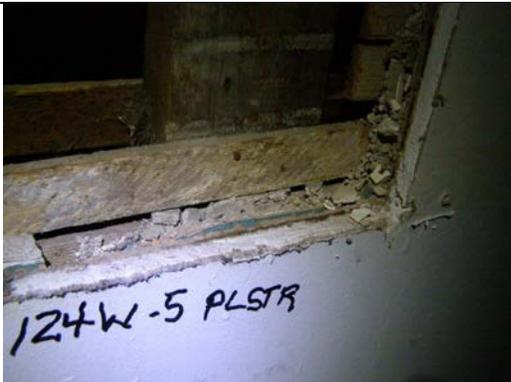
Photo 5: Plaster (122W-5) Family Room, Wall D.  
No Asbestos Detected

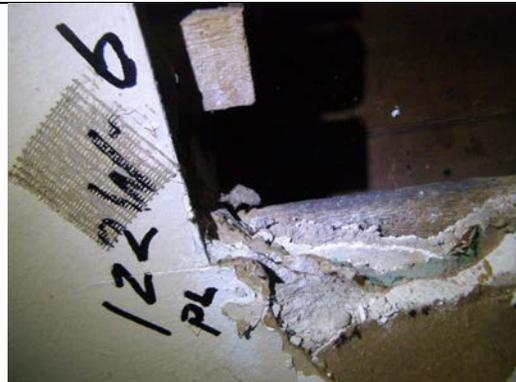
Photo 6: Plaster (122W-6) Kitchen, Wall C.  
No Asbestos Detected

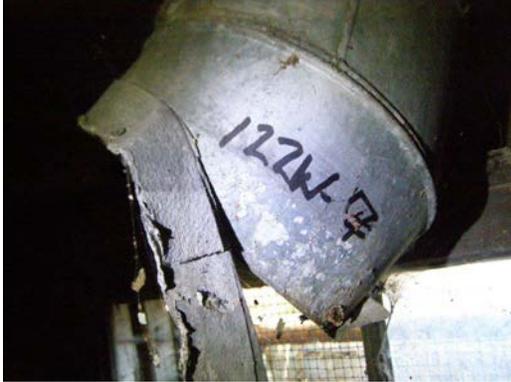
- Seam Tape, Basement, 122 Watterson
- Seam Tape, Basement, 124 Watterson
- Furnace Board, Basement, 124 Watterson

Photo 7: Seam Tape (122W-7) Basement, Wall B.  
65% Chrysotile Asbestos Detected.

Confirmed or assumed asbestos-containing materials, which will be disturbed during demolition activities, are regulated under current Federal and State regulations. Hart Environmental Resources recommends the removal of these materials by a licensed asbestos abatement contractor. It is also strongly recommended that the specifications for the removal program be developed by a licensed Asbestos Project Designer to ensure that all regulatory requirements are satisfied. The work should be properly documented in the event of future litigation.

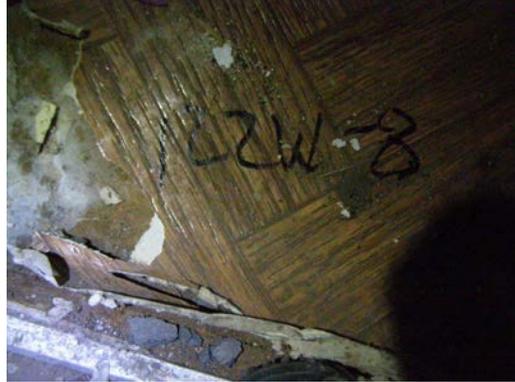
Photo 8: Flooring (122W-8) Kitchen, Floor.  
No Asbestos Detected.

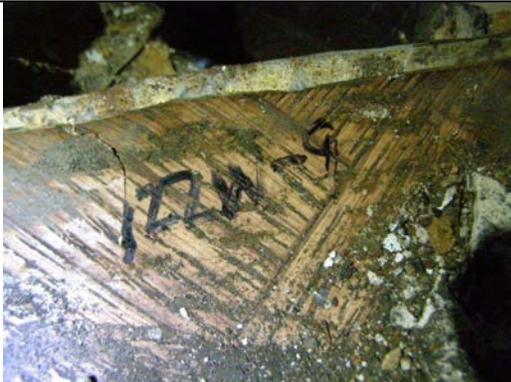
Photo 9: Flooring (122W-9) Kitchen, Floor.  
No Asbestos Detected.

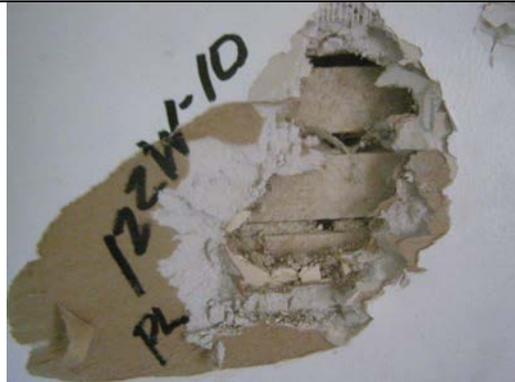
Photo 10: Plaster (122W-10) Bedroom 2, Wall A.  
No Asbestos Detected.

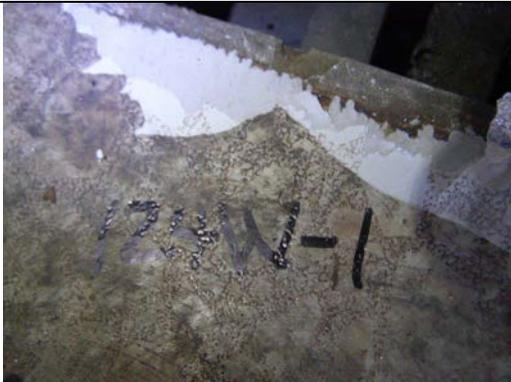
Photo 11: Flooring (124W-1) Family Room, Floor.  
No Asbestos Detected.

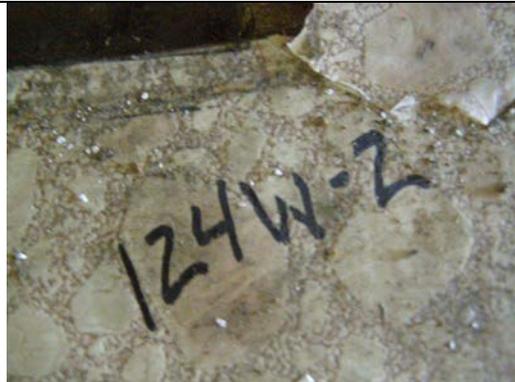
Photo 12: Flooring (124W-2) Family Room, Floor.  
No Asbestos Detected.

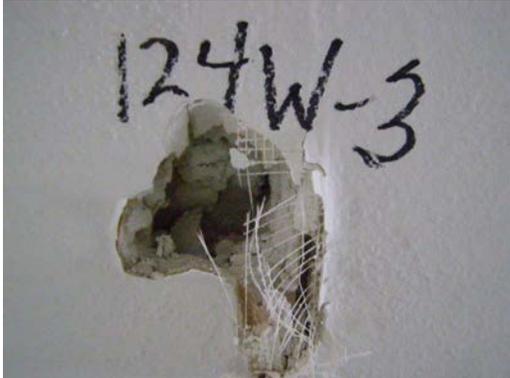
Photo 13: Drywall/J.C. (124W-3) Family Room, Wall D.  
No Asbestos Detected.

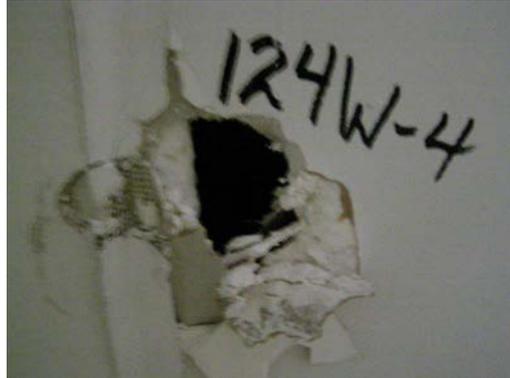
Photo 14: Drywall/J.C. (124W-4) Living Room, Wall C.  
No Asbestos Detected.

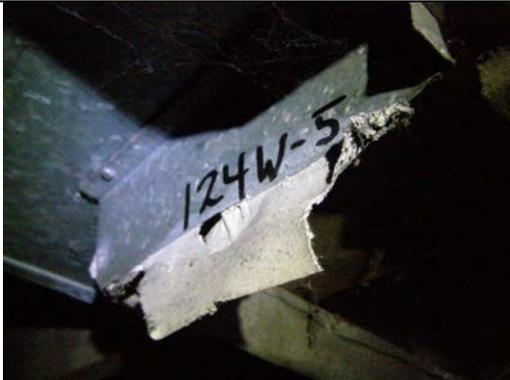
122W-9 15-09-03070-009	-	2	Flooring, Kitchen, Floor, Inhomogeneous	Non-friable	None Detected
122W-10 15-09-03070-010	-	1	Plaster, Bedroom 2, Wall A, Inhomogeneous	Non-friable	None Detected
124W-1 15-09- 03070-011A	-	2	Flooring (Linoleum), Family Room, Floor, Inhomogeneous	Non-friable	None Detected
124W-1 15-09- 03070-011B	-	1	Flooring (Mastic), Family Room, Floor, Homogeneous	Non-friable	None Detected
124W-2 15-09-03070-012A	-	2	Flooring (Linoleum), Family Room, Floor, Inhomogeneous	Non-friable	None Detected
124W-2 15-09-03070-012B	-	1	Flooring (Mastic), Family Room, Floor, Homogeneous	Non-friable	None Detected
124W-3 15-09-03070-013	-	2	Drywall/J.C., Family Room, Wall D, Inhomogeneous	Non-friable	None Detected
124W-4 15-09-03070-014	-	2	Drywall/J.C., Living Room, Wall C, Inhomogeneous	Non-friable	None Detected
124W-5 15-09-03070-015	2 sq ft.	1	Seam Tape, Basement, Ceiling, Homogeneous	Friable	<b>65% Chrysotile Asbestos Present</b>

Photo 15: Seam Tape (124W-5) Basement, Ceiling  
65% Chrysotile Asbestos Detected.

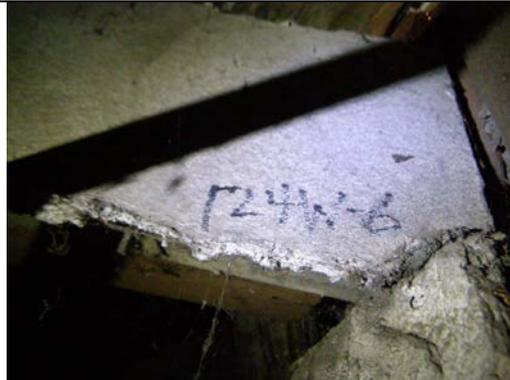
124W-6 15-09-03070-016	3 sq ft.	1	Furnace Board, Basement, Ceiling, Homogeneous	Non-friable	<b>45% Chrysotile Asbestos Present</b>
124W-7 15-09-03070-017	-	1	Plaster, Landing to 2 <sup>nd</sup> Floor, Wall B, Inhomogeneous	Non-friable	None Detected
124W-8 15-09-03070-018	-	2	Plaster, 2 <sup>nd</sup> Floor Stairs, Wall D, Inhomogeneous	Non-friable	None Detected
124W-9 15-09-03070-019	-	2	Drywall/J.C., Bath, Wall B, Inhomogeneous	Non-friable	None Detected
124W-10 15-09-03070-020	-	1	Plaster, Living Room, Wall B, Inhomogeneous	Non-friable	None Detected

Photo 16: Furnace Board (124W-6) Basement, Ceiling.  
45% Chrysotile Asbestos Detected.

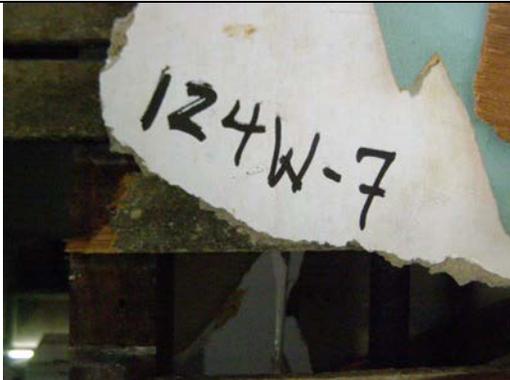
Photo 17: Plaster (124W-7) Landing to 2<sup>nd</sup> Floor, Wall B.  
No Asbestos Detected.

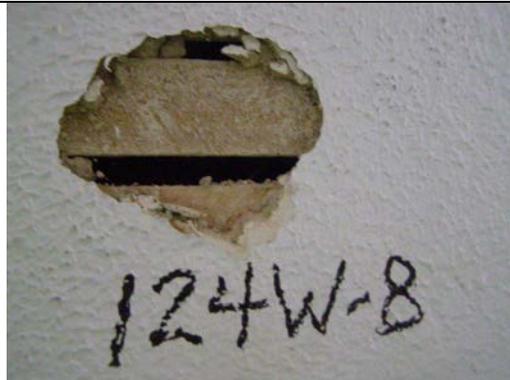
Photo 18: Plaster (124W-8) 2<sup>nd</sup> Floor Stairs, Wall D.  
No Asbestos Detected.

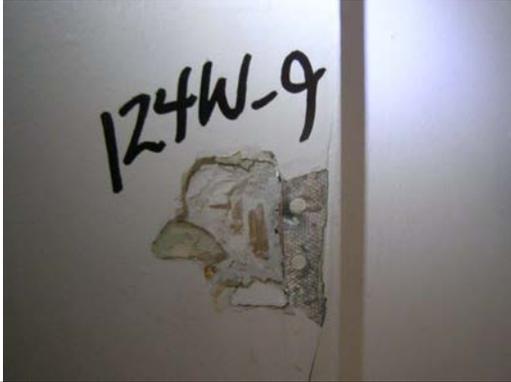
**Photo 19: Drywall/J.C. (124W-9) Bath, Wall B.  
No Asbestos Detected.**

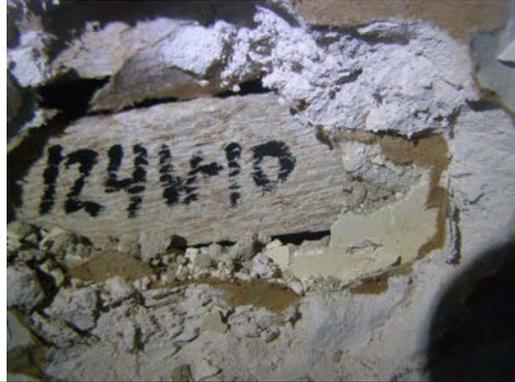
**Photo 20: Plaster (124W-10) Living Room, Wall B.  
No Asbestos Detected.**

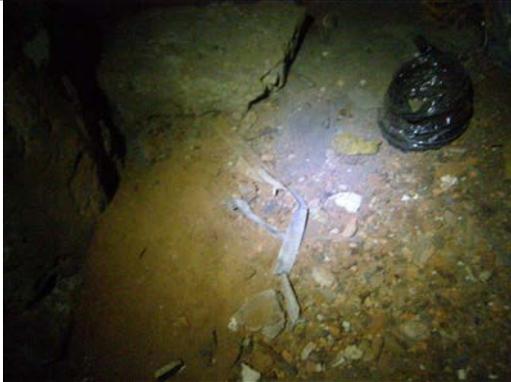
**Photo 21: Ground Debris with Seam Tape.**
