ASBESTOS INSPECTION REPORT

**175 N. Ardmore Ave.
Dayton, OH 45417**

Re: Asbestos Inspection
175 N. Ardmore Ave.
Dayton, OH 45417

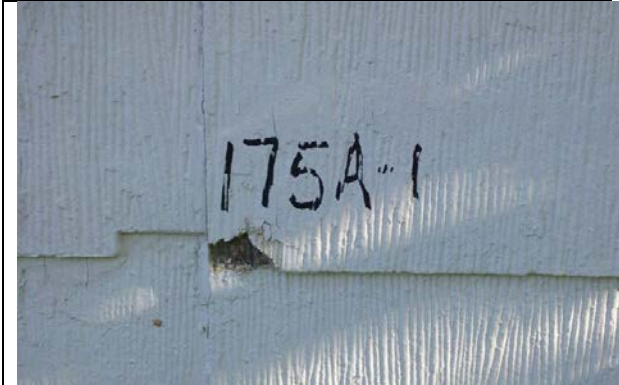
- Transite, Exterior
- Duct Work Wrap, Family Room
- Seam Tape, Basement
- Boot Wrap, Basement

Photo 1: Transite (175A-1) Exterior.
20% Chrysotile Asbestos Detected.

Resources recommends the removal of these materials by a licensed asbestos abatement contractor. It is also strongly recommended that the specifications for the removal program be developed by a licensed Asbestos Project Designer to ensure that all regulatory requirements are satisfied. The work should be properly documented in the event of future litigation.

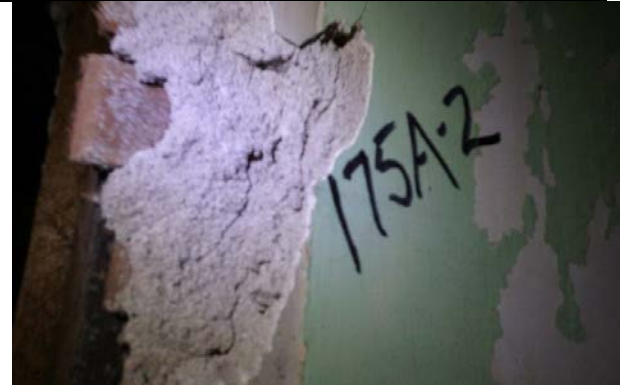
Photo 2: Plaster (175A-2) Living Room, Wall C.
No Asbestos Detected.

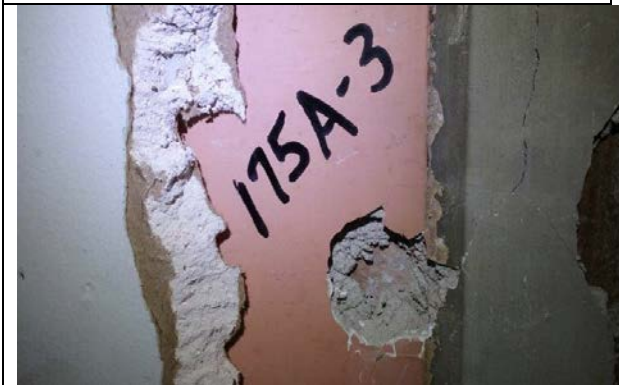
Photo 3: Drywall/J.C. (175A-3) Dining Room, Wall A.
No Asbestos Detected.

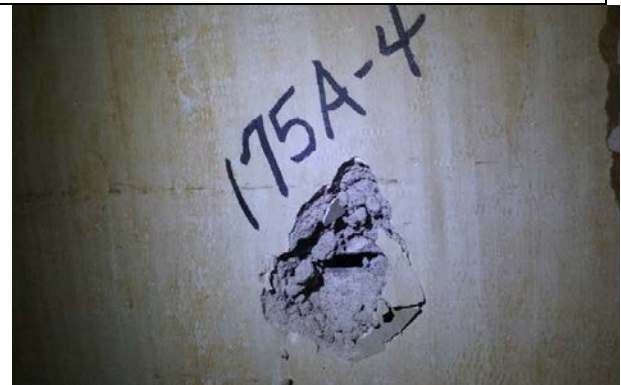
Photo 4: Plaster (175A-4) Family Room, Wall C.
No Asbestos Detected.

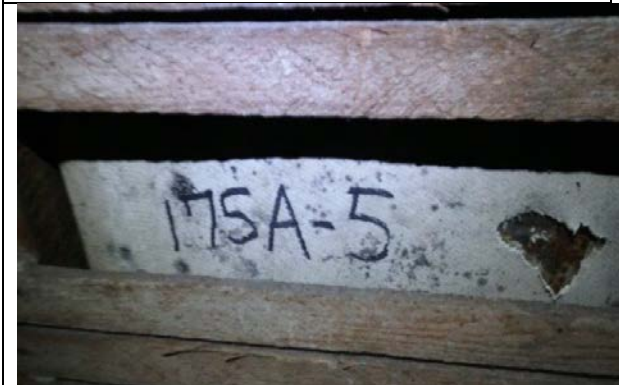
Photo 5: Duct Work Wrap (175A-5) Family Room, Wall B.
65% Chrysotile Asbestos Detected.

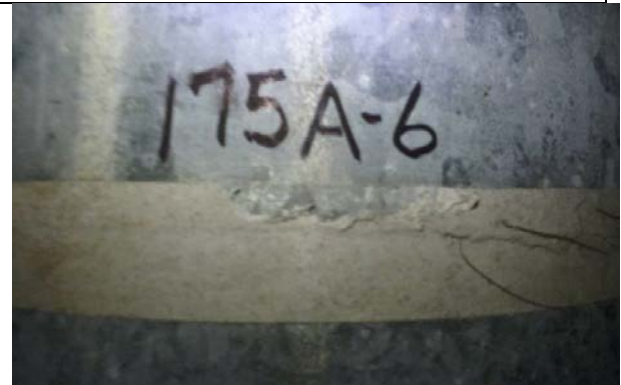
Photo 6: Seam Tape (175A-6) Basement, Ceiling.
80% Chrysotile Asbestos Detected.

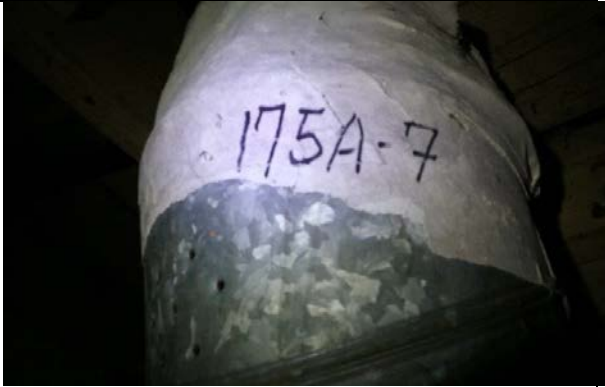
Photo 7: Boot Wrap (175A-7) Basement.
65% Chrysotile Asbestos Detected.

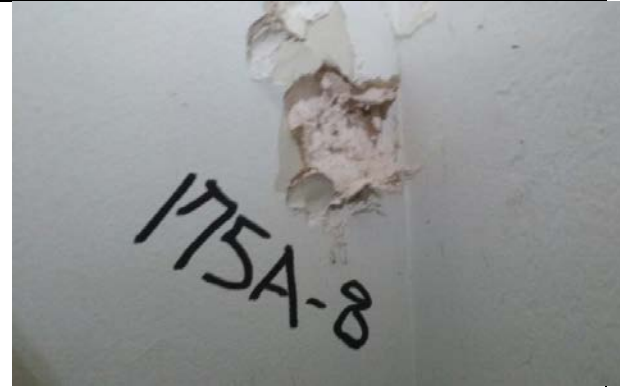
Photo 8: Drywall/J.C. (175A-8) Living Room, Wall A.
No Asbestos Detected.

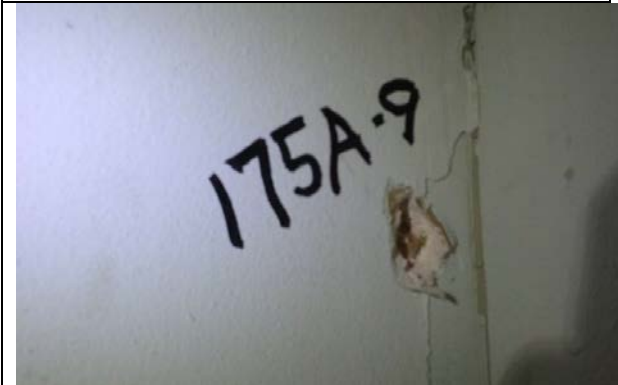
Photo 9: Drywall/J.C. (175A-9) Dining Room, Wall D.
No Asbestos Detected.

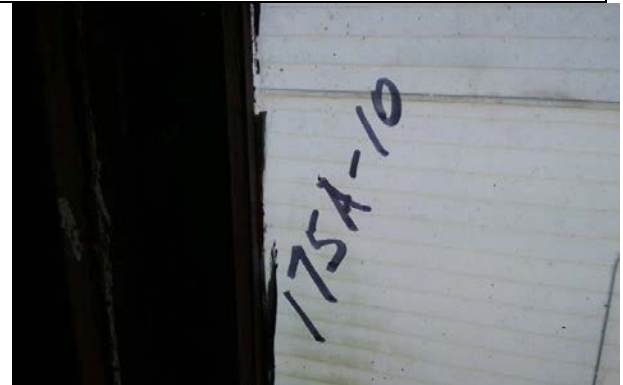
Photo 10: Window Glazing (175A-10) Hall, Wall B.
No Asbestos Detected.

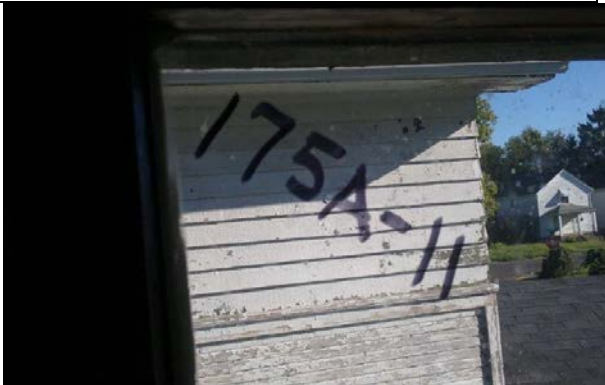
Photo 11: Window Glazing (175A-11) Bedroom 1, Wall D.
No Asbestos Detected.

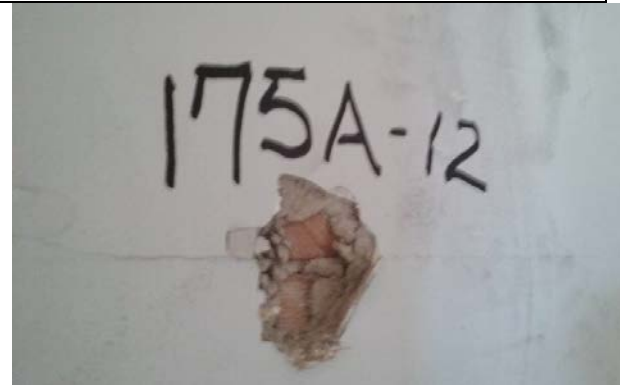
Photo 12: Plaster (175A-12) Bedroom 1, Closet.
No Asbestos Detected.

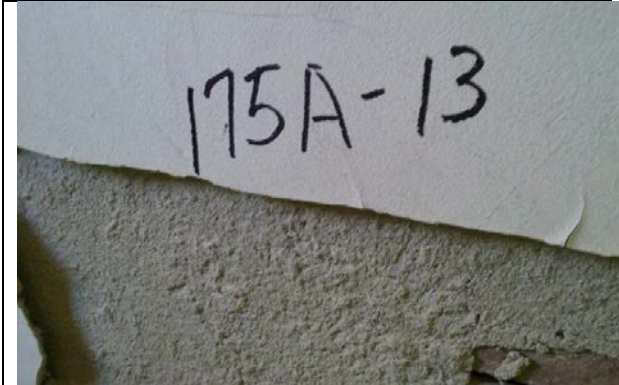
**Photo 13: Plaster (175A-13) 2nd Floor Stairs, Wall D.
No Asbestos Detected.**

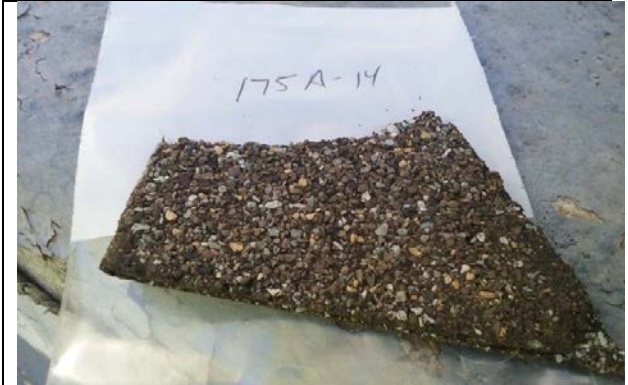
**Photo 14: Roof Shingle (175A-14) Roof.
No Asbestos Detected.**

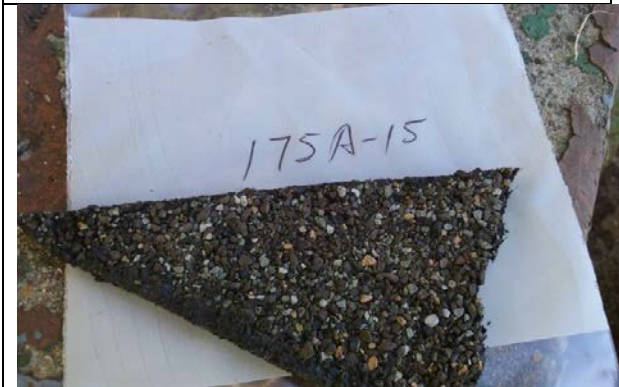
**Photo 15: Roof Shingle (175A-15) Roof.
No Asbestos Detected.**
