## **ASBESTOS INSPECTION REPORT**

**205 N. Ardmore Ave.  
Dayton, OH 45417**

**Lynda M. Hart  
Asbestos Hazards Evaluation Specialist  
Ohio #ES-32558  
September 23, 2015**

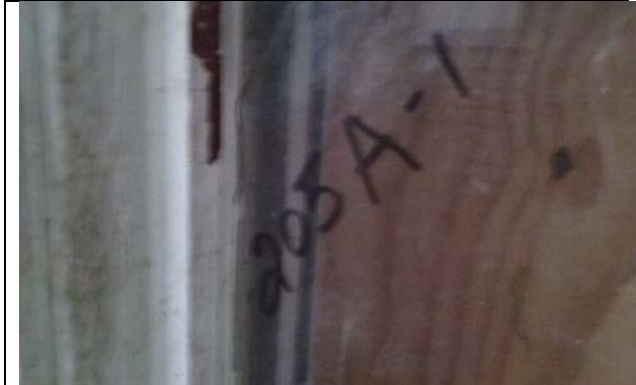
Photo 1: Window Glazing (205A-1) Living Room, Wall A.  
Trace <1% Chrysotile Asbestos Detected (PC=0.50%).

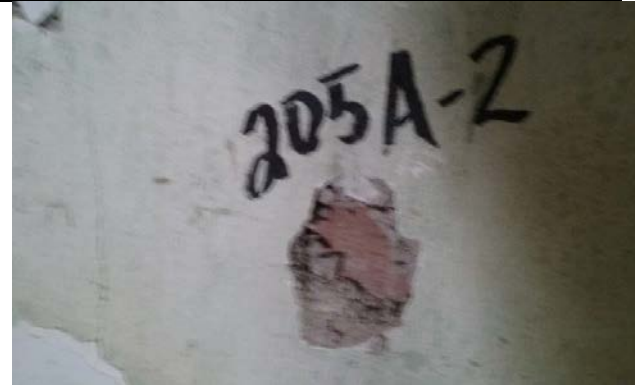
Photo 2: Plaster (205A-2) Living Room, Wall B. Trace <1%  
Chrysotile Asbestos Detected (Base Coat) (PC=0.25%).

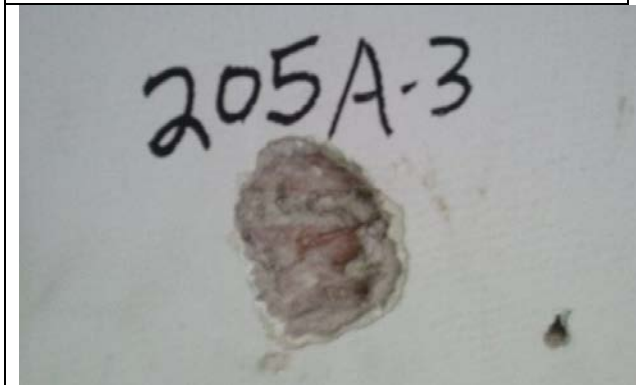
Photo 3: Plaster/Text. Pt. (205A-3) Dining Room, Wall A.  
Trace <1% Chrysotile Asbestos Detected (Plaster Texture  
PC=0.50%) (Plaster Base Coat PC=0.25%).

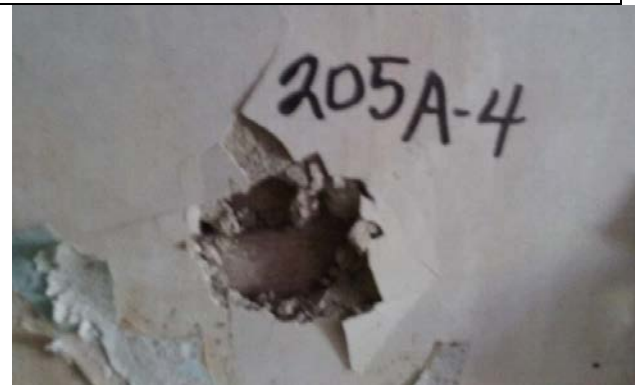
Photo 4: Plaster (205A-4) Kitchen, Wall D.  
Trace <1% Chrysotile Asbestos Detected (Base Coat)  
(PC=0.25%).

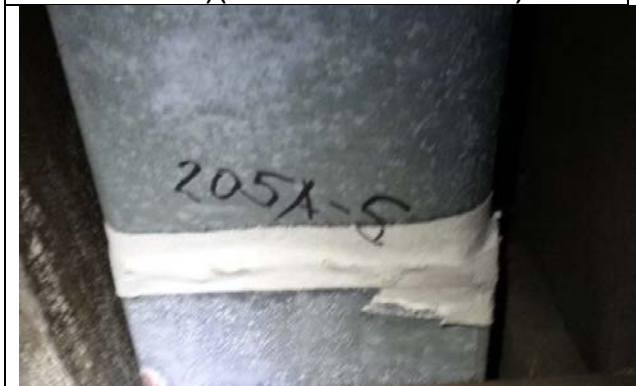
Photo 5: Seam Tape (205A-5) Basement, Ceiling.  
70% Chrysotile Asbestos Detected.

Confirmed or assumed asbestos-containing materials, which will be disturbed during demolition activities, are regulated under current Federal and State regulations. Hart Environmental Resources recommends the removal of these materials by a licensed asbestos abatement contractor. It is also strongly recommended that the specifications for the removal program be developed by a licensed Asbestos Project Designer to ensure that all regulatory requirements are satisfied. The work should be properly documented in the event of future litigation.

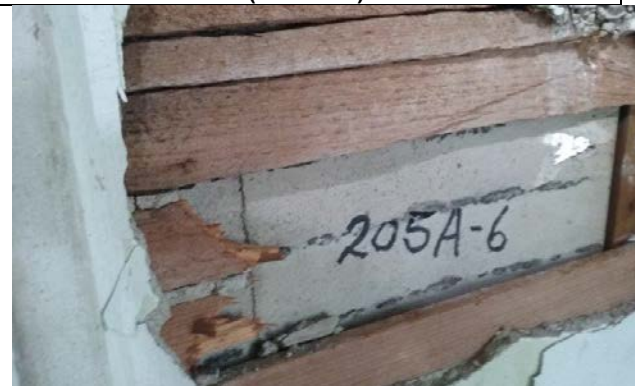
Photo 6: Duct Work Wrap (205A-6) Dining Room, Wall D.  
70% Chrysotile Asbestos Detected.

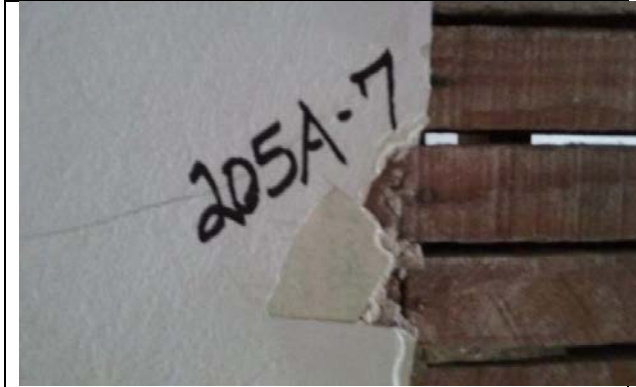
Photo 7: Plaster/Text. Pt. (205A-7) Hall, Wall B.  
Trace <1% Chrysotile Asbestos Detected (Plaster Texture  
PC=0.25%) (Plaster Base Coat PC=0.25%).

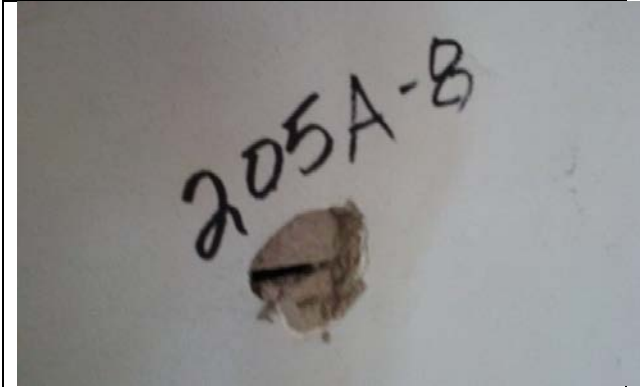
Photo 8: Plaster/Text. Pt. (205A-8) Bedroom 2, Wall C.  
Trace <1% Chrysotile Asbestos Detected (Base Coat)  
(PC=<0.25%).

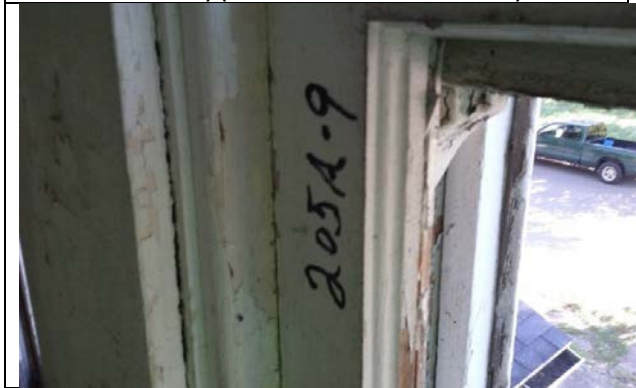
Photo 9: Window Glazing (205A-9) Bedroom 2, Wall A.  
Trace <1% Chrysotile Asbestos Detected (PC=0.25%).

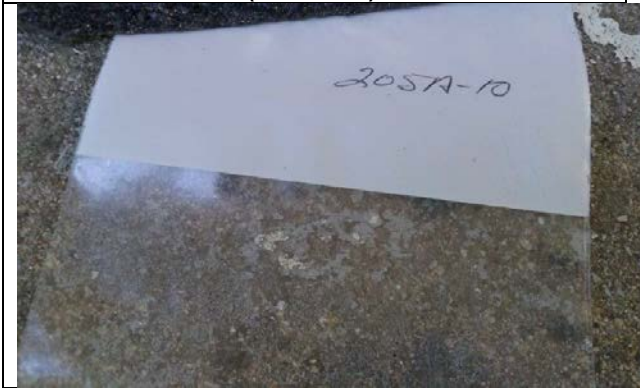
Photo 10: Roof Shingle (205A-10) Roof.  
No Asbestos Detected.

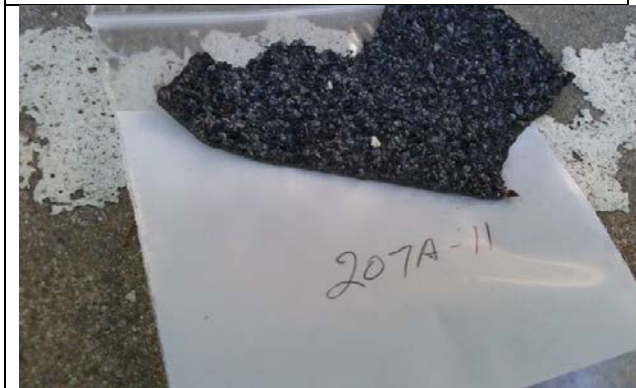
Photo 11: Roof Shingle (205A-11) Roof.  
No Asbestos Detected.
