ASBESTOS INSPECTION REPORT

**221 N. Ardmore Ave.
Dayton, OH 45417**

Re: Asbestos Inspection
221 N. Ardmore Ave.
Dayton, OH 45417

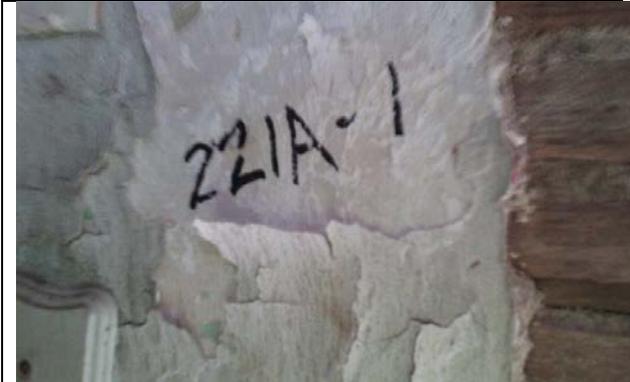
Photo 1: Plaster/Txt Paint (221A-1) Living Room, Wall A.
No Asbestos Detected.

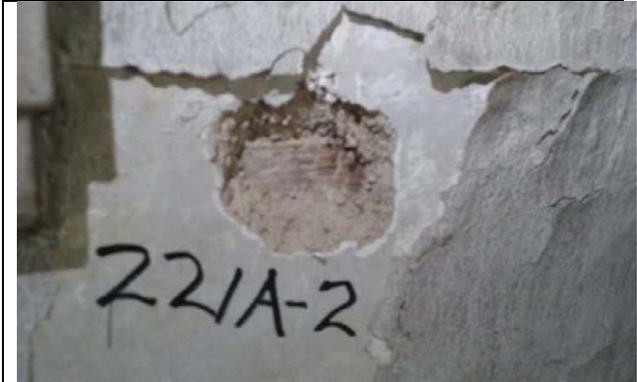
Photo 2: Plaster/Txt Paint (221A-2) Dining Room, Wall D.
No Asbestos Detected.

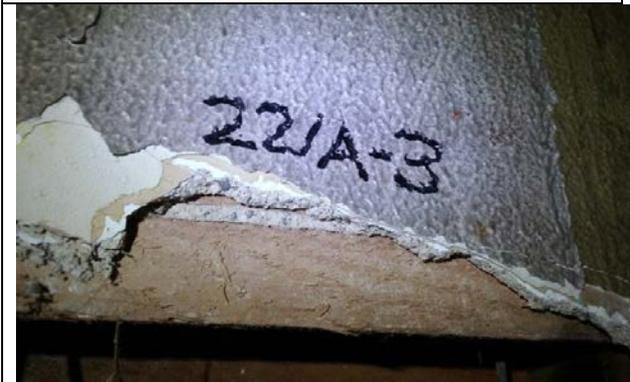
Photo 3: Plaster/Txt Paint (221A-3) Kitchen, Wall A.
No Asbestos Detected.

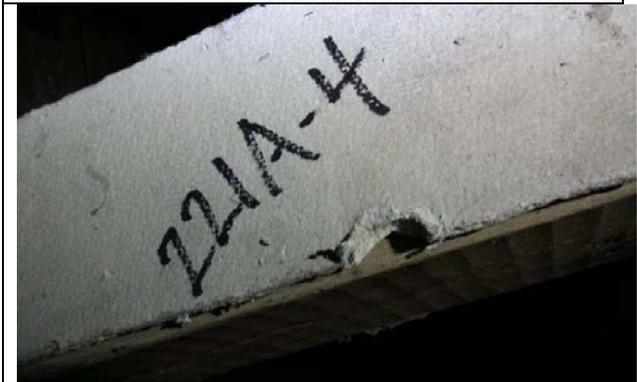
- Furnace Board, Basement
- Seam Tape, Basement
- Duct Work Wrap, Living Room, Dining Room

Photo 4: Furnace Board (221A-4) Basement, Ceiling.
65% Chrysotile Asbestos Detected.

Confirmed or assumed asbestos-containing materials, which will be disturbed during demolition activities, are regulated under current Federal and State regulations. Hart Environmental Resources recommends the removal of these materials by a licensed asbestos abatement contractor. It is also strongly recommended that the specifications for the removal program be developed by a licensed Asbestos Project Designer to ensure that all regulatory requirements are satisfied. The work should be properly documented in the event of future litigation.

<u>Material</u>	<u>Est. Qty.</u>	<u>Est. Unit Cost</u>	<u>Est. Cost</u>
Furnace Board	15 sq ft.	\$ 20/sq ft.	\$ 300
Seam Tape	1 sq ft.	\$ 20/sq ft.	\$ 20
Duct Work Wrap	50 sq ft.	\$ 20/sq ft.	\$ 1000
Duct Work Boots	2 ea	\$ 25/ea	\$ 50
Total			\$ 1370

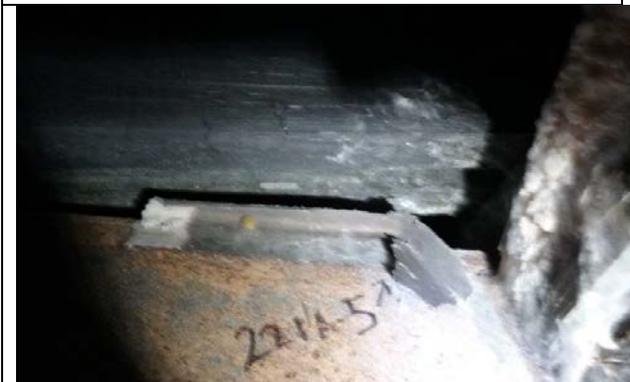
Photo 5: Seam Tape (221A-5) Basement, Ceiling.
80% Chrysotile Asbestos Detected.

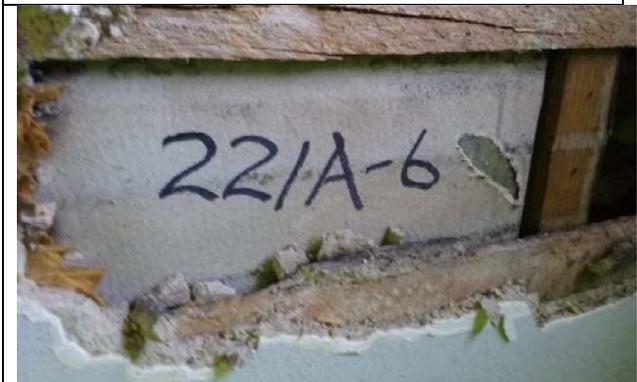
Photo 6: Duct Work Wrap (221A-6) Living Room, Wall C.
75% Chrysotile Asbestos Detected

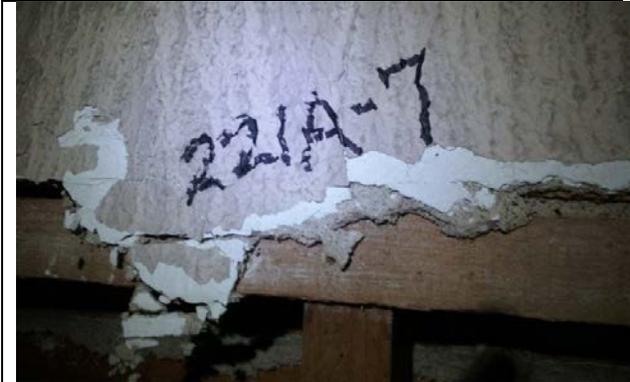
Photo 7: Plaster/Txt Paint (221A-7) Hall, Wall D.
No Asbestos Detected.

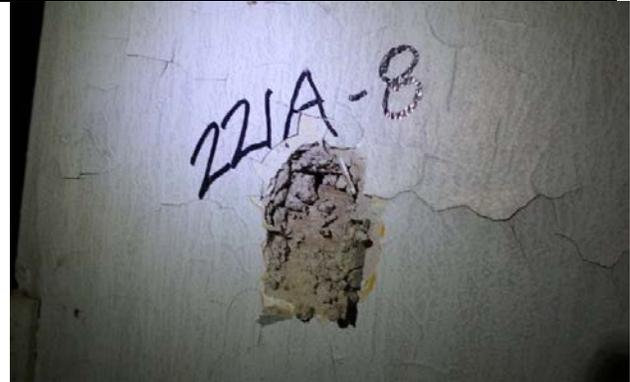
Photo 8: Plaster (221A-8) Bathroom 3, Wall B
No Asbestos Detected.

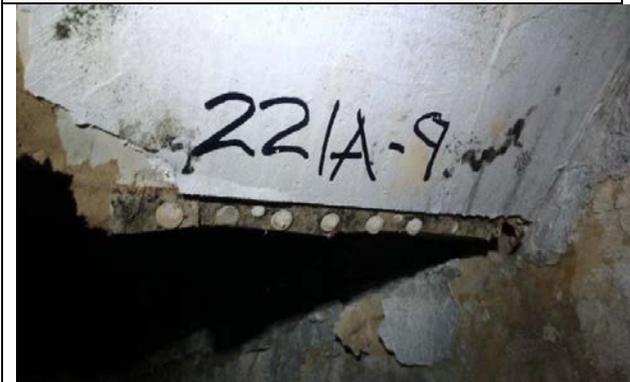
Photo 9: Drywall/J.C. (221A-9) 2nd Floor Stairs, Ceiling.
No Asbestos Detected.

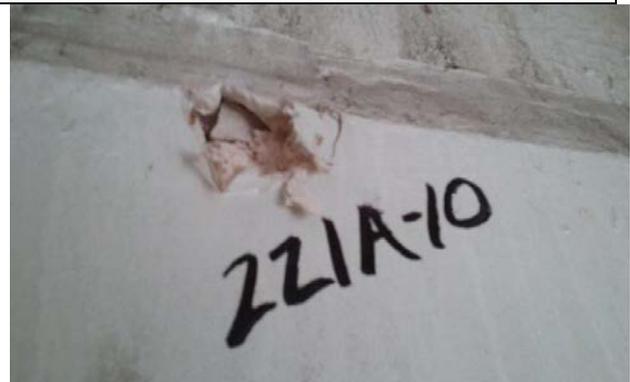
Photo 10: Drywall/J.C. (221A-10) Living Room, Wall A.
No Asbestos Detected.

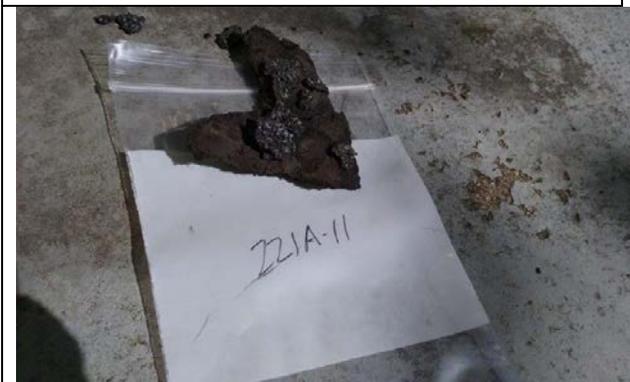
Photo 11: Roof Shingle (221A-11) Exterior.
No Asbestos Detected.

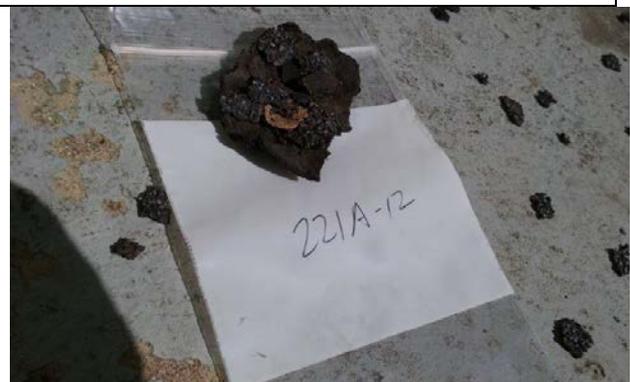
Photo 12: Roof Shingle (221A-12) Exterior.
No Asbestos Detected.
