ASBESTOS INSPECTION REPORT

**2025 Kensington Dr.
Dayton, OH 45406**

**Lynda M. Hart
Asbestos Hazards Evaluation Specialist
Ohio #ES-32558
October 27, 2015**

Re: Asbestos Inspection
2025 Kensington Dr.
Dayton, OH 45406

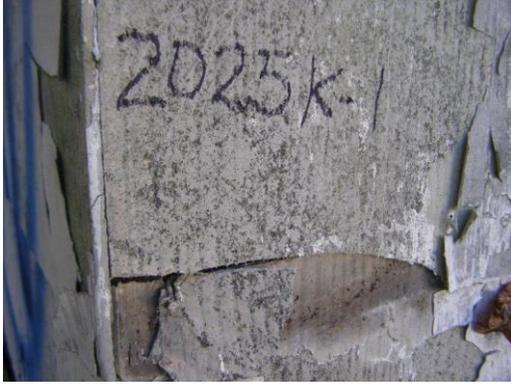
- Transite, House Exterior
- Transite, Garage
- Floor Tile, Basement

Photo 1: Transite (2025K-1) Exterior, Wall D.
20% Chrysotile Asbestos Detected.

Confirmed or assumed asbestos-containing materials, which will be disturbed during demolition activities, are regulated under current Federal and State regulations. Hart Environmental Resources recommends the removal of these materials by a licensed asbestos abatement contractor. It is also strongly recommended that the specifications for the removal program be developed by a licensed Asbestos Project Designer to ensure that all regulatory requirements are satisfied. The work should be properly documented in the event of future litigation.

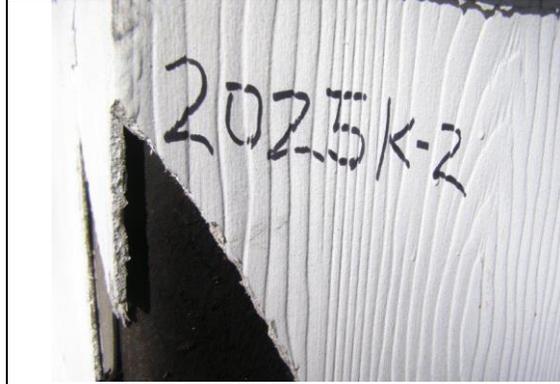
Photo 2: Transite (2025K-2) Exterior, Garage.
20% Chrysotile Asbestos Detected.

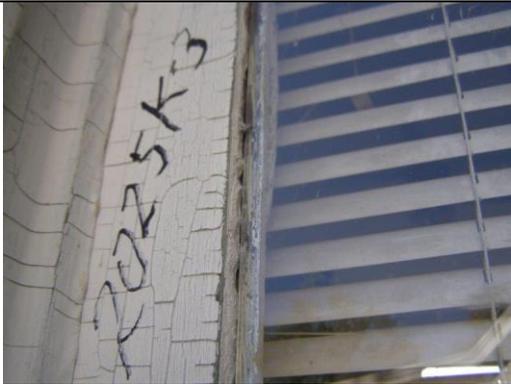
Photo 3: Window Glazing (2025K-3) Exterior, Wall D.
No Asbestos Detected.

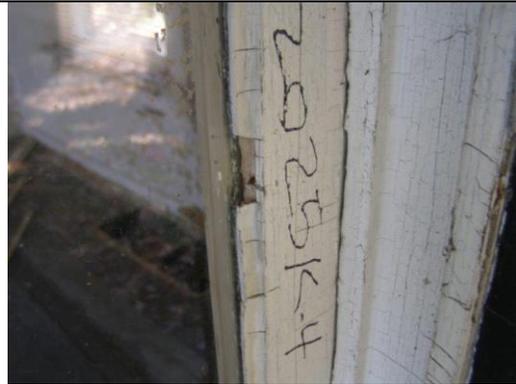
Photo 4: Window Glazing (2025K-4) Living Room, Wall A
Exterior. No Asbestos Detected.

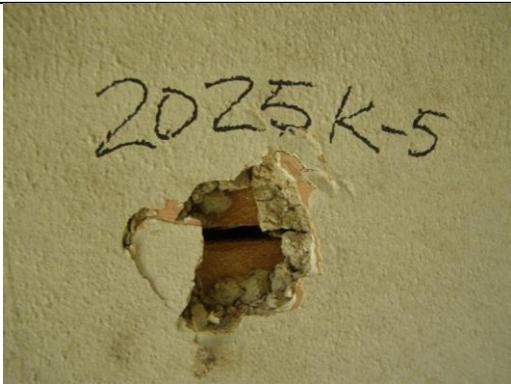
Photo 5: Plaster (2025K-5) Living Room, Wall C.
No Asbestos Detected.

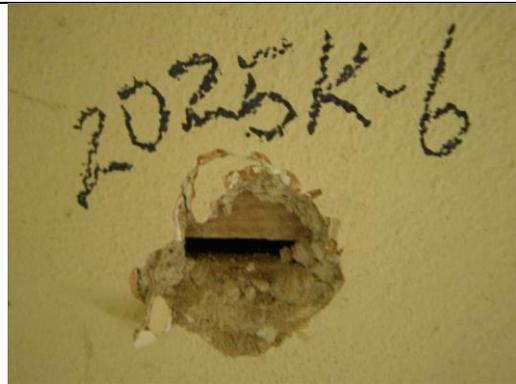
Photo 6: Plaster (2025K-6) Dining Room, Wall D.
No Asbestos Detected.

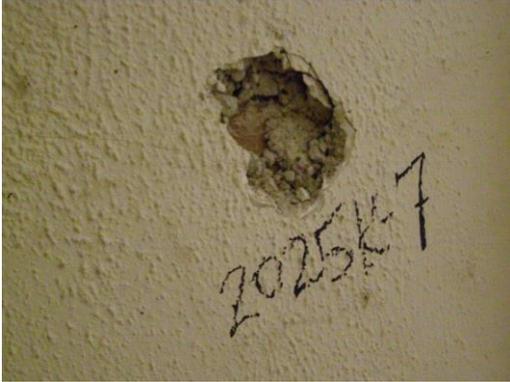
Photo 7: Plaster (2025K-7) Bedroom 1, Wall C.
No Asbestos Detected.

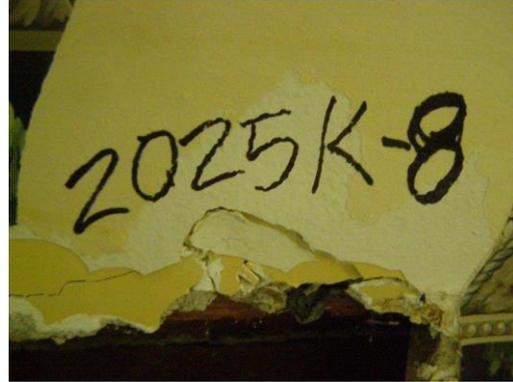
Photo 8: Drywall/J.C. (2025K-8) Kitchen, Wall A.
No Asbestos Detected.

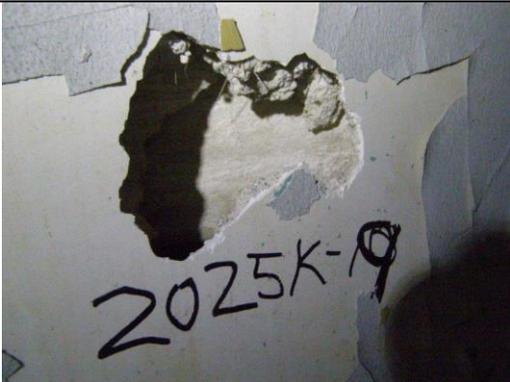
Photo 9: Plaster (2025K-9) Bedroom 2, Wall B.
No Asbestos Detected.

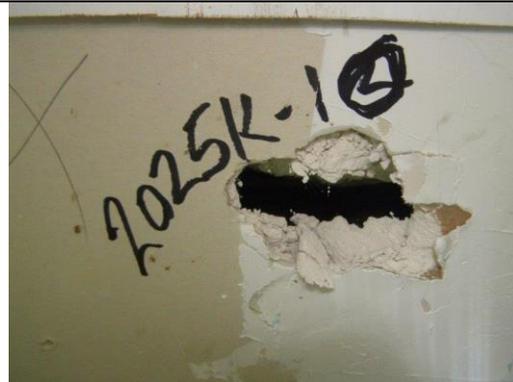
Photo 10: Drywall/J.C. (2025K-10) Kitchen, Wall B.
No Asbestos Detected.

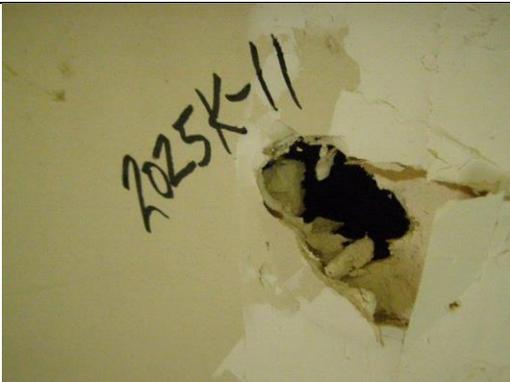
Photo 11: Drywall/J.C. (2025K-11) Kitchen, Wall B.
No Asbestos Detected.

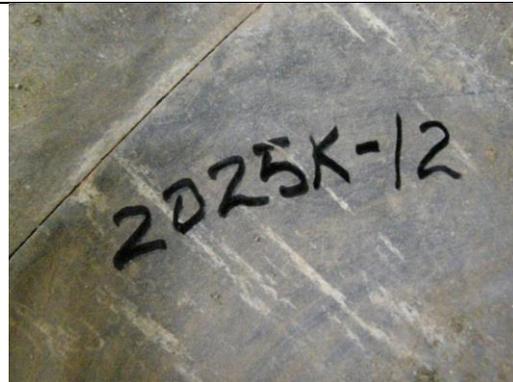
Photo 12: Floor Tile (2025K-12) Basement, Floor.
4% Chrysotile Asbestos Detected (PC=3.25%).

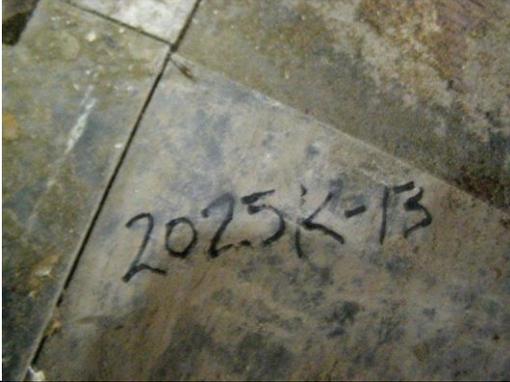
**Photo 13: Floor Tile (2025K-13) Basement, Floor.
4% Chrysotile Asbestos Detected (PC=3.0%).**

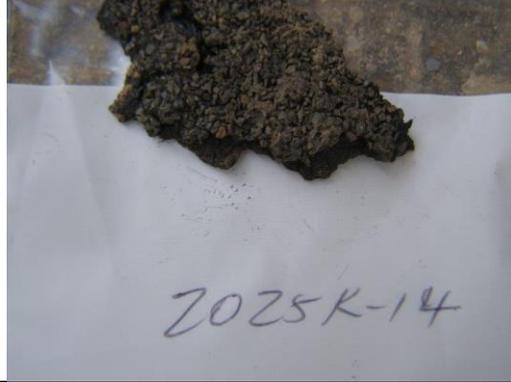
**Photo 14: Roof Shingle (2025K-14) Exterior.
No Asbestos Detected.**

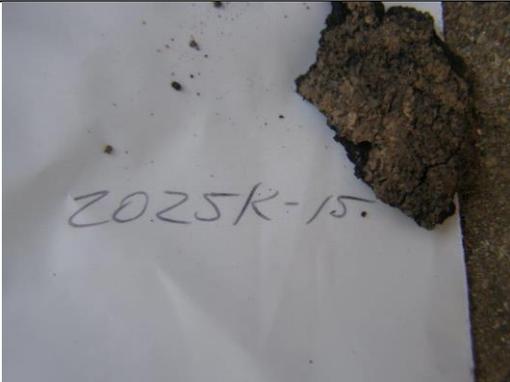
**Photo 15: Roof Shingle (2025K-15) Exterior.
No Asbestos Detected.**
