ASBESTOS INSPECTION REPORT

**2033 Kensington Dr.
Dayton, OH 45406**

Re: Asbestos Inspection
2033 Kensington Dr.
Dayton, OH 45406

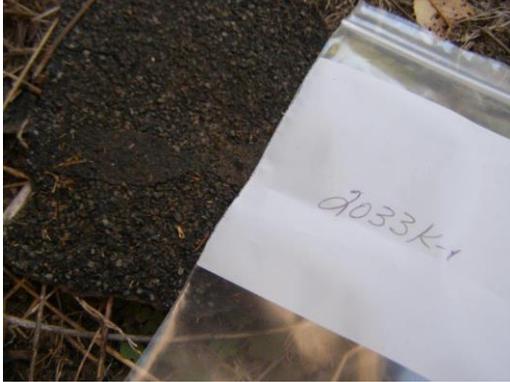
Photo 1: Roof Shingle (2033K-1) Exterior.
No Asbestos Detected.

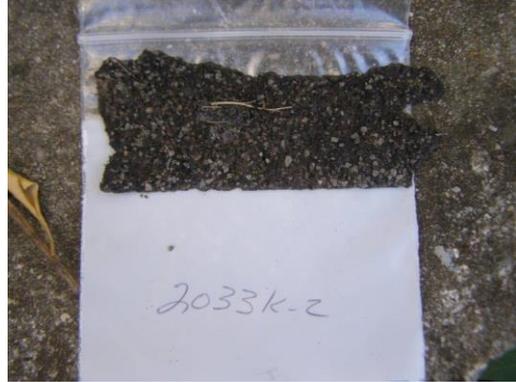
Photo 2: Roof Shingle (2033K-2) Exterior.
No Asbestos Detected.

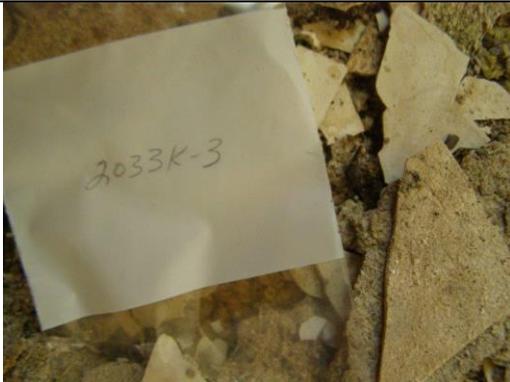
Photo 3: Plaster (2033K-3) Living Room, Ceiling.
Trace <1% Chrysotile Asbestos Detected (PC=0.50%).

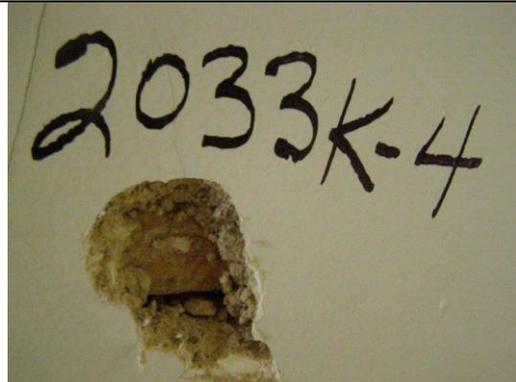
Photo 4: Plaster (2033K-4) Hall, Wall C.
Trace <1% Chrysotile Asbestos Detected (PC=0.25%).

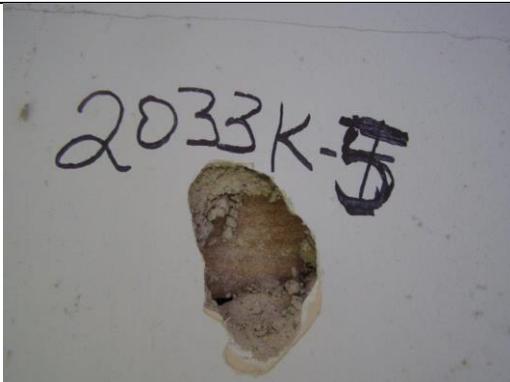
Photo 5: Plaster (2033K-5) Bath, Wall D.
Trace <1% Chrysotile Asbestos Detected (PC=0.50%).

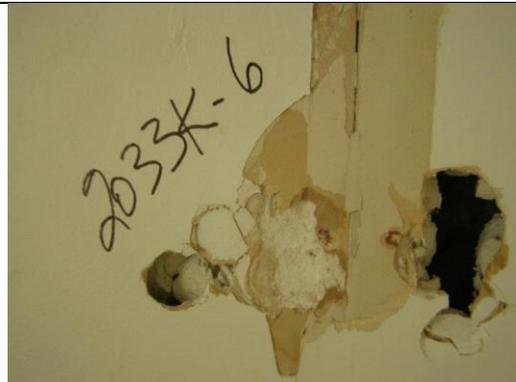
It should be noted that the joint compound, in Bedroom 1, was found to be greater than 1% asbestos. The drywall/joint compound composite, however, was less than 1%. As there was less than 50 sq. ft. of the joint compound, the Ohio Department of Health and the Ohio EPA do not consider this to be an asbestos-containing material. OSHA, however, does consider this an asbestos-containing material. Therefore, worker protection must be provided during demolition.

Photo 6: Drywall/J.C. (2033K-6) Bedroom 1, Wall C.
Trace <1% Chrysotile Asbestos Detected (Joint Compound PC=0.50%) (Composite PC=0.75%).

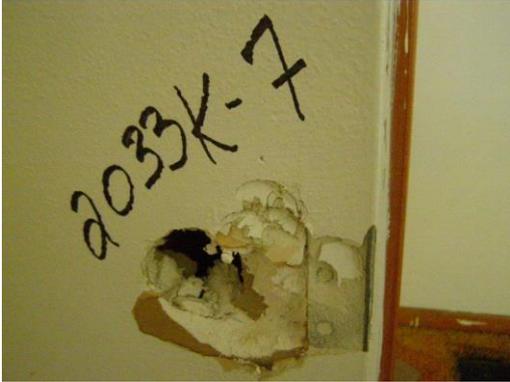
**Photo 7: Drywall/J.C. (2033K-7) Bedroom 2, Wall A.
Trace <1% Chrysotile Asbestos Detected (PC=1.0%).**

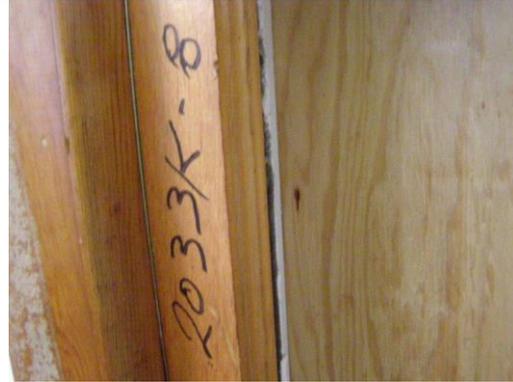
**Photo 8: Window Glazing (2033K-8) Bedroom 2, Wall D.
Trace <1% Chrysotile Asbestos Detected (PC=0.50%).**

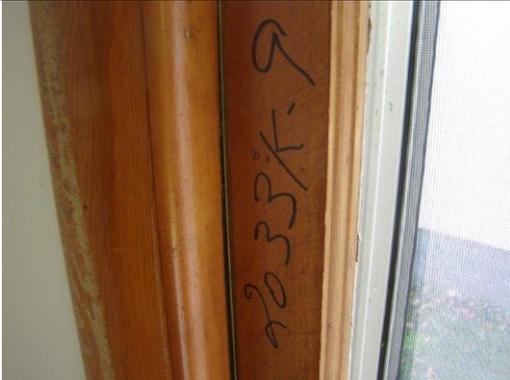
**Photo 9: Window Glazing (2033K-9) Bedroom 1, Wall B.
Trace <1% Chrysotile Asbestos Detected (PC=0.25%).**

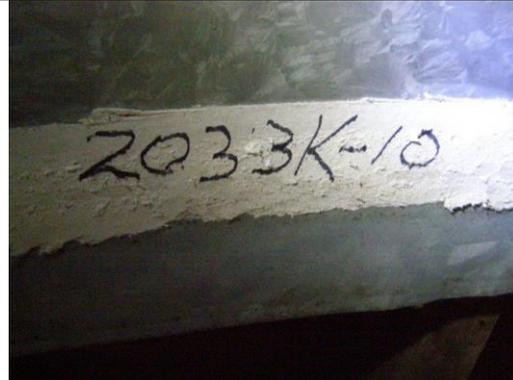
- Seam Tape, Basement

**Photo 10: Seam Tape (2033K-10) Basement, Ceiling.
55% Chrysotile Asbestos Detected.**

Confirmed or assumed asbestos-containing materials, which will be disturbed during demolition activities, are regulated under current Federal and State regulations. Hart Environmental Resources recommends the removal of these materials by a licensed asbestos abatement contractor. It is also strongly recommended that the specifications for the removal program be

<u>Material</u>	<u>Est. Qty.</u>	<u>Est. Unit Cost</u>	<u>Est. Cost</u>
Seam Tape	2 sq ft.	\$ 20/sq ft.	\$ 40
