## **ASBESTOS INSPECTION REPORT**

**105-107 Knecht Dr.  
Dayton, OH 45405**

**Lynda M. Hart  
Asbestos Hazards Evaluation Specialist  
Ohio #ES-32558  
October 30, 2015**

Re: Asbestos Inspection  
105-107 Knecht Dr.  
Dayton, OH 45405

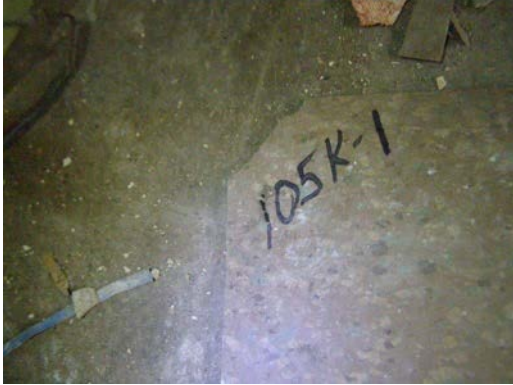
Photo 1: Tile(105K-1) Kitchen, Floor.  
3% Chrysotile Asbestos Detected (PC=2.50%).

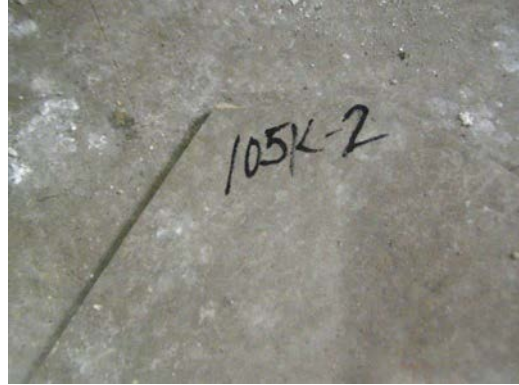
Photo 2: Tile (105K-2) Kitchen, Floor.  
3% Chrysotile Asbestos Detected (PC=3.50%).

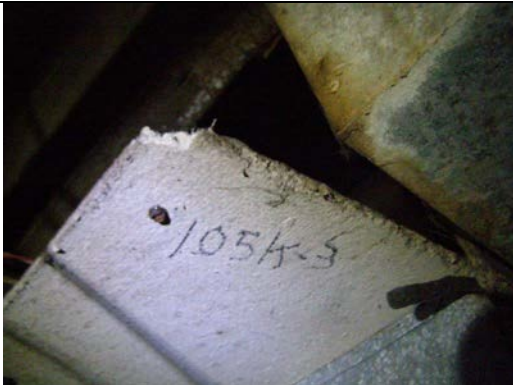
Photo 3: Furnace Board (105K-3) Basement.  
68% Chrysotile Asbestos Detected.

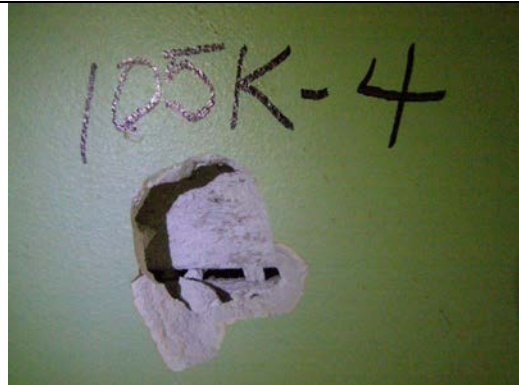
Photo 4: Plaster (105K-4) Kitchen, Wall A.  
Trace <1% Chrysotile Asbestos Detected (PC=<0.25%).

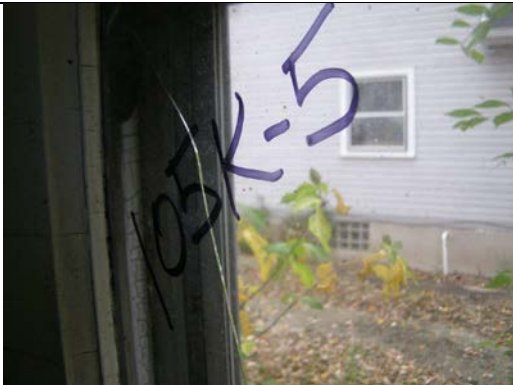
Photo 5: Window Glazing (105K-5) Kitchen, Wall B.  
No Asbestos Detected.

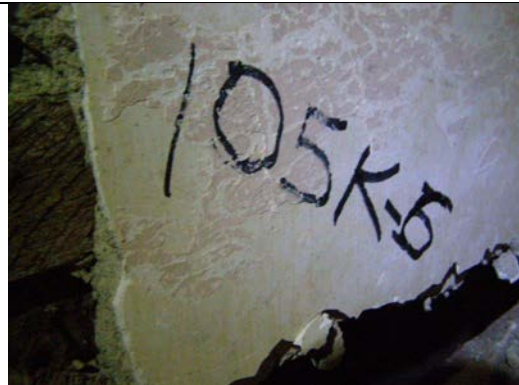
Photo 6: Plaster (105K-6) Dining Room, Wall D.  
Trace <1% Chrysotile Asbestos Detected (PC=<0.25%).

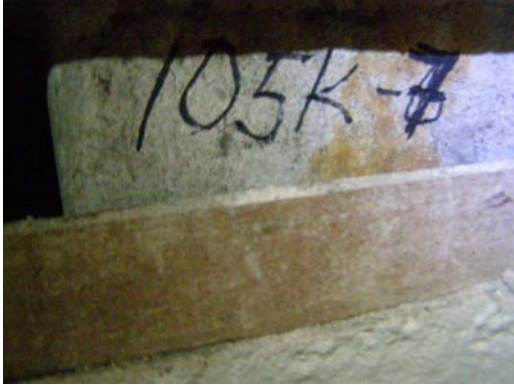
Photo 7: Duct Work Wrap (105K-7) Dining Room  
65% Chrysotile Asbestos Detected.

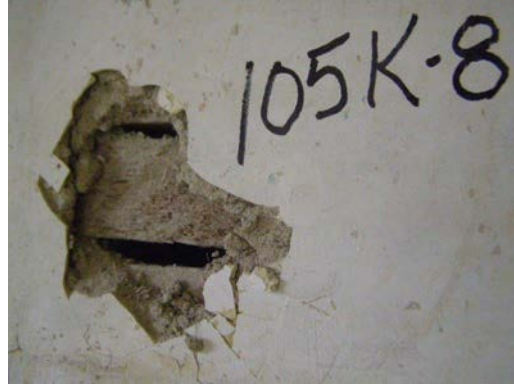
Photo 8: Plaster (105K-8) Bedroom 3 Closet, Wall B.  
Trace <1% Chrysotile Asbestos Detected (PC=<0.25%).

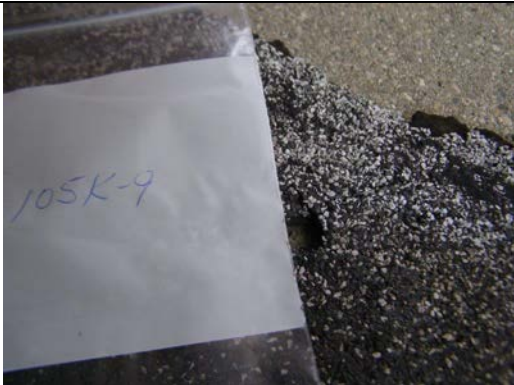
Photo 9: Roof Shingle (105K-9) Exterior.  
No Asbestos Detected.

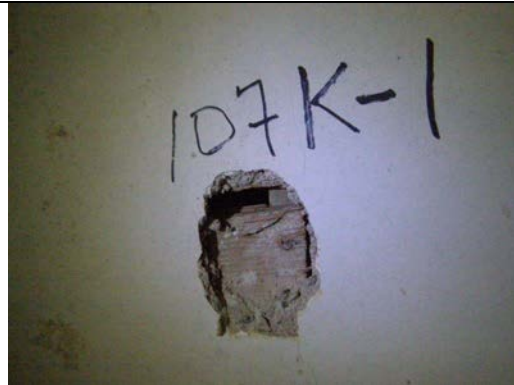
Photo 10: Plaster (107K-1) Dining Room, Wall B.  
Trace <1% Chrysotile Asbestos Detected (PC=0.50%).

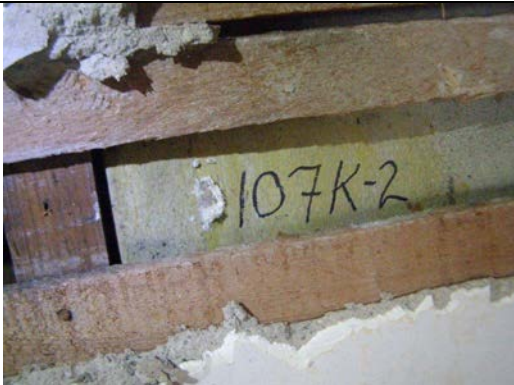
Photo 11: Duct Work Wrap (107K-2) Dining Room,  
Wall B. 65% Chrysotile Asbestos Detected.

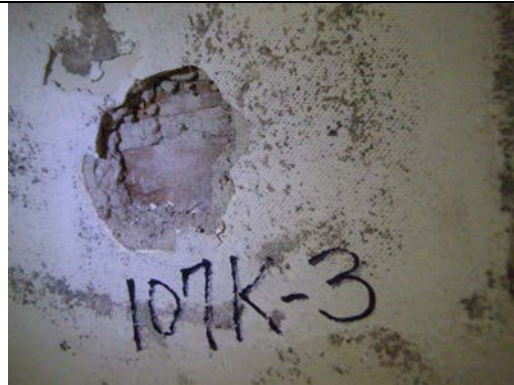
Photo 12: Plaster (107K-3) Living Room, Wall D.  
Trace <1% Chrysotile Asbestos Detected (PC=0.25%).

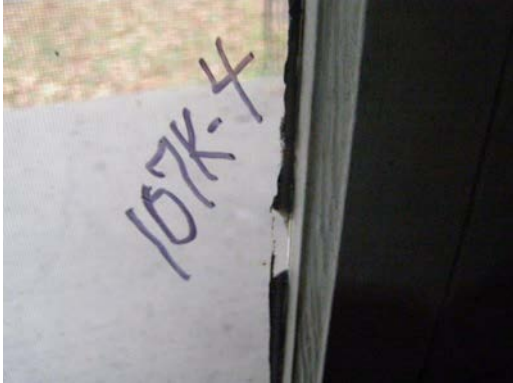
Photo 13: Window Glazing (107K-4) Living Room, Wall A. No Asbestos Detected.

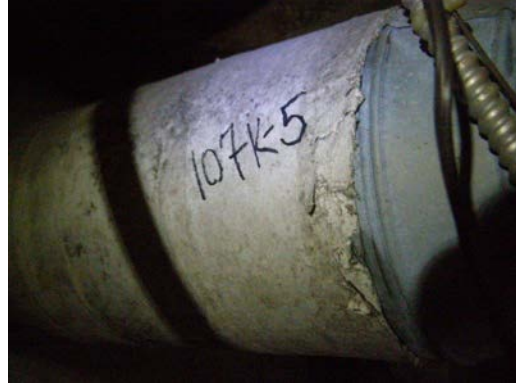
Photo 14: Duct Work Wrap (107K-5) Basement, Ceiling. 65% Chrysotile Asbestos Detected.

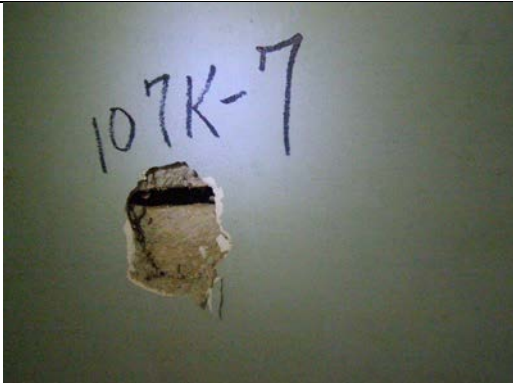
Photo 15: Plaster (107K-7) Bedroom 2, Wall B. Trace <1% Chrysotile Asbestos Detected PC=<0.25%).

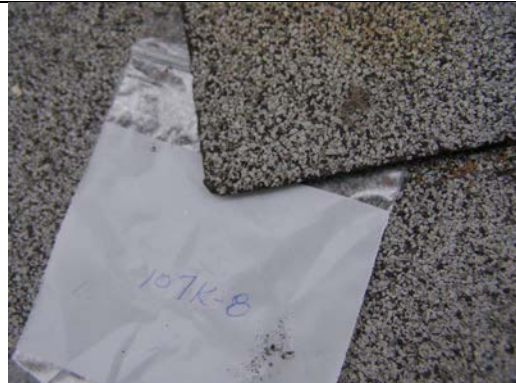
Photo 16: Roof Shingle (107K-8) Exterior. No Asbestos Detected.
