ASBESTOS INSPECTION REPORT

**109-111 Knecht Dr.
Dayton, OH 45405**

Re: Asbestos Inspection
109-111 Knecht Dr.
Dayton, OH 45405

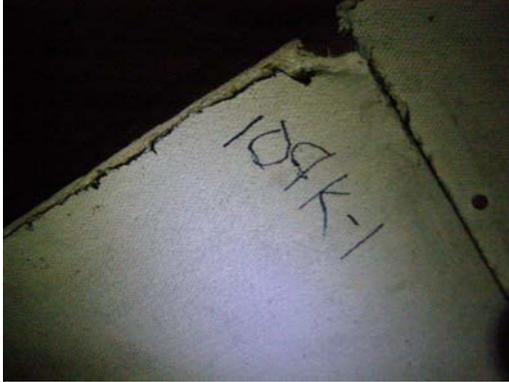
Photo 1: Furnace Board (109K-1) Basement, Ceiling.
65% Chrysotile Asbestos Detected.

Confirmed or assumed asbestos-containing materials, which will be disturbed during demolition activities, are regulated under current Federal and State regulations. Hart Environmental Resources recommends the removal of these materials by a licensed asbestos abatement contractor. It is also strongly recommended that the specifications for the removal program be developed by a licensed Asbestos Project Designer to ensure that all regulatory requirements are satisfied. The work should be properly documented in the event of future litigation.

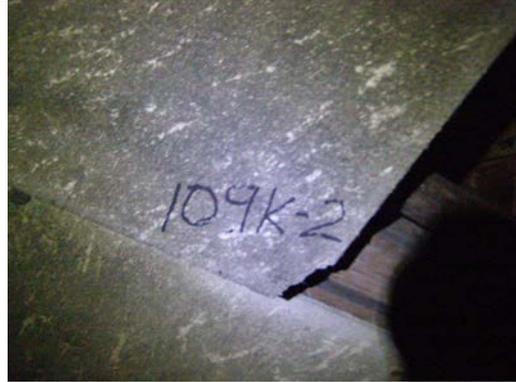
Photo 2: Transite (109K-2) Basement, Ceiling.
20% Chrysotile Asbestos Detected.

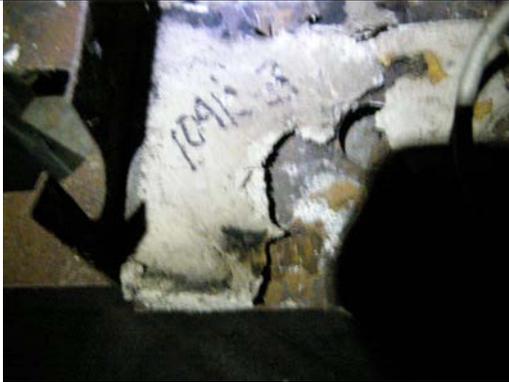
Photo 3: Furnace Insulation (109K-3) Basement,
Furnace. 65% Chrysotile Asbestos Detected.

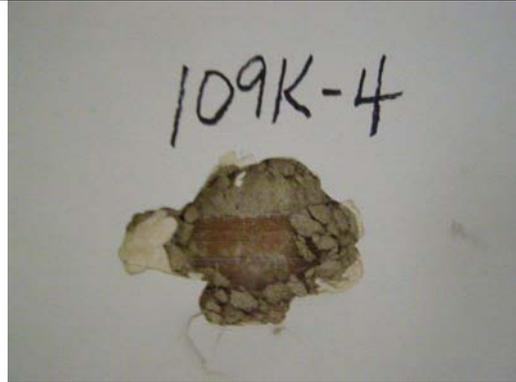
Photo 4: Plaster (109K-4) Kitchen, Wall C.
Trace <1% Chrysotile Asbestos Detected (PC=<0.25%).

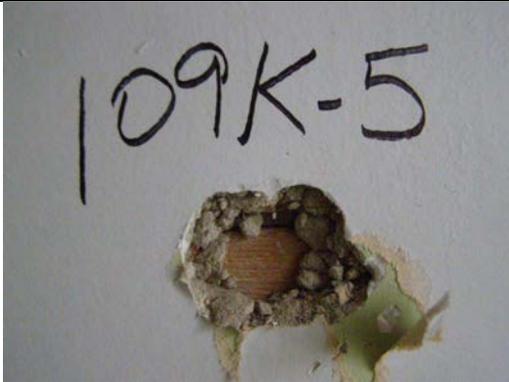
Photo 5: Plaster (109K-5) Bedroom, Wall A.
Trace <1% Chrysotile Asbestos Detected (PC=<0.25%).

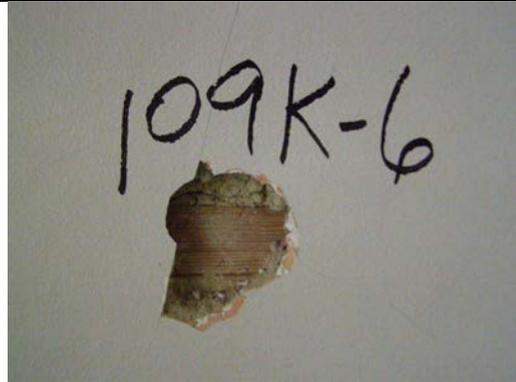
Photo 6: Plaster (109K-6) Living Room, Wall B.
Trace <1% Chrysotile Asbestos Detected (PC=<0.25%).

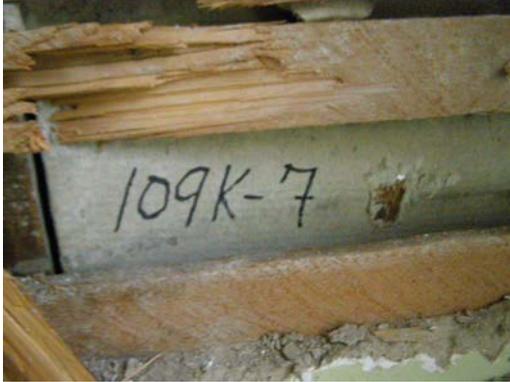
**Photo 7: Duct Work Wrap (109K-7) Bedroom, Wall A.
65% Chrysotile Asbestos Detected.**

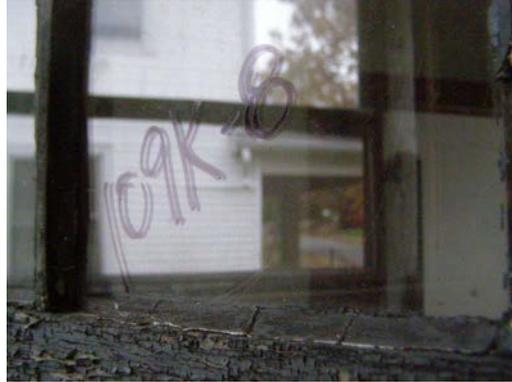
**Photo 8: Window Glazing (109K-8) Living Room, Wall B.
2% Chrysotile Asbestos Detected (PC=0.75%).**

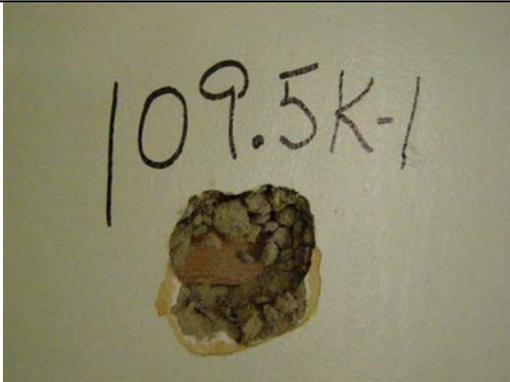
**Photo 9: Plaster (109.5K-1) Kitchen, Wall A.
Trace <1% Chrysotile Asbestos Detected (PC=0.25%).**

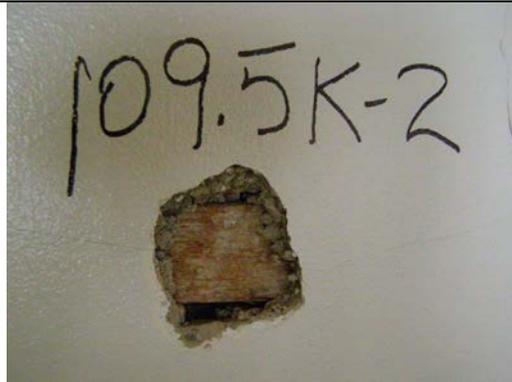
**Photo 10: Plaster (109.5K-2) Living Room, Wall D.
Trace <1% Chrysotile Asbestos Detected (PC=<0.25%).**

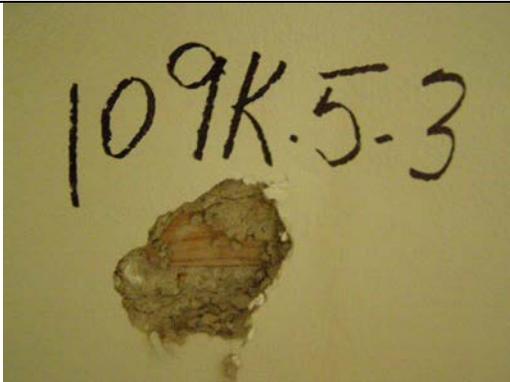
**Photo 11: Plaster (109.5K-3) Bedroom, Wall B.
Trace <1% Chrysotile Asbestos Detected (PC=0.25%).**

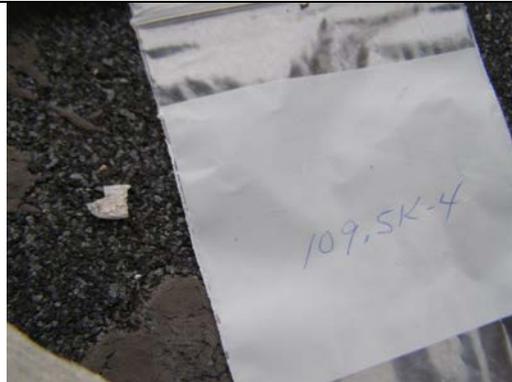
**Photo 12: Roof Shingle (109.5K-4) Exterior.
No Asbestos Detected.**

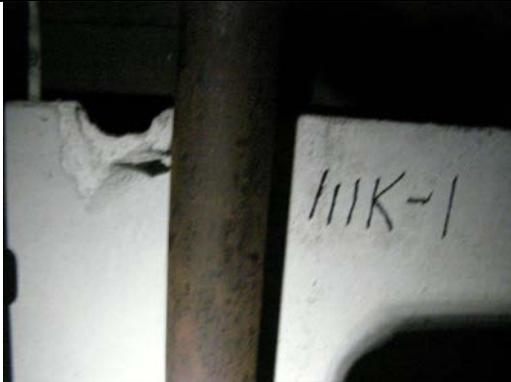
Photo 13: Furnace Board (111K-1) Basement, Ceiling.
65% Chrysotile Asbestos Detected.

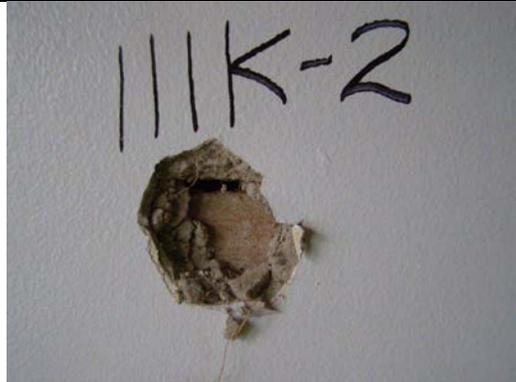
Photo 14: Plaster (111K-2) Dining Room, Wall A.
Trace <1% Chrysotile Asbestos Present (PC=<0.25%).

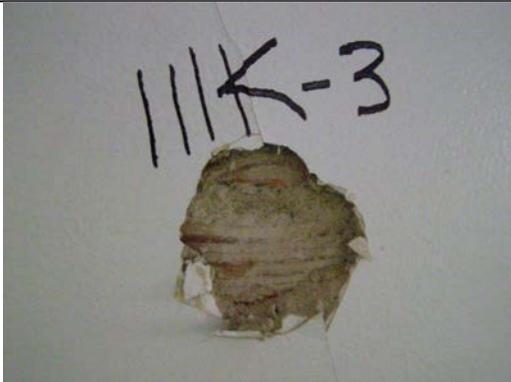
Photo 15: Plaster (111K-3) Living Room, Wall D.
Trace <1% Chrysotile Asbestos Present (PC=0.25%).

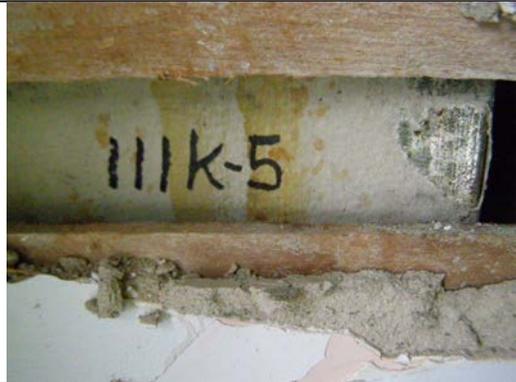
Photo 16: Duct Work Wrap (111K-5) Dining Room, Wall D.
65% Chrysotile Asbestos Present.

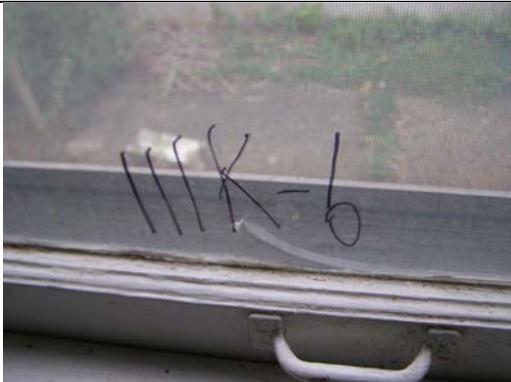
Photo 17: Window Glazing (111K-6) Dining Room,
Wall A. No Asbestos Detected.

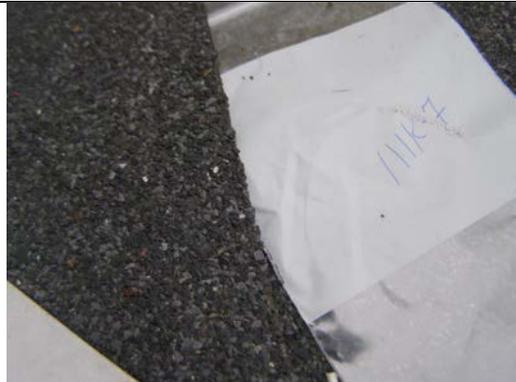
Photo 18: Roof Shingle (111K-7) Exterior.
No Asbestos Detected.
